Middletown Township
Bayshore Library Branch
180 Main Street Port Monmouth, New Jersey

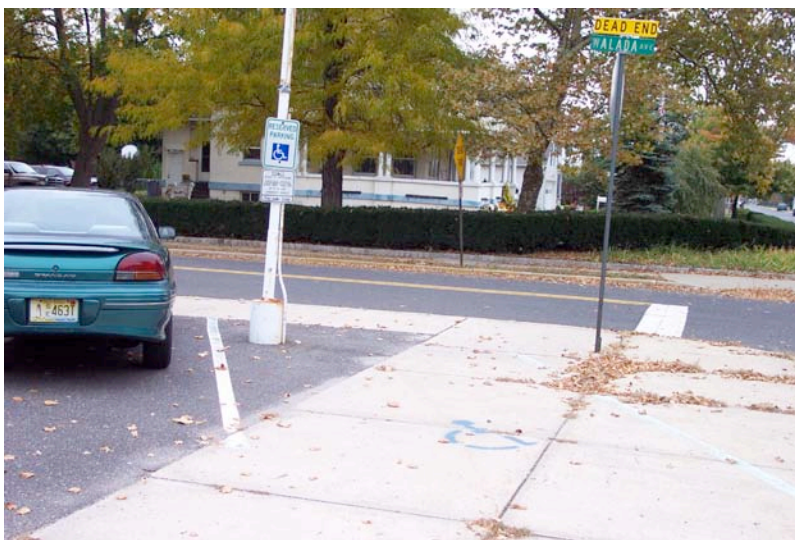
1. The following problems were found in the parking area.
 - a. There is no access aisle next to the designated disabled parking space, contrary to ANSI section 502.3 and ADAAG section 4.6.3.
 - b. The parking space is not long enough per ANSI section 502.2 and ADAAG section 4.6.3.
 - c. The disabled parking space, when utilized, blocks the sidewalk which is the designated route of travel around this facility, contrary to ANSI section 403.5 and ADAAG section 4.3.3.

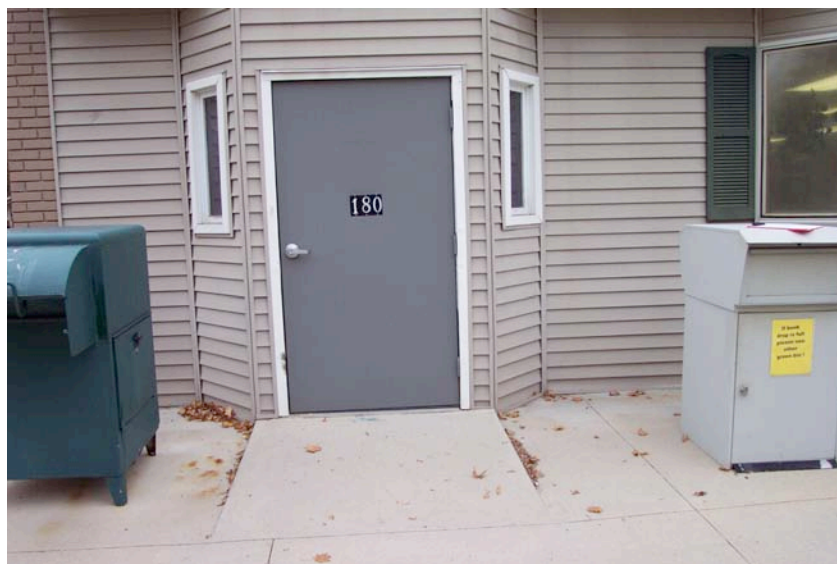
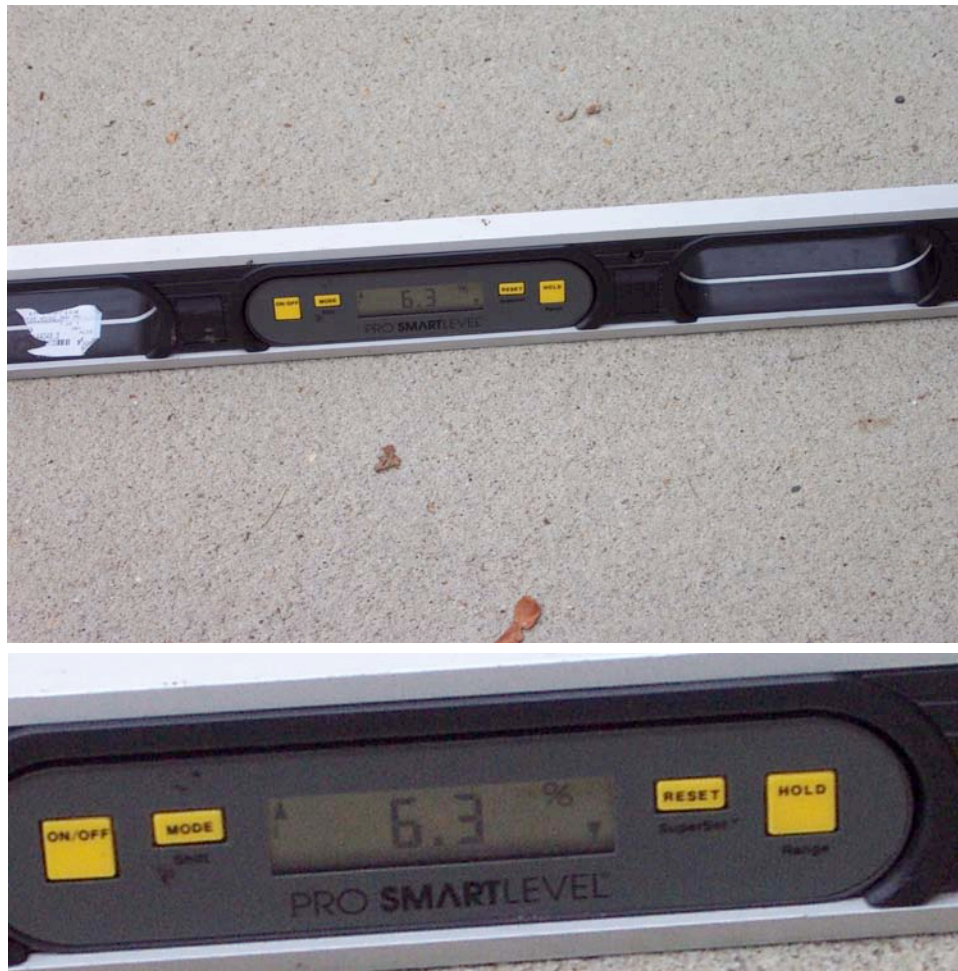
2. The front entrance ramp has a slope of 6.3%, contrary to ANSI section 404.2.4.5 and ADAAG section 4.16.6.

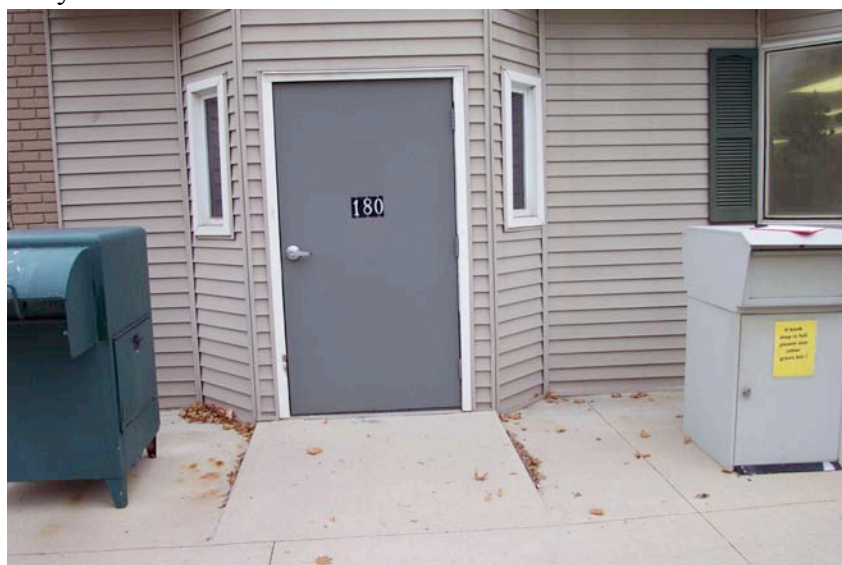
3. The return book bay to the left of the front door requires more than 5 pounds of pressure to operate, contrary to ANSI section 309.4 and ADAAG section 4.27.4.

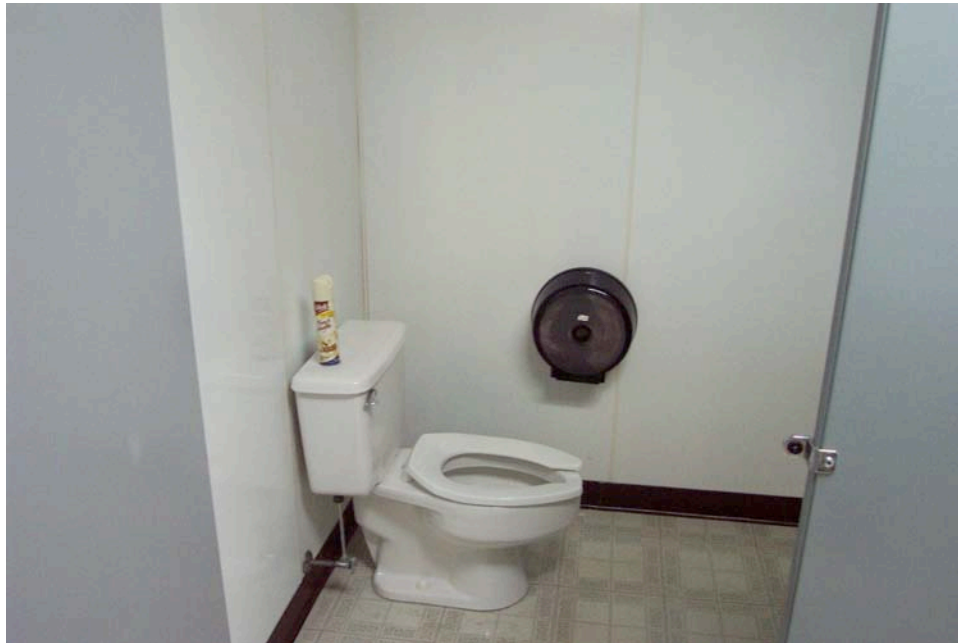
4. The women's restroom has the following problems to be corrected.
 - a. The toilet measures 19 inches off of the side wall, contrary to ANSI section 604.2 and ADAAG section 4.17.3.
 - b. The toilet measures 15 inches high above the finished floor, contrary to ANSI section 604.4 and ADAAG section 4.16.3.
 - c. There are no grab bars mounted behind and to the side of the toilet, contrary to ANSI section 604.5 and ADAAG section 4.17.6.

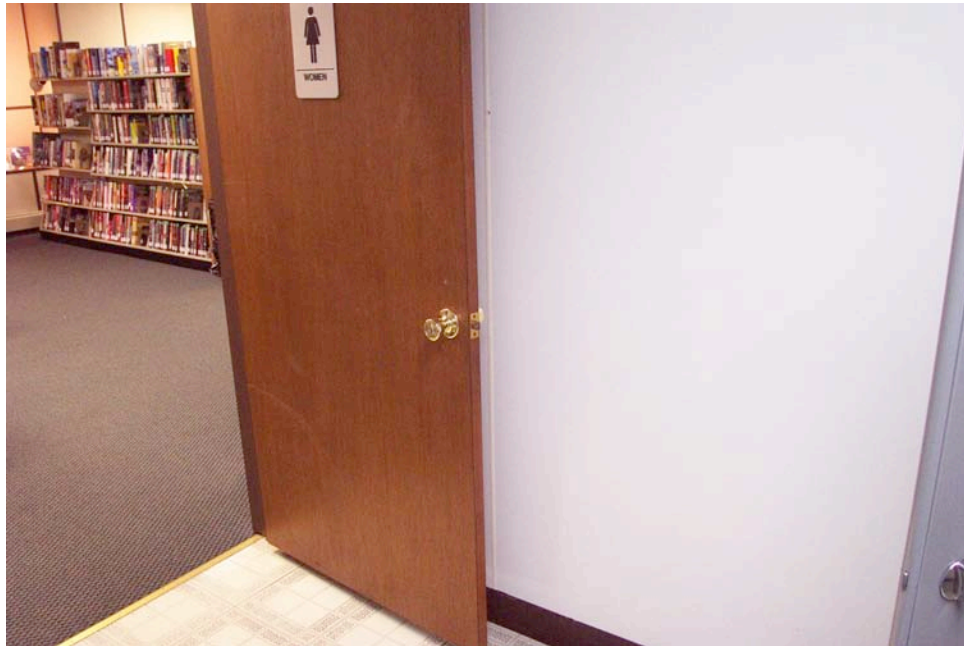
- d. There is a pinch lock on the stall door which requires pinching, grasping, and twisting of the wrist and hand, contrary to ANSI section 404.2.7 and ADAAG section 4.13.9.
- e. There is non self closing door on the stall, contrary to ANSI section 404.3.
- f. There is a round door knob on the bathroom door, contrary to ANSI section 404.2.7 and ADAAG section 4.13.9. There is no sign mounted at 60 inches on the latch side of the door per ADAAG section 4.30.4.30.6 or ANSI section 703.2.7 which states the sign shall be mounted at a height of 48 inches on center.

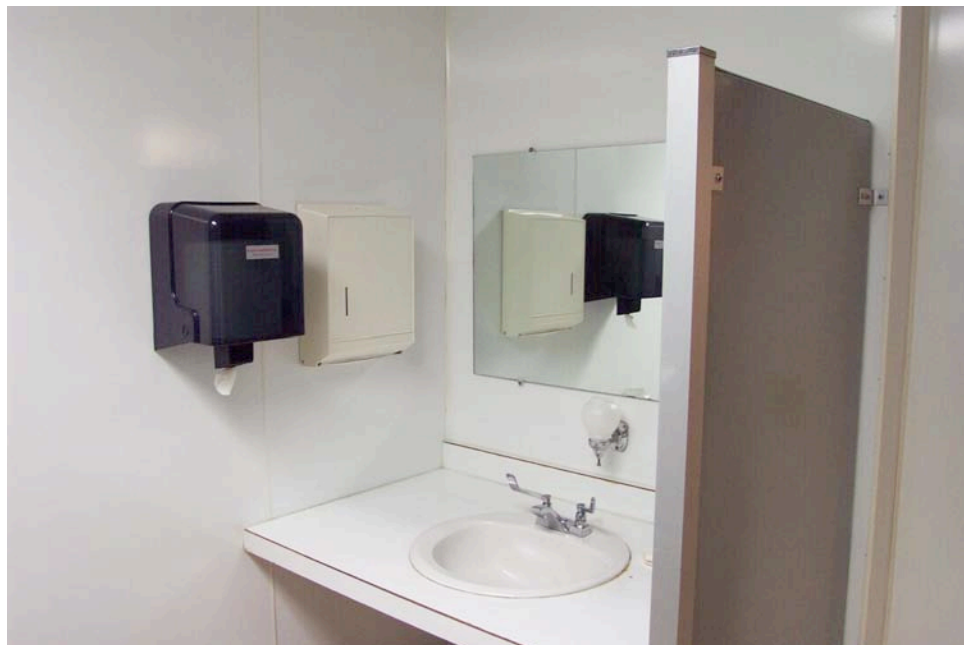
- g. The paper towel dispenser measures 49 inches above the finished floor for a frontal approach, contrary to ANSI section 308.2.1 and ADAAG section 4.2.5.

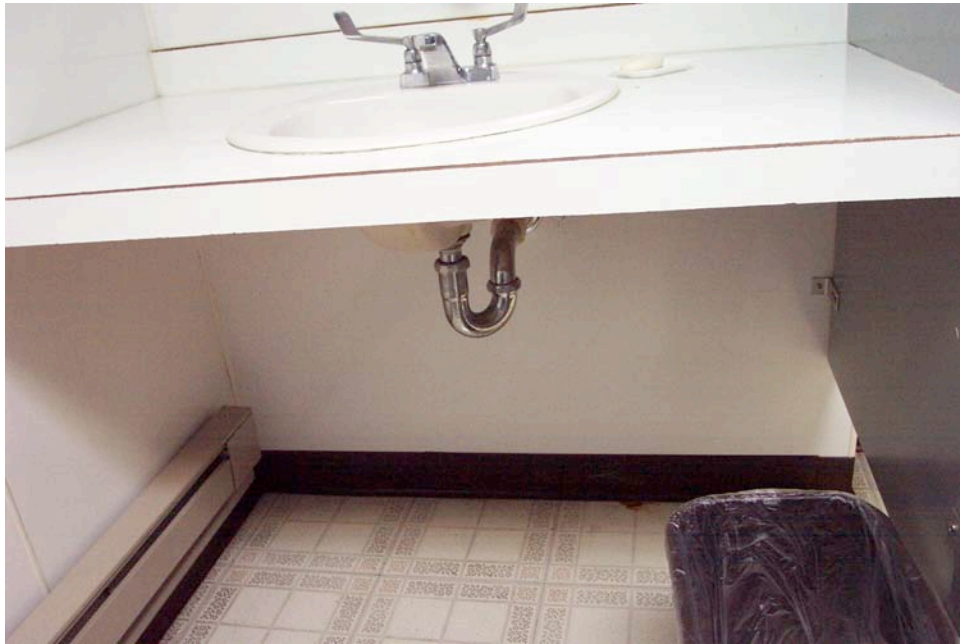
- h. The hot water and drain pipes under the sink are not insulated, contrary to ANSI section 606.6 and ADAAG section 4.19.4.

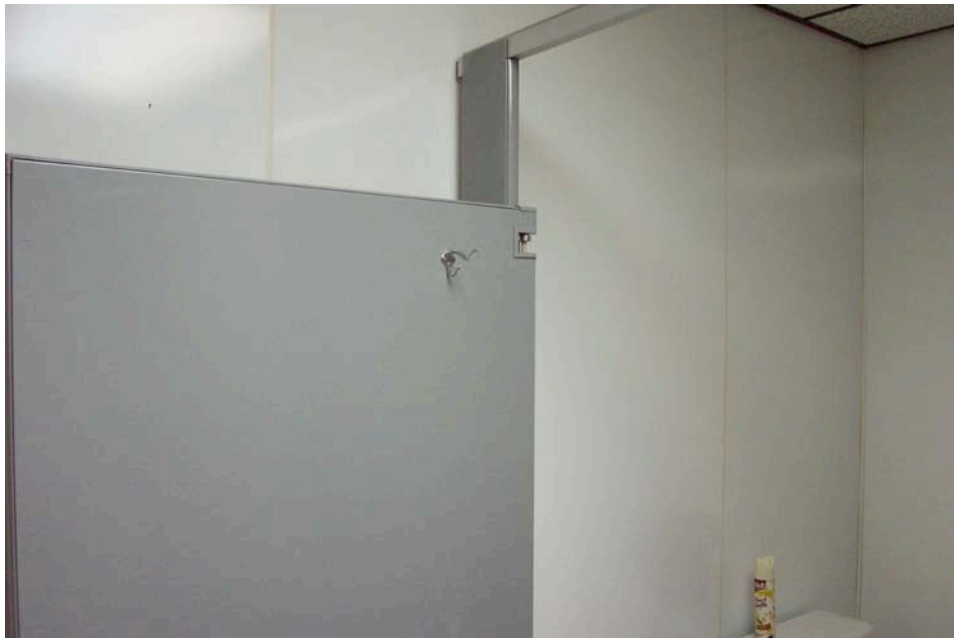
- i. The mirror measures 45 inches above the finished floor to the bottom of the reflective surface, contrary to ANSI section 603.3 and ADAAG section 4.19.6.
- j. The coat hook measures 65 inches above the finished floor, contrary to ANSI section 603.4 and ADAAG section 4.2.5.

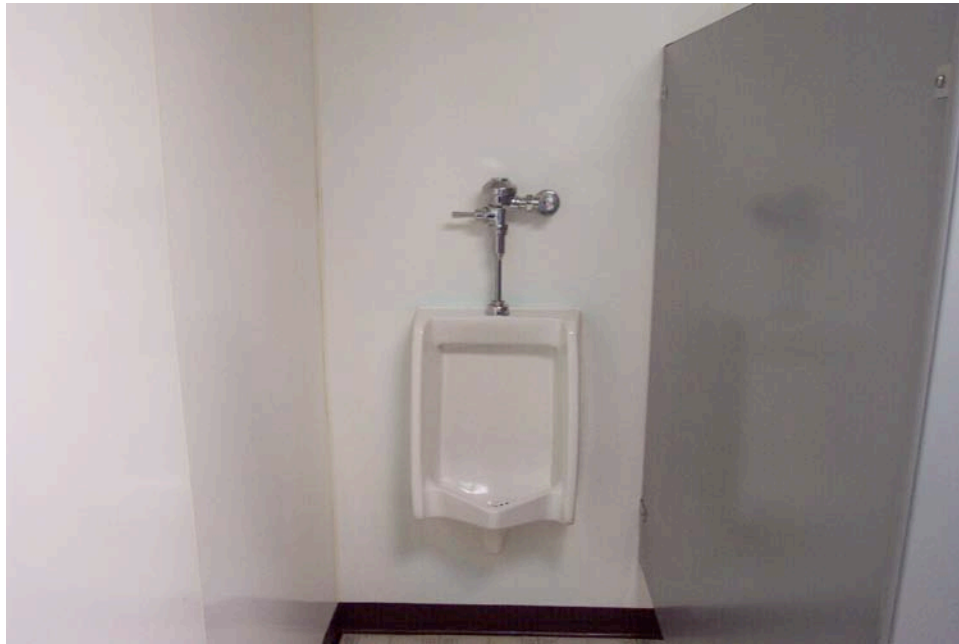
- 5. The men's bathroom has the following problems to be corrected.
 - a. The urinal measures 22.5 inches to the lip and 52 inches to the flush valve above the finished floor, contrary to ANSI section 605.2 and ADAAG section 4.18.2.

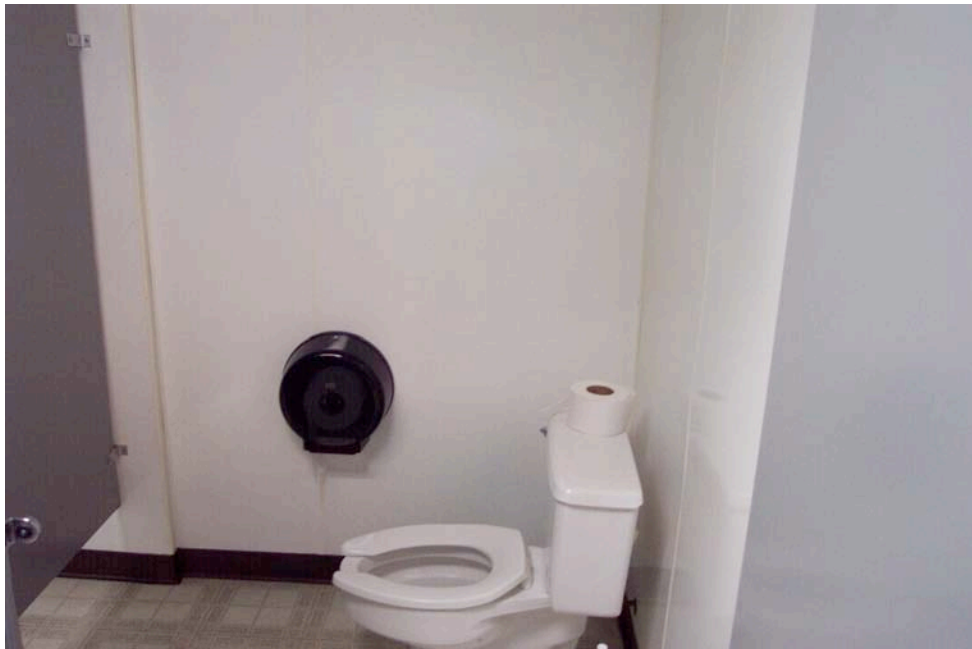
- b. The toilet measures 19 inches off of the side wall, contrary to ANSI section 604.2 and ADAAG section 4.16.2.
- c. The toilet measures 15 inches high above the finished floor, contrary to ANSI section 604.4 and ADAAG section 4.16.3. The flush valve is on the narrow side of the stall contrary to ADAAG section 4.16.5.
- d. There are no grab bars mounted behind and to the side of the toilet, contrary to ANSI section 604.5 and ADAAG section 4.17.6.

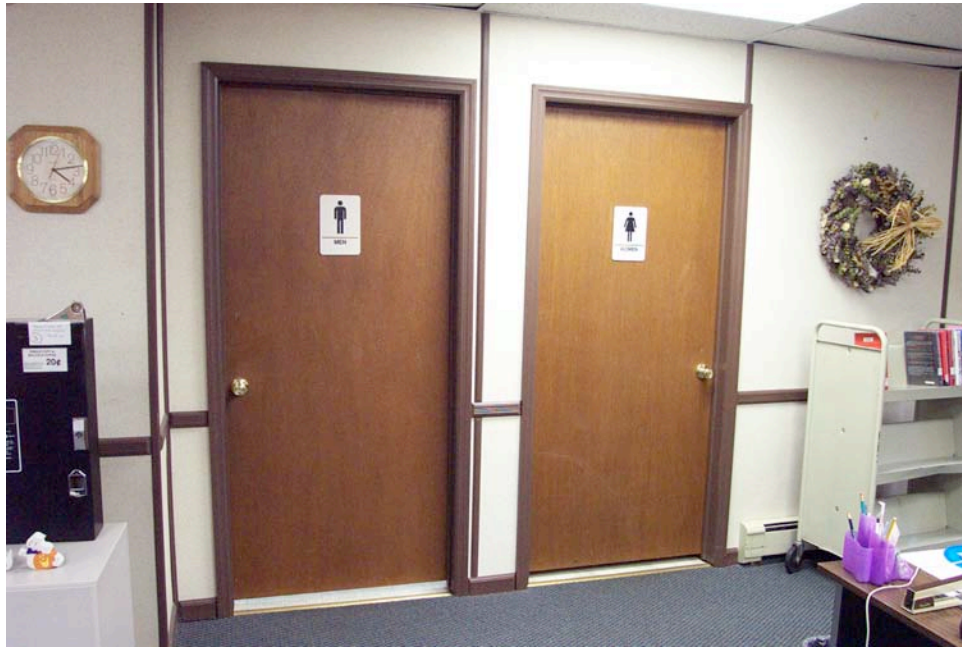
- e. There is a pinch lock on the stall door which requires pinching, grasping, and twisting of the wrist and hand, contrary to ANSI section 404.2.7 and ADAAG section 4.13.9.
- f. There is non self closing door on the stall, contrary to ANSI section 404.3.
- g. There is a round door knob on the bathroom door, contrary to ANSI section 404.2.7 and ADAAG section 4.13.9. There is no sign mounted at 60 inches on the latch side of the door per ADAAG section 4.30.4.30.6 or ANSI section 703.2.7 which states the sign shall be mounted at a height of 48 inches on center.

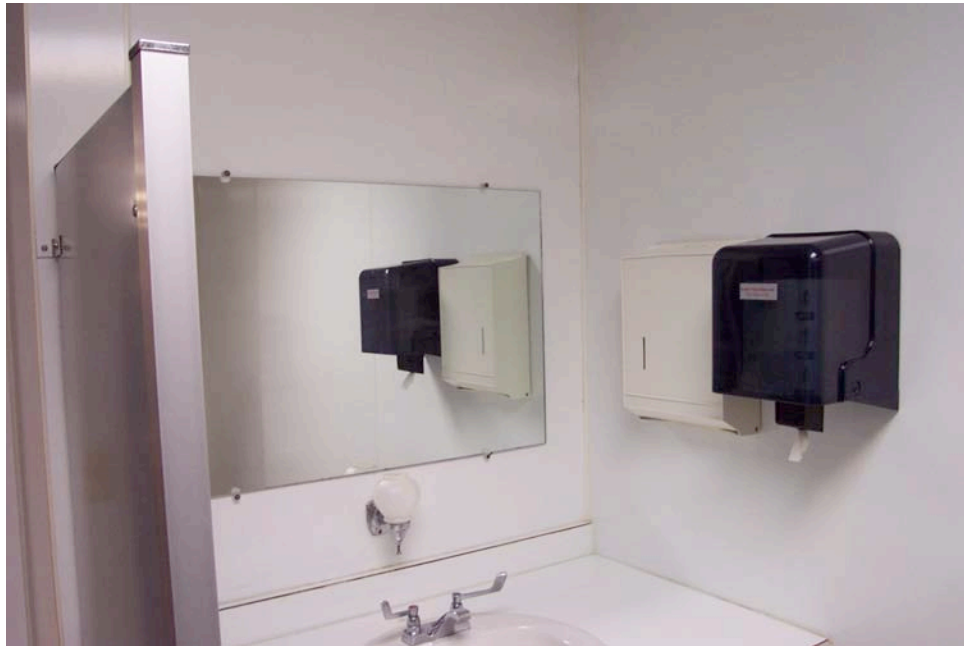
- h. The paper towel dispenser measures 49 inches above the finished floor for a frontal approach, contrary to ANSI section 308.2.1 and ADAAG section 4.2.5.
- i. The hot water and drain pipes under the sink are not insulated, contrary to ANSI section 606.6 and ADAAG section 4.19.4.
- j. The mirror measures 45 inches above the finished floor to the bottom of the reflective surface, contrary to ANSI section 603.3 and ADAAG section 4.19.6.

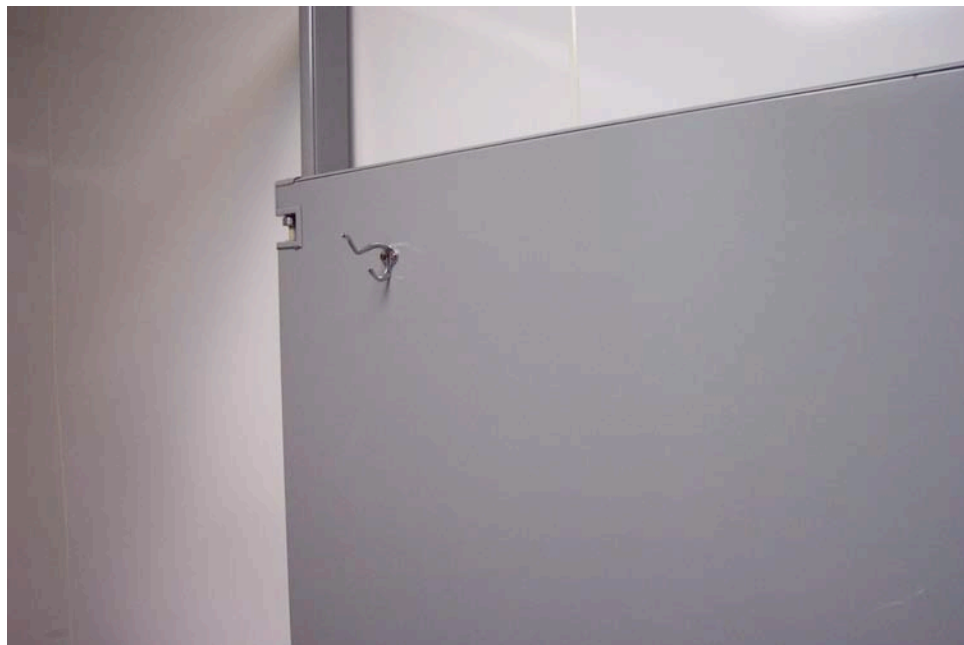
- k. The coat hook measures 65 inches above the finished floor, contrary to ANSI section 603.4 and ADAAG section 4.2.5.

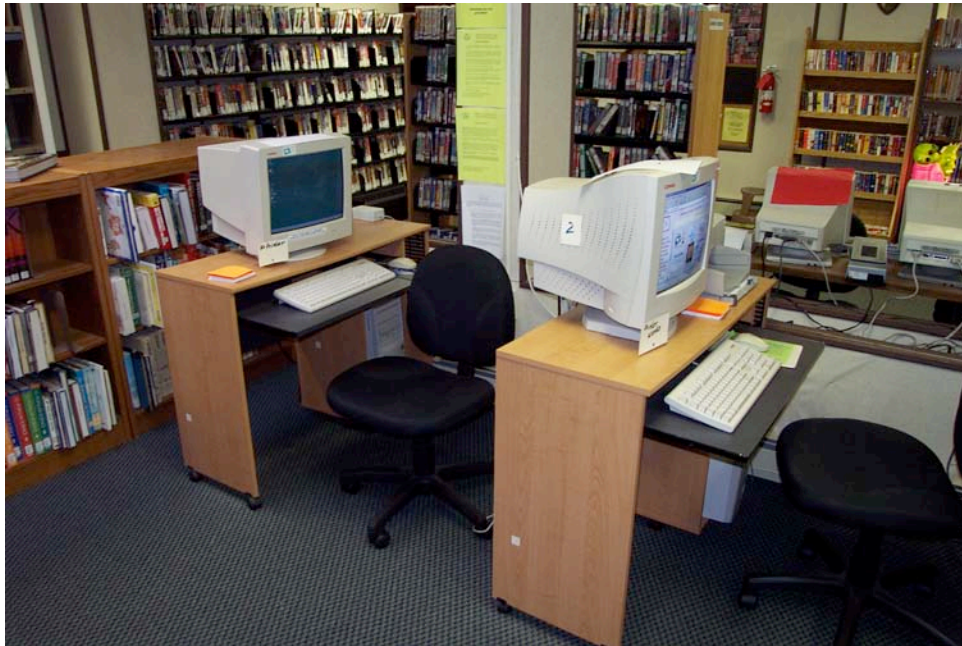
- 6. The computer resource desk is not accessible according to the guidelines set by ANSI section 902.3 and ADAAG sections 4.32.3 and 4.32.4.

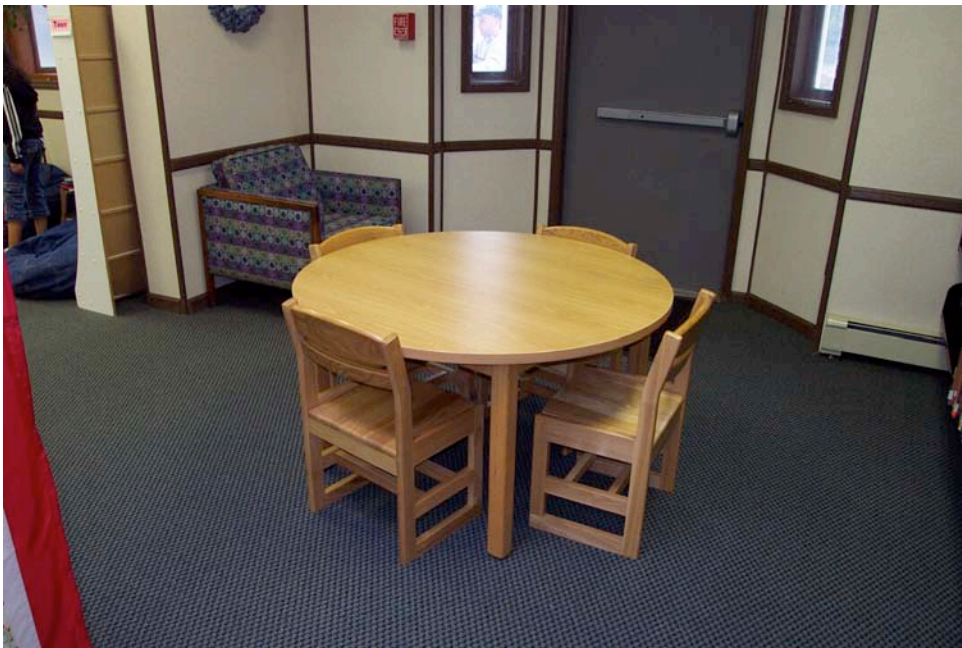
7. The tables in the library measure 25.5 inches above the finished floor, contrary to ANSI section 902.3 and ADAAG section 4.32.4.

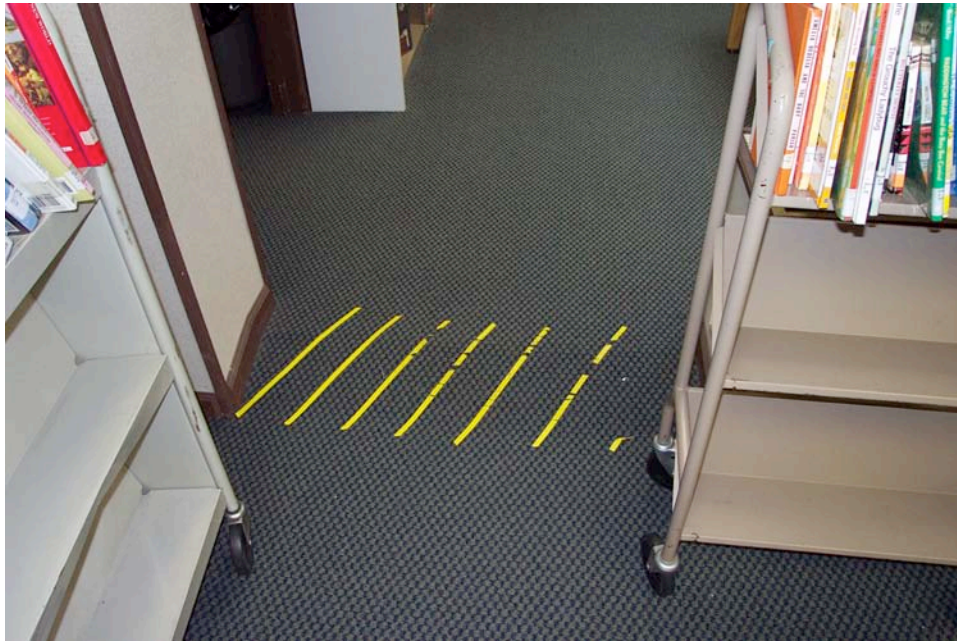
8. There are return book carts that are frequently positioned within the path of travel, therefore reducing the accessible route to less than 36 inches wide, contrary to ANSI section 403.3 and ADAAG section 4.3.3.

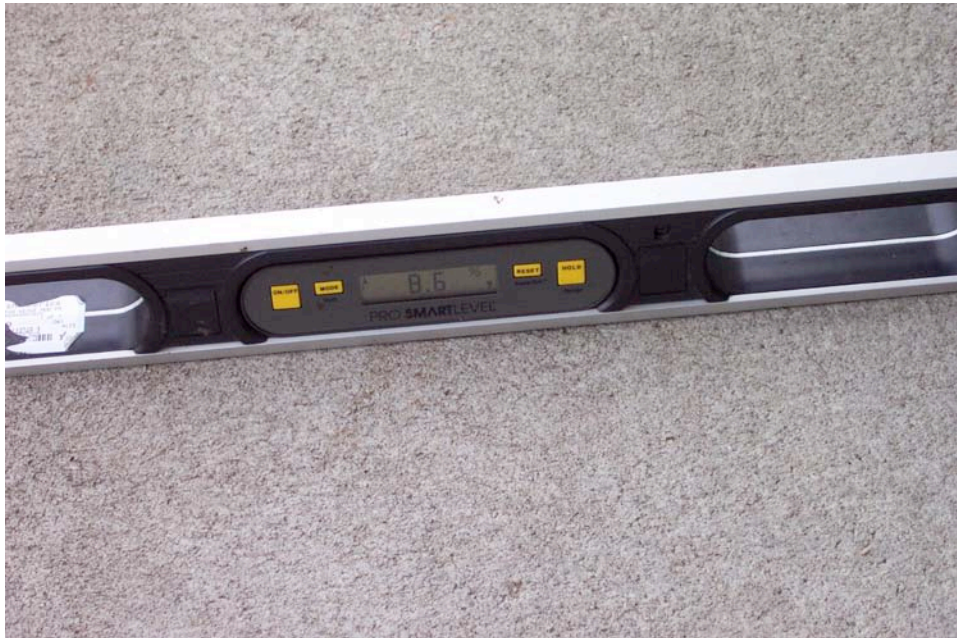
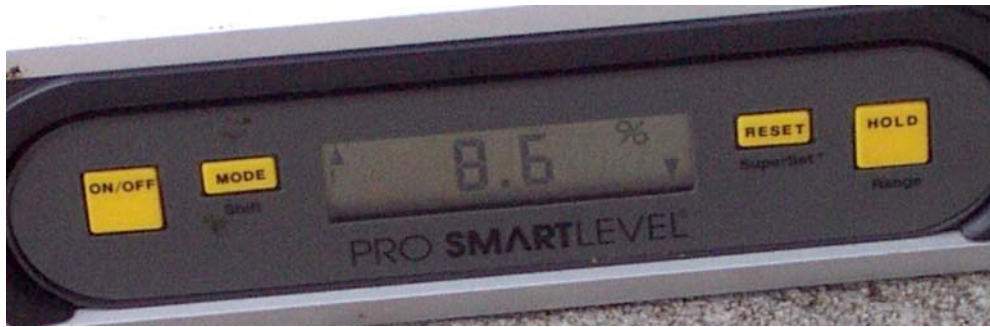
9. The back door has a ramp with a slope of 8.6%, contrary to ANSI section 405.2 and ADAAG section 4.8.2.

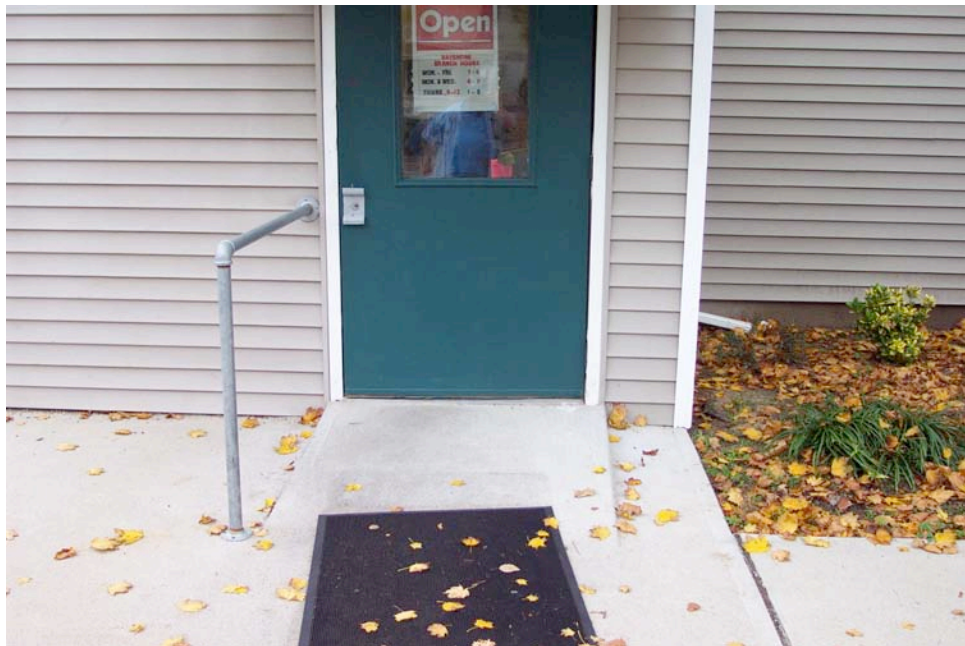
10. The door closes faster than 5 seconds when measured from a 90 degree angle to within 12 degrees of the door jam, contrary to ANSI section 404.2.8.1 and ADAAG section 4.13.10.
