Navesink Library

149 Monmouth Ave. Navesink, NJ

Upon inspection the following problems were confirmed at the Navesink Branch Library located 149 Monmouth Ave, Navesink, NJ.

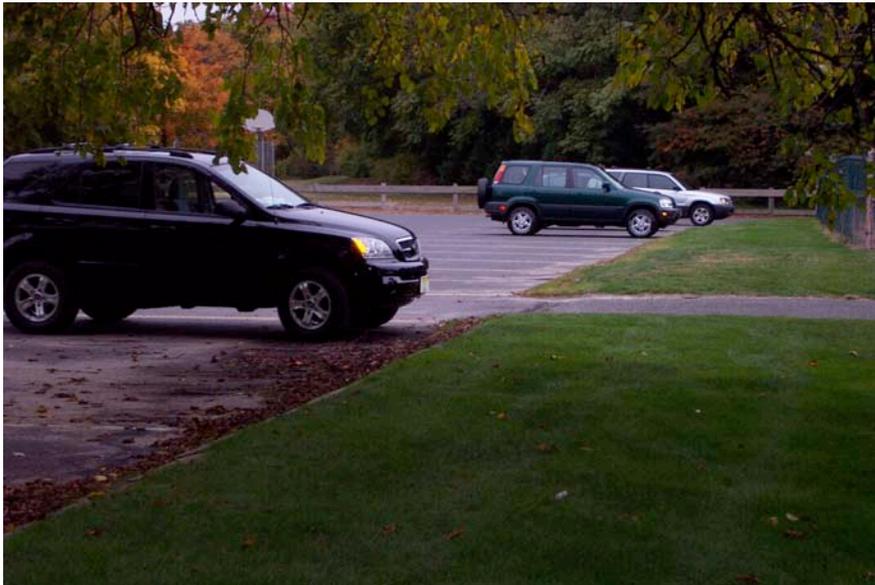
1. There are no designated disabled parking spaces at this location, contrary to ANSI section 502 and ADAAG section 4.6. Each space should be installed on a level area with a slope no greater than 2% in any direction. They should be the closest to an accessible entrance, which in this case appears to be the rear entrance. Since this library is located next to a school and the parking lot is utilized by both facilities there should be at least two accessible parking spaces on either side of the sidewalk leading to the library. The spaces should be 8 feet wide with an 8 foot access aisle between the two spaces which leads to the sidewalk and then to the accessible entrance. Each space should have proper signage designating the space as handicapped accessible and below the international handicapped accessibility symbol should be a sign designating the fines associated with violations of illegally parking in these spaces.

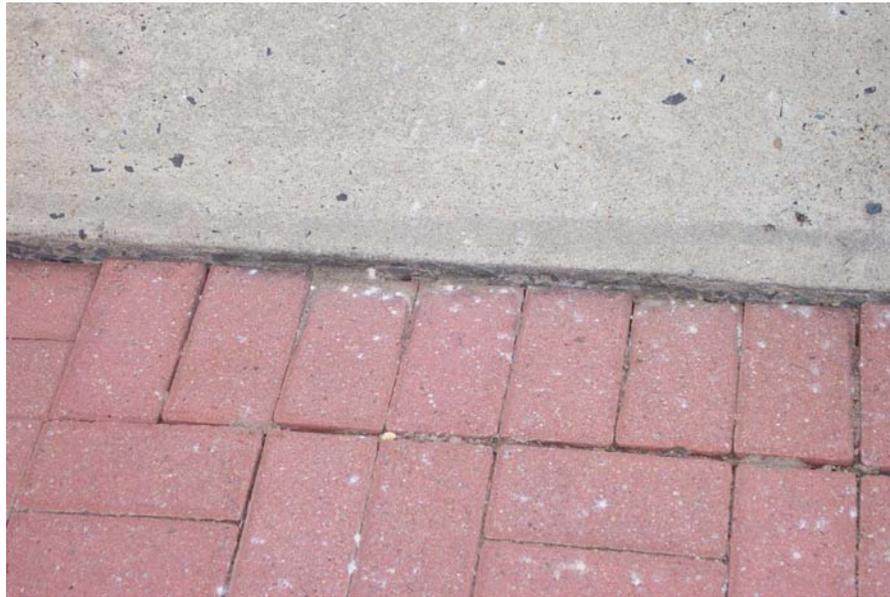
2. There is no access to the front entrance due to the steps lacking an accessible means of travel into this entrance, contrary to ANSI section 303.2 and ADAAG section 4.5.2.
3. The ramp at the parking area has the following problems to be corrected.
 - a. There is a 1 inch threshold transition to the ramp, contrary to ANSI section 303.2 and ADAAG section 4.5.2. The pink bricks will need to be removed and the ground will have to be leveled so there is a level transition between the brick and the concrete ramp.

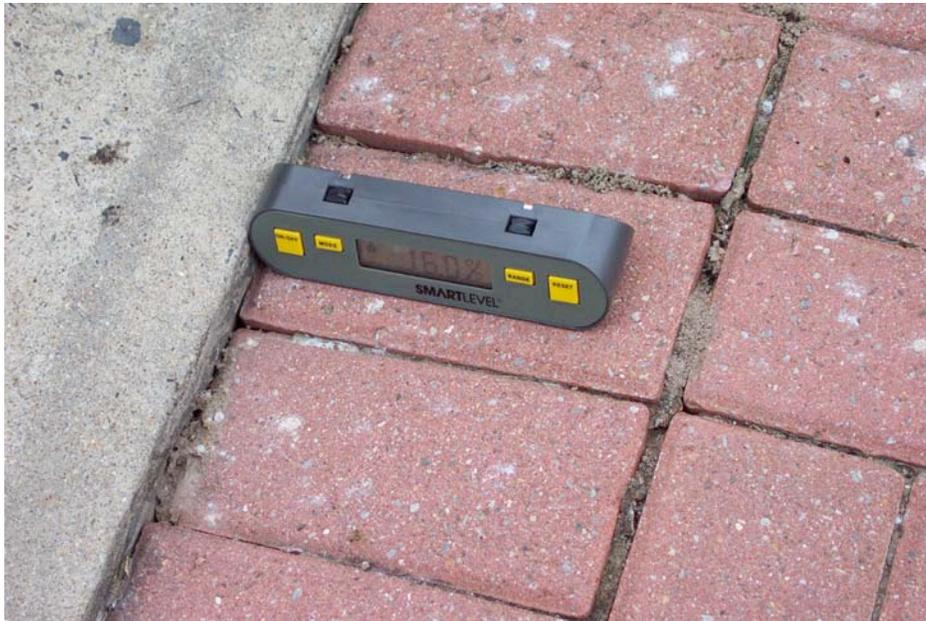
- b. The bottom landing has a slope of 16%, contrary to ANSI section 405.7.1 and ADAAG section 4.8.2. These bricks should be level since they exist directly after a ramp and by leveling this area the excessive slope will be eliminated.

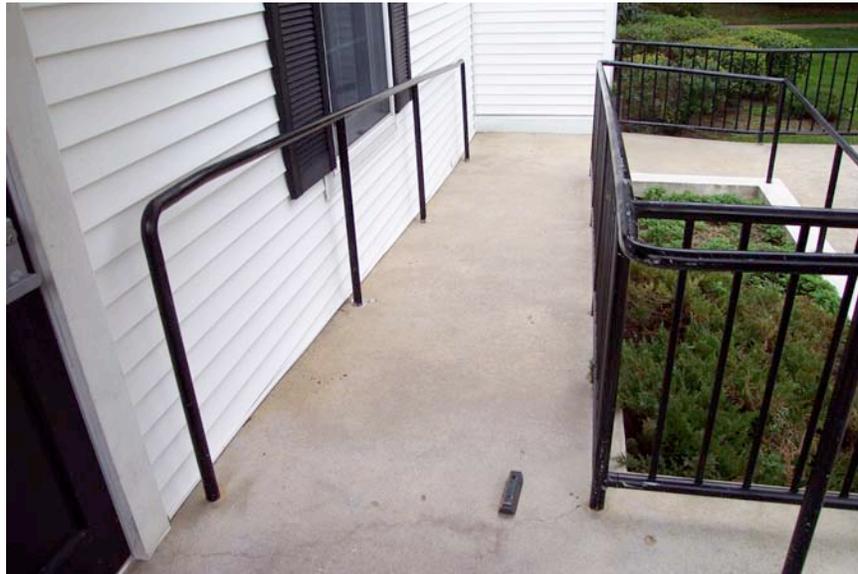
- c. The handrails have extensions of 6 inches at the bottom of the ramp and there are no extensions at the top, contrary to ANSI section 505.10.1 and ADAAG section 4.8.5. The handrail extensions should be a minimum of 12 inches beyond the slope at the top and bottom of the ramp.

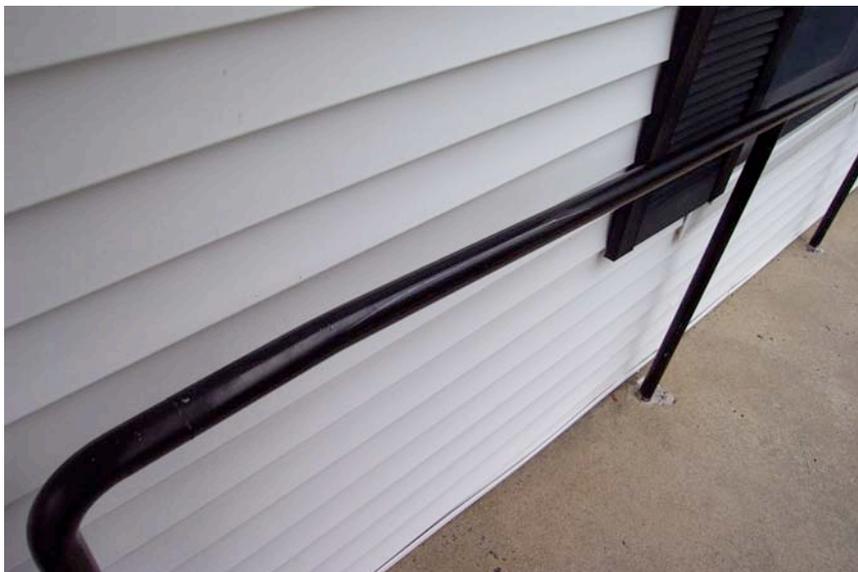
- d. The handrails extend 3 inches off of the wall, contrary to ANSI section 505.1 and ADAAG section 4.8.5. This handrail on the right side of the ramp facing the top will need to be relocated so that the railing is no more than 1.5 inches off of the wall to lessen the possibility of a guest getting their arm caught between the handrail and the wall.

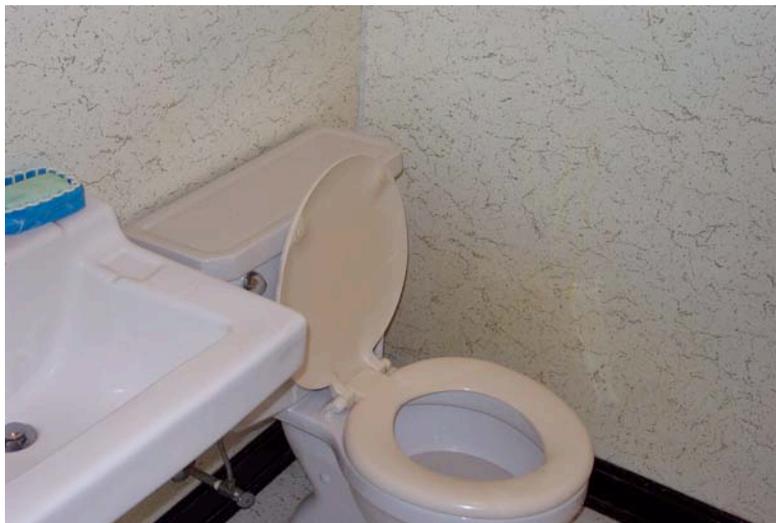
5. The bathroom has the following problems which need to be corrected.
 - a. The toilet is less than 17 inches high above the finished floor, contrary to ANSI section 604.4 and ADAAG section 4.16.3.
 - b. There are no grab bars behind and beside the toilet, contrary to ANSI section 604.5 and ADAAG section 4.16.4.
 - c. There is no transfer room next to the toilet, contrary to ANSI section 604.2 and ADAAG section 4.16.2.

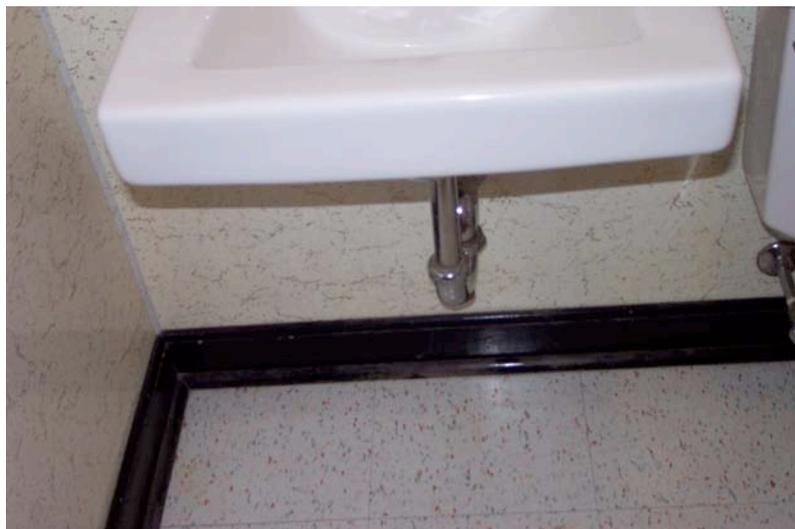
- d. The hot water and drain pipes under the sink are not insulated, contrary to ANSI section 606.6 and ADAAG section 4.19.4.

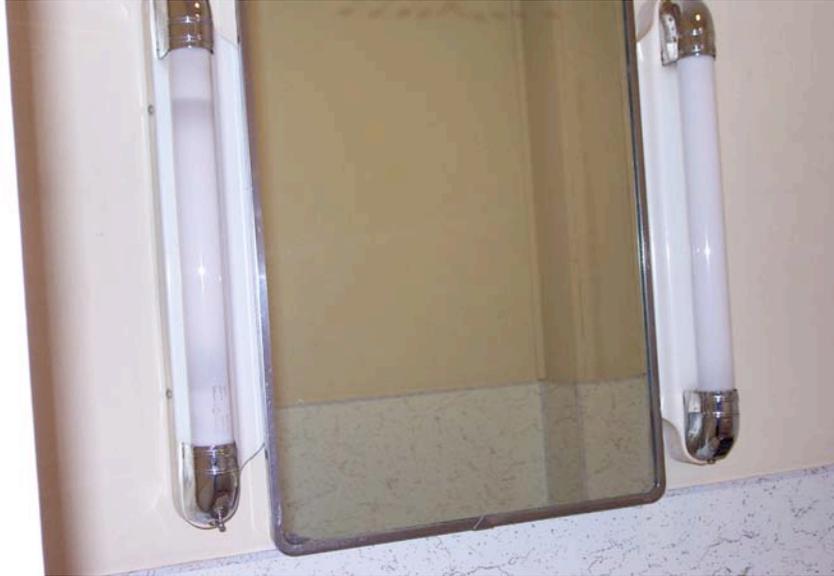
- e. The mirror measures higher than 40 inches above the finished floor when measured to the bottom of the reflective surface, contrary to ANSI section 603.3 and ADAAG section 4.19.6.

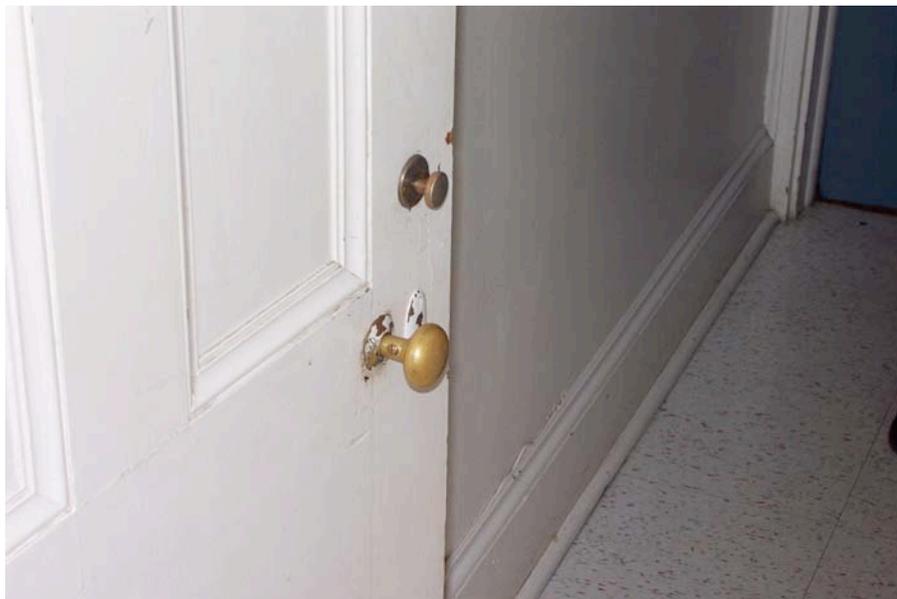
- f. There is a round knob on the door which requires pinching, grasping, and twisting of the wrist and hand, contrary to ANSI section 404.2.7 and ADAAG section 4.13.9.
- g. The door has a round lock on the knob used to secure the door, which requires pinching, grasping, and twisting of the wrist and hand, contrary to ANSI section 404.2.7 and ADAAG section 4.13.9.
- h. The bathroom door is 32 inches wide, contrary to ANSI section 404.2.3 and ADAAG section 4.13.5.

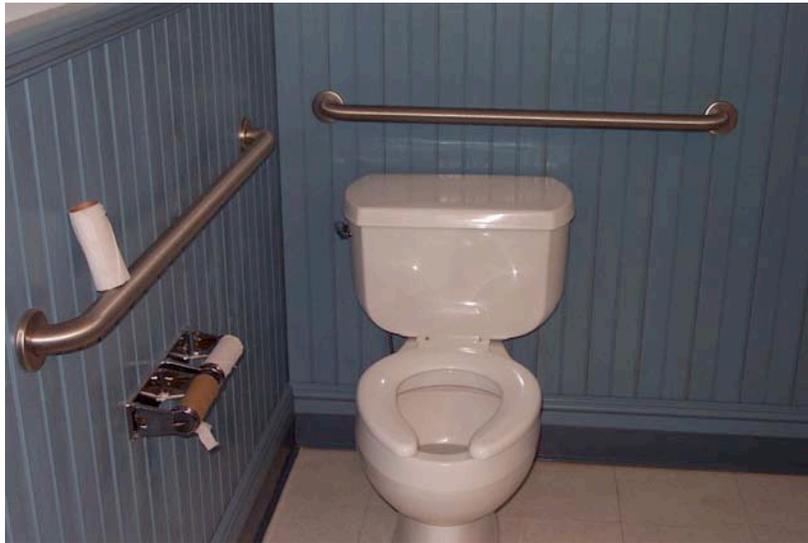
(b.) The bathroom in the theater portion of the building (see picture below), is accessible except for a few areas such as the flush valve on the toilet water tank. These bathrooms and a path to these bathrooms needs to be available to a guest using this library.

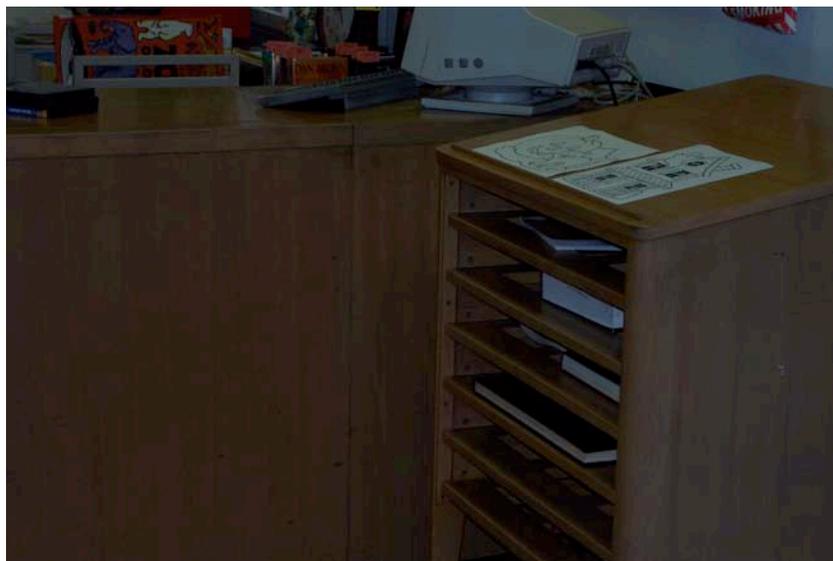
6. The library counter does not have a lowered section of 3 feet long and no more than 34 inches high, contrary to ANSI section 904.3 and ADAAG section 7.2.

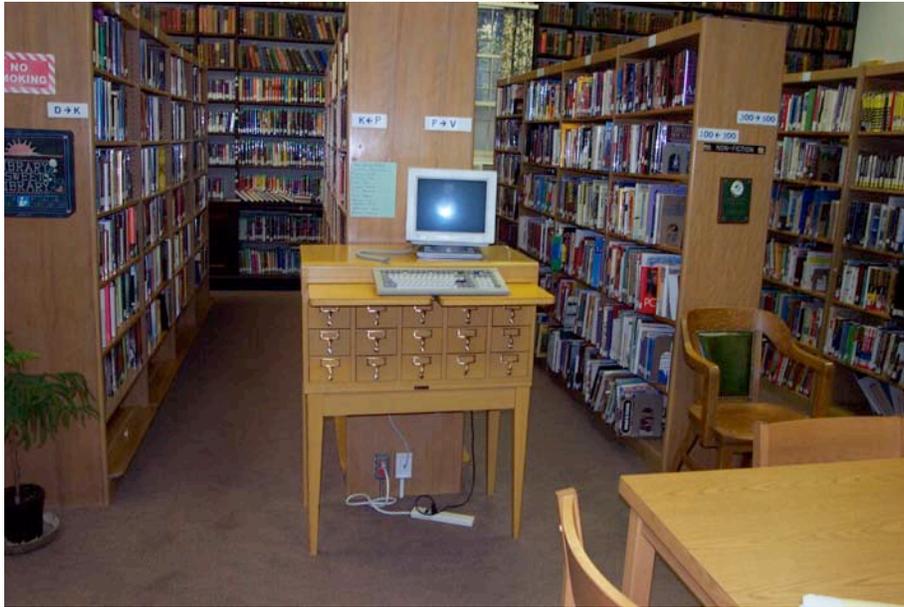
7. The computer keyboard counter is higher than 36 inches above the finished floor to the top of the keyboard, contrary to ANSI section 902.3 and ADAAG section 4.32.4.

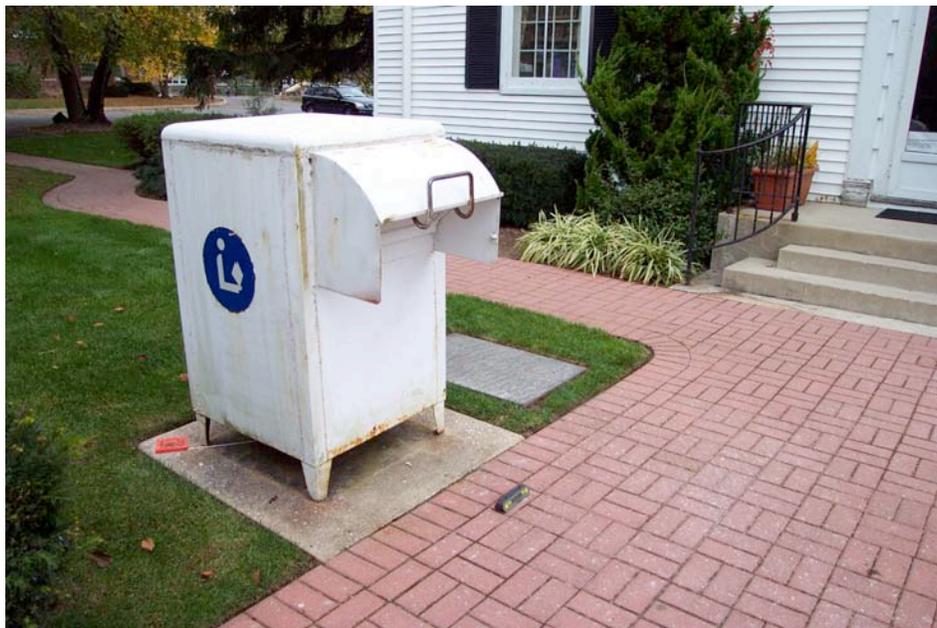
8. The slope at the return bay is 3.1%, contrary to ANSI section 305.2 and ADAAG section 4.3.7.

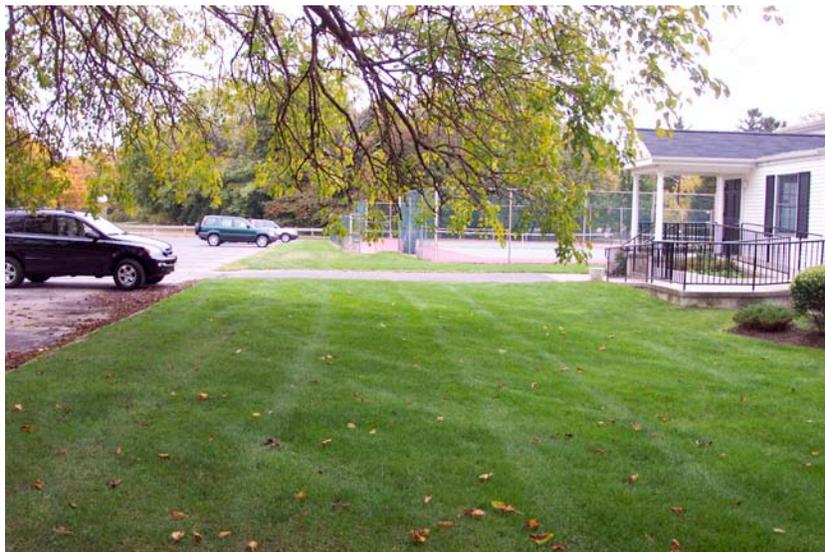
9. Upon discussions with the librarian it was stated that this entrance is only used by patrons who come to see performances of a local theatre group. Since this appears to be the only entrance that can be made into an accessible element, upon correction of the problems outlined this door needs to be open during business hours to allow disabled guests the ability to enter and utilize the facilities.
