Middletown Public Library  
Main Branch  
55 New Monmouth Rd Middletown, NJ

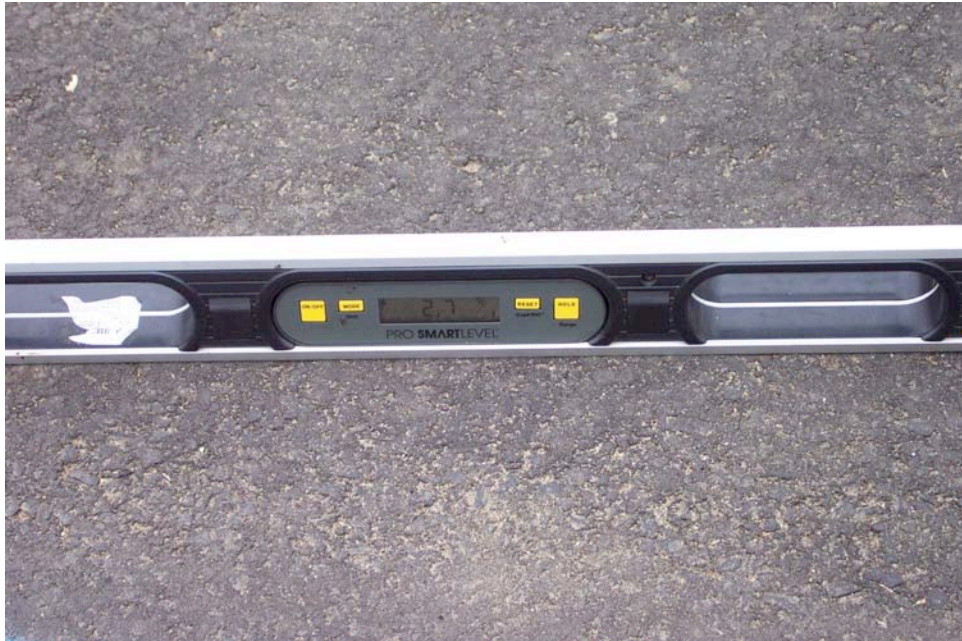
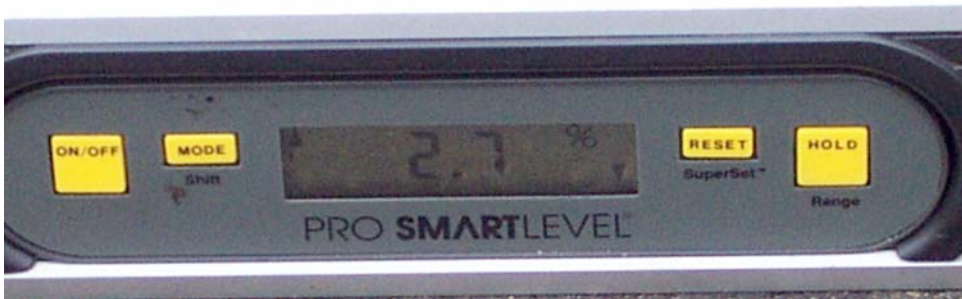
1. The parking has the following problems to be corrected.
  - a. The cross slope at the access aisle is 2.7%, contrary to ANSI section 502.4 and ADAAG section 4.6.3.

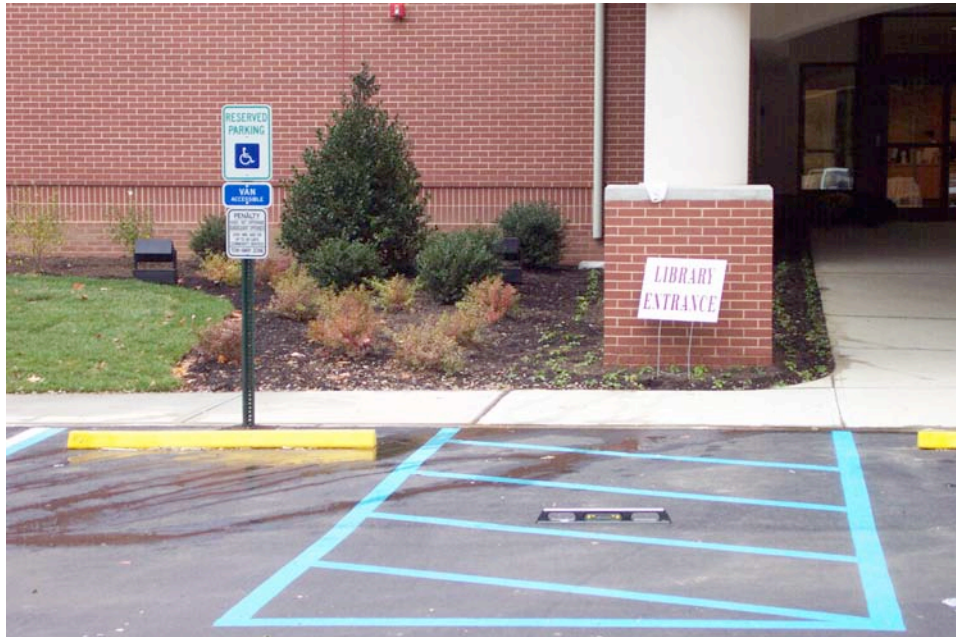
- b. The running slope at the access aisle is 2.2%, contrary to ANSI section 502.4 and ADAAG section 4.6.3.

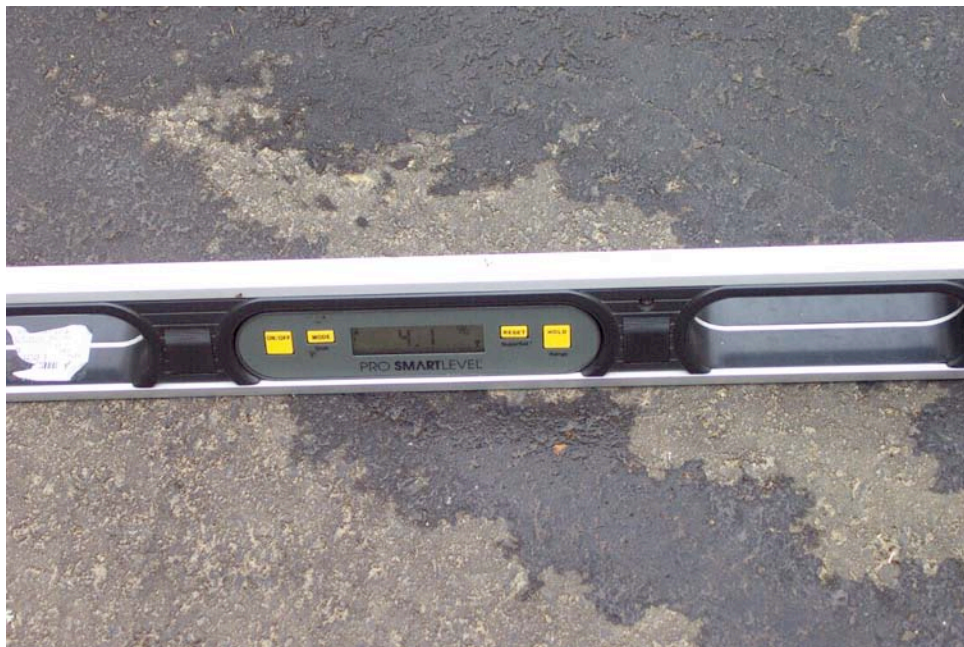
- c. The left space facing the library has a running slope of 4.1%, and a cross slope of 3.0%, contrary to ANSI section 502.4 and ADAAG section 4.6.3.

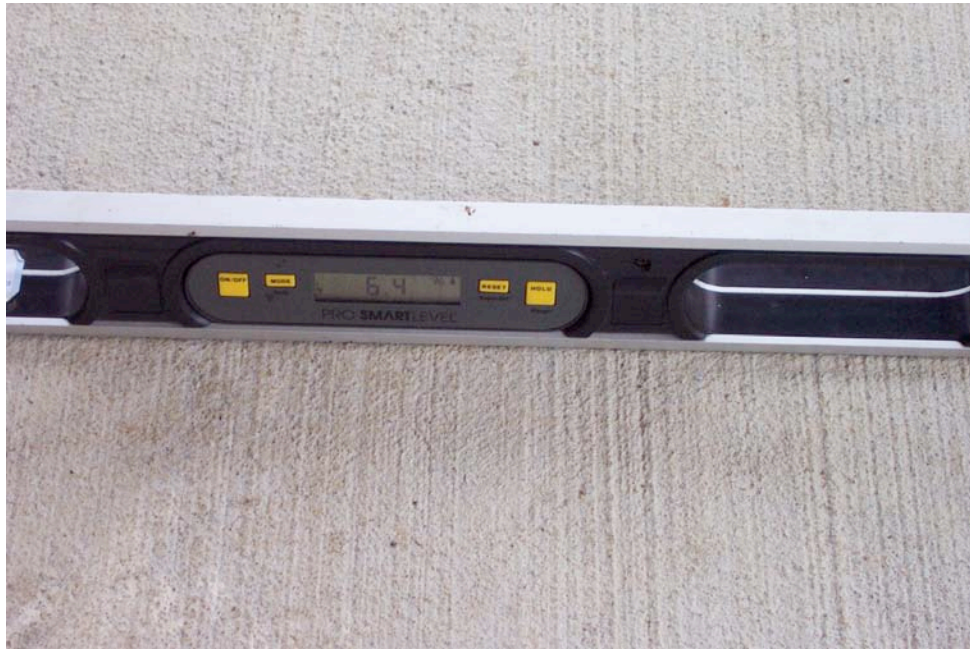
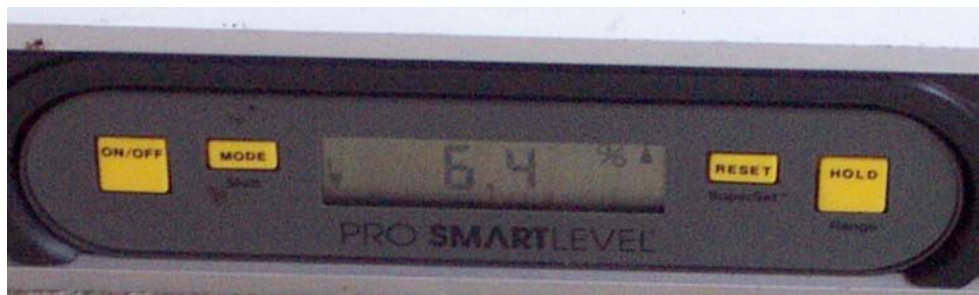
2. The front ramp has 8 sections with the following running slope measurements, contrary to ANSI section 405.1 and ADAAG section 4.8.1.
  - a. The second section from the bottom has a slope of 6.2%.
  - b. The third section from the bottom has a slope of 6.4%.

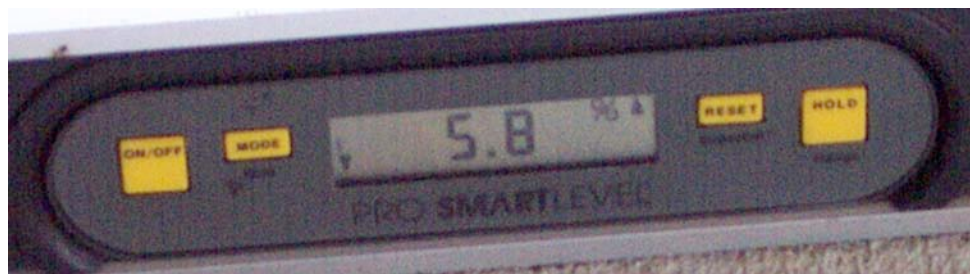
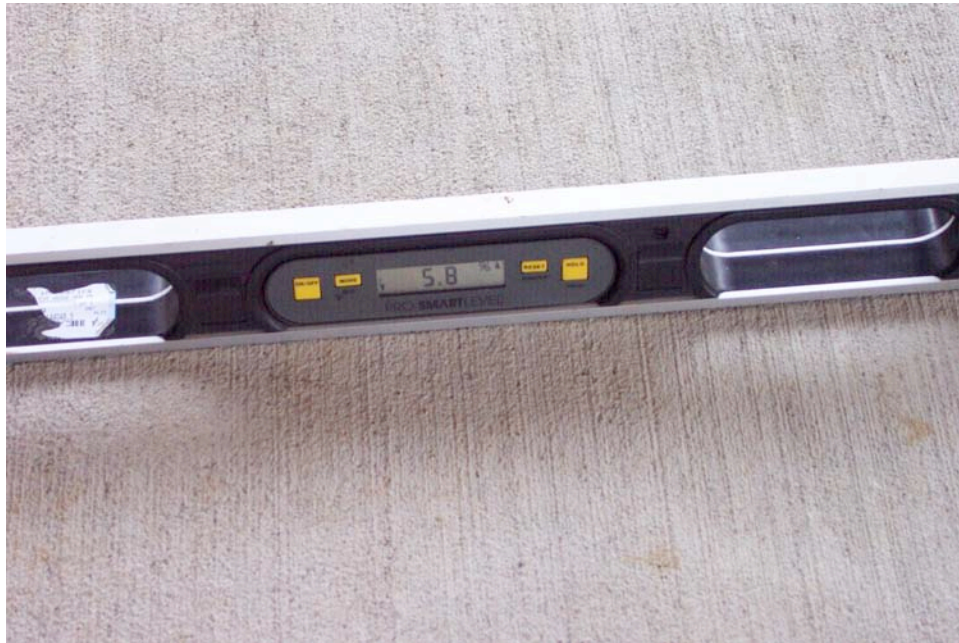
- c. The fourth section has a slope of 5.5%.
- d. The fifth section has a slope of 5.8%.

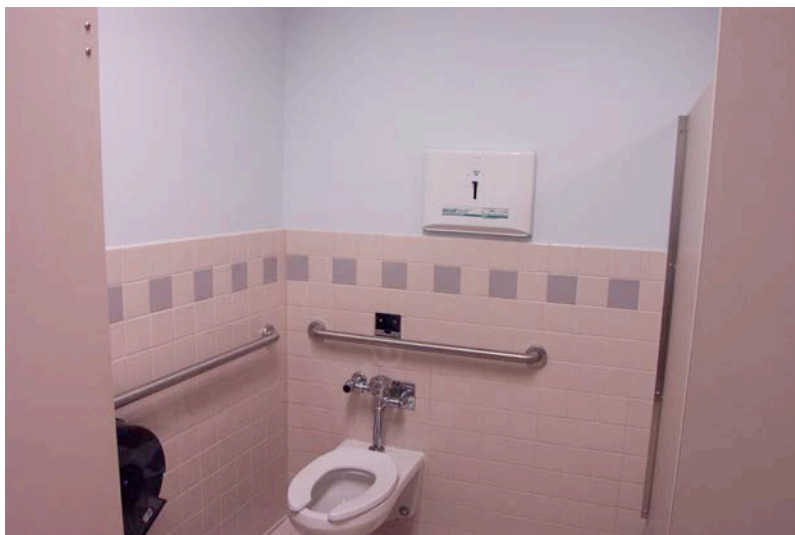
- e. The sixth section has a slope of 4.1%, which is within the guidelines.
  - f. The seventh section has a slope of 4.9%, which is also fine.
  - g. The eighth section has a slope of 5.3%.
3. The men's bathroom in the library has the following problems to be corrected.
- a. The toilet is mounted at 19 inches on center from the side wall, contrary to ANSI section 604.2 and ADAAG section 4.17.3
  - b. The toilet paper dispenser measures 44 inches off of the back wall, contrary to ADAAG section 4.16.6.
  - c. The seat cover dispenser measures 60 inches above the finished floor, contrary to ANSI section 308.2.1 and ADAAG section 4.27.3.

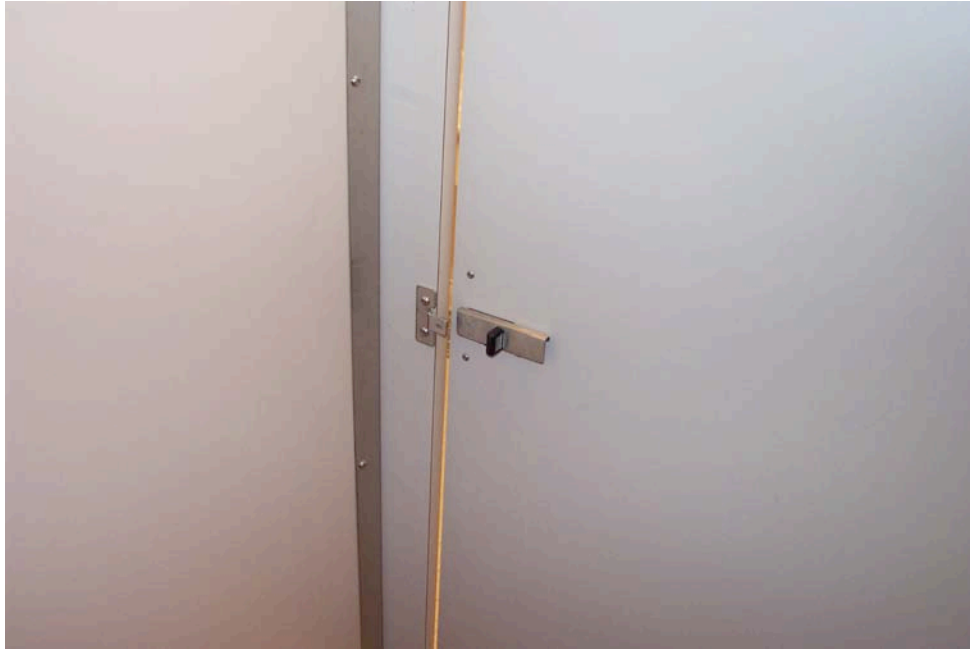
- d. There is a pinch lock on the stall door which requires pinching, grasping, and twisting of the wrist and hand, contrary to ANSI section 404.2.7 and ADAAG section 4.13.9.

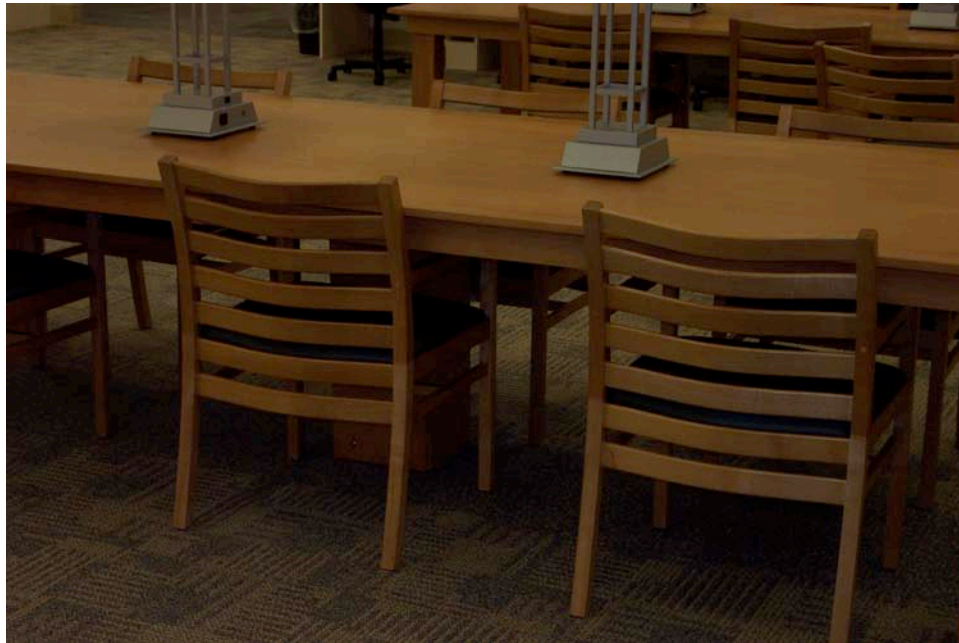
6. The tables in the main library measure 26 inches to the bottom of the edging, contrary to ANSI section 902.3 and ADAAG section 4.32.4.

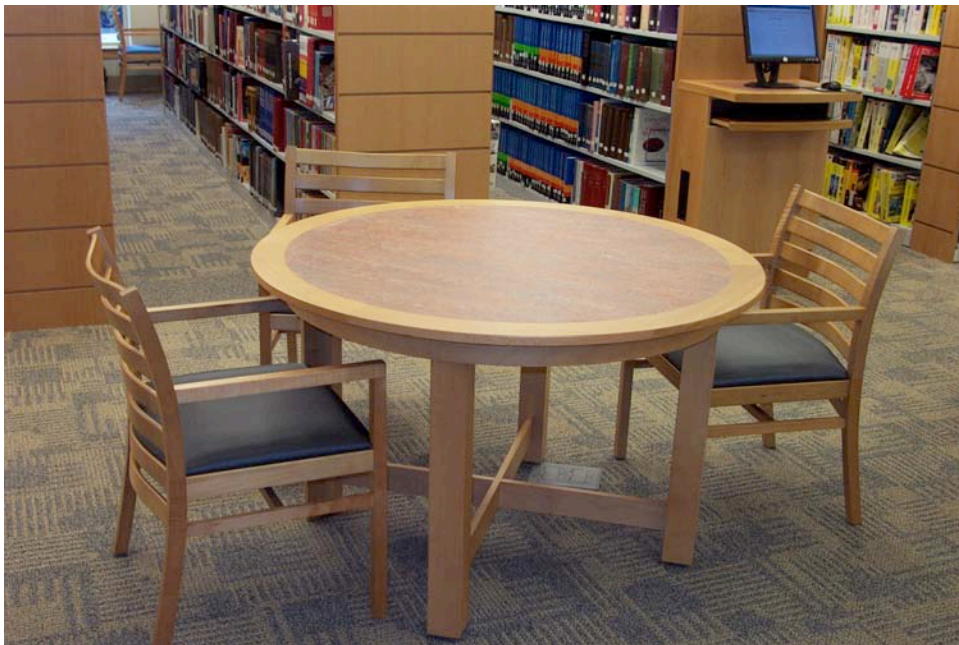
7. The round tables measure 26.5 inches to the bottom above the finished floor, contrary to ANSI section 902.3 and ADAAG section 4.32.3. There is no underside clearance of 19 inches.

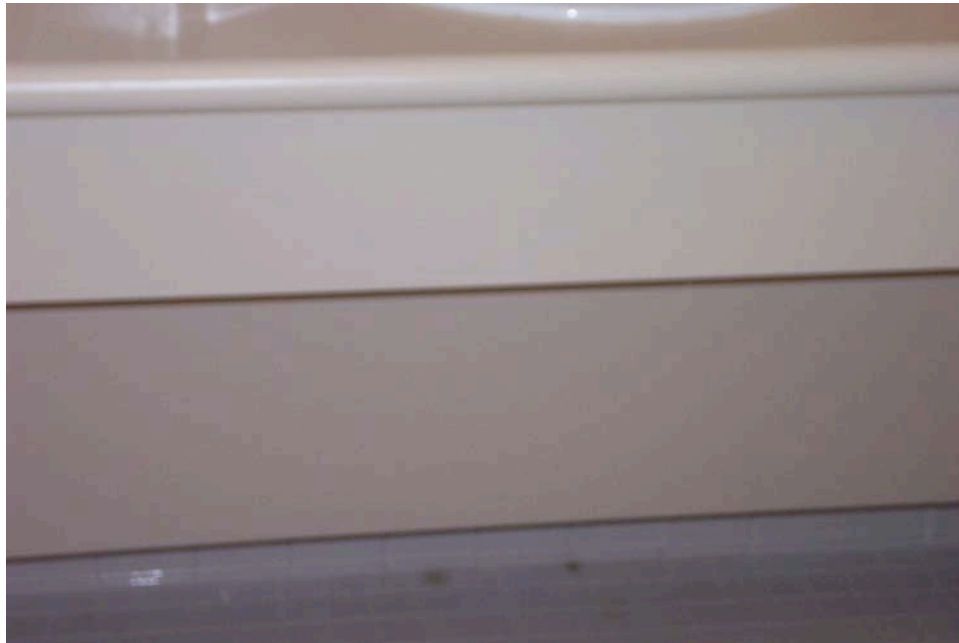
8. The check out counter in the library is above 36 inches when measured above the floor contrary to ANSI section 904.3 and ADAAG section 7.2

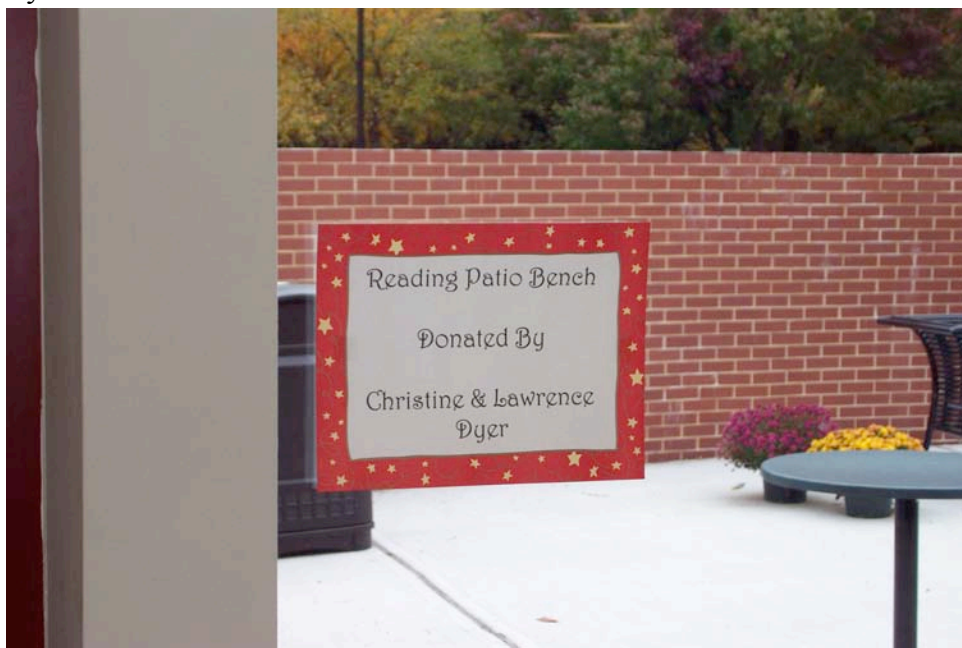
9. The secondary means of egress has tables that are not accessible contrary to ANSI section 902.3 and ADAAG section 4.32.3. Where as these tables are not built in, the important matter is offering equal accommodations to disabled customers. This area is used as a study area and should have accessible elements also.

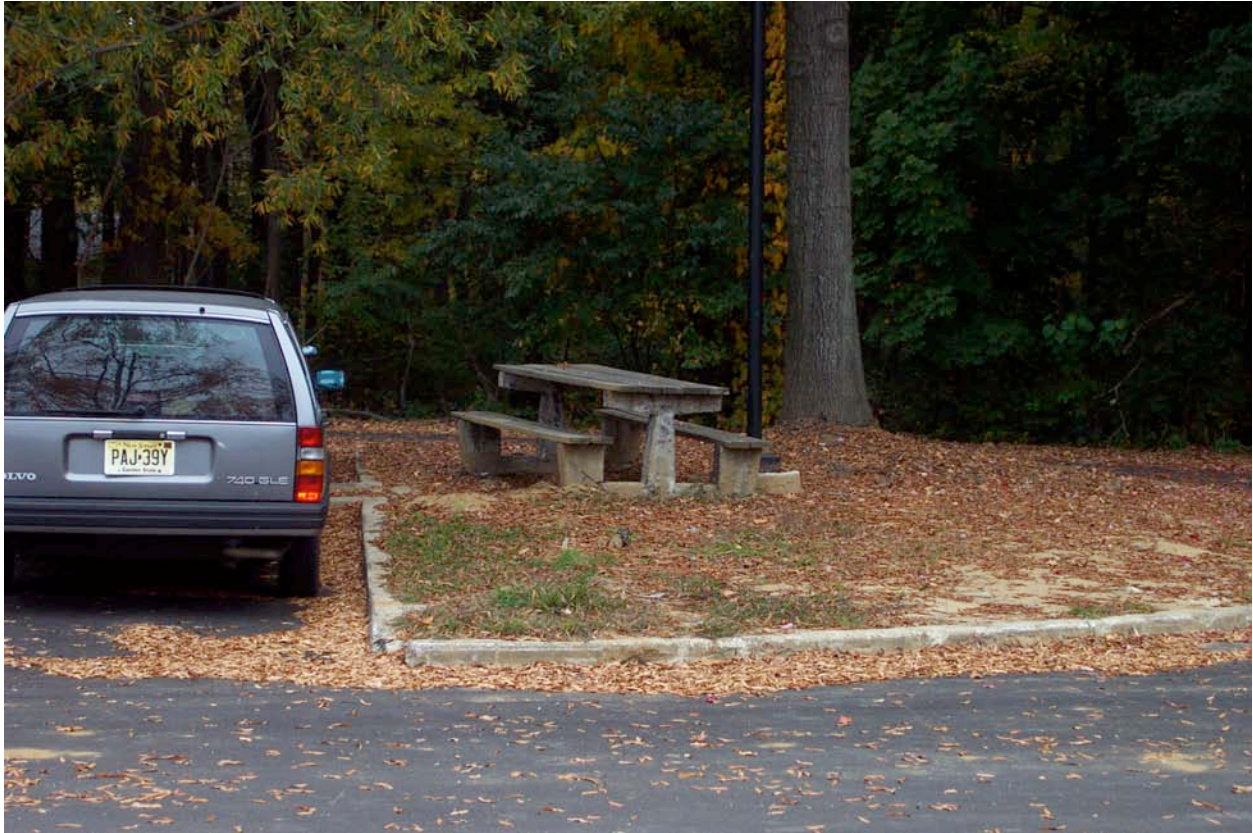
10. There is a concrete picnic table without proper clearance of 30 inches by 48 inches with 19 inches of under side clearance contrary to ANSI section 902.2 and ADAAG section 4.3.

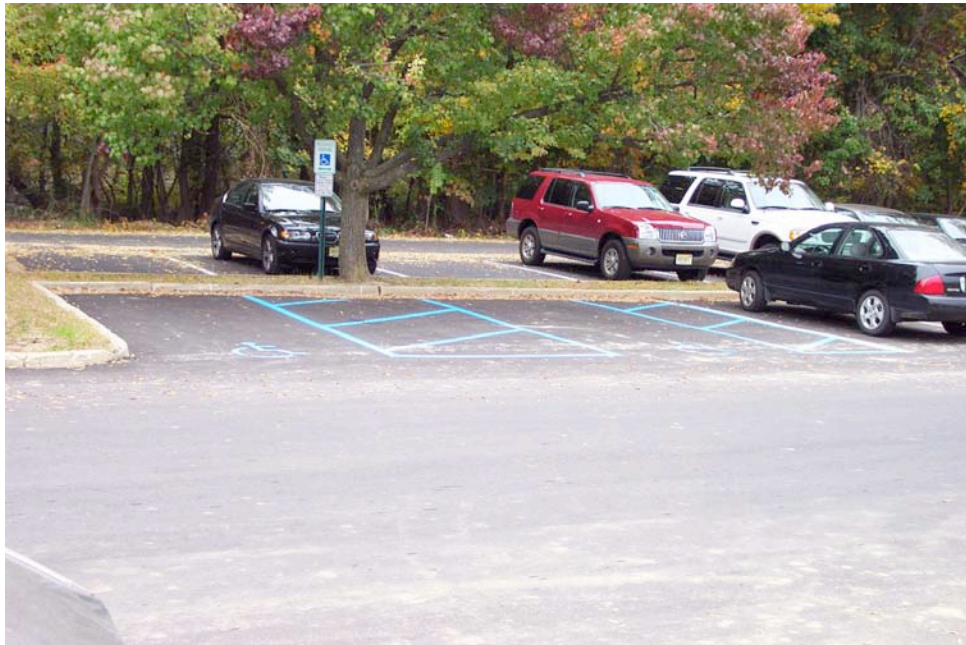
11. The curb cut onto the sidewalk is not across from the parking spaces and forces the customer to enter the street to access the sidewalk contrary to ANSI section 502.3 and ADAAG section 4.6.2.
