## Johnson Gill Annex and Courthouse 1 Kings Highway, Middletown, NJ

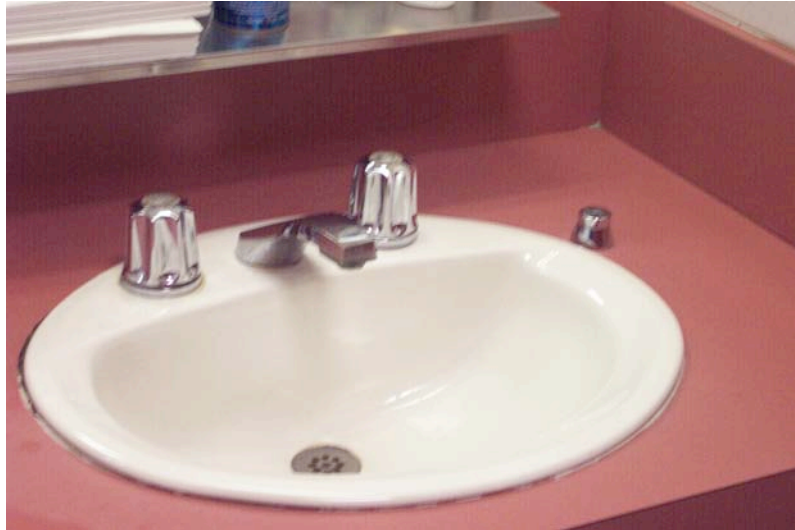
1. The women's bathroom at the Johnson Gill Annex building has the following problems which need to be corrected.
  - a. The stall measures 65 inches by 59 inches.
  - b. There are round handles on the faucets which require guests to twist with the wrist, contrary to ANSI section 309.4 and ADAAG section 4.19.5.

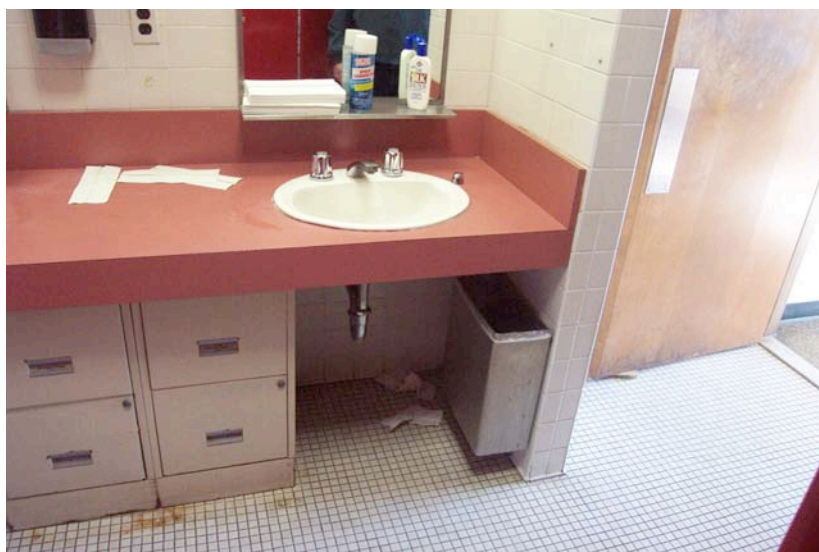
- c. The sink apron measures 28.75 inches when measured to the lip, contrary to ADAAG section 4.19.2.
  - d. There is no insulation on the hot water and drain pipes under the sink to avoid possible contact by a disabled person, contrary to ANSI section 606.6 and ADAAG section 4.19.4.

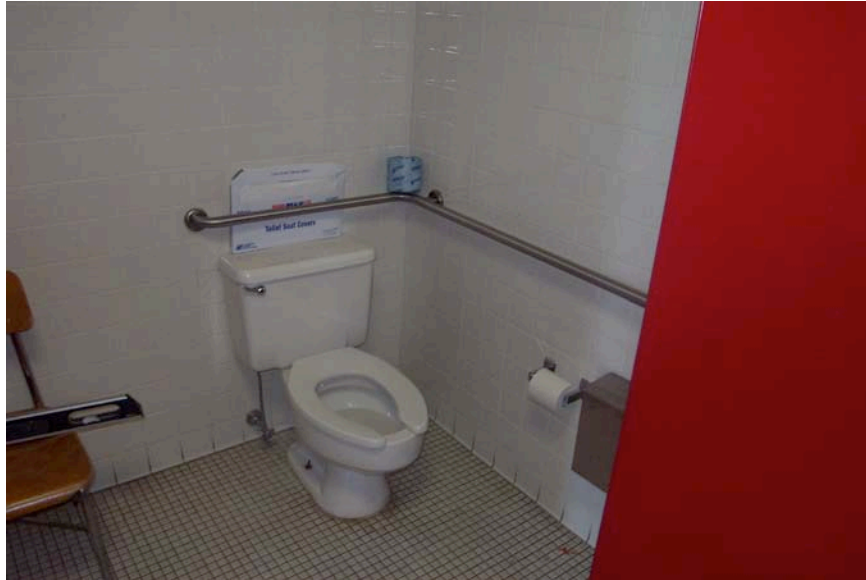
- e. The back grab bar measures 31 inches long, contrary to ANSI section 604.5 and ADAAG section 4.17.6.
- f. The side grab bar measures 48 inches long, contrary to ANSI section 604.5 and ADAAG section 4.17.6.
- g. The toilet measures 15.5 inches above the finished floor to the lip, contrary to ANSI section 604.4 and ADAAG section 4.16.3.

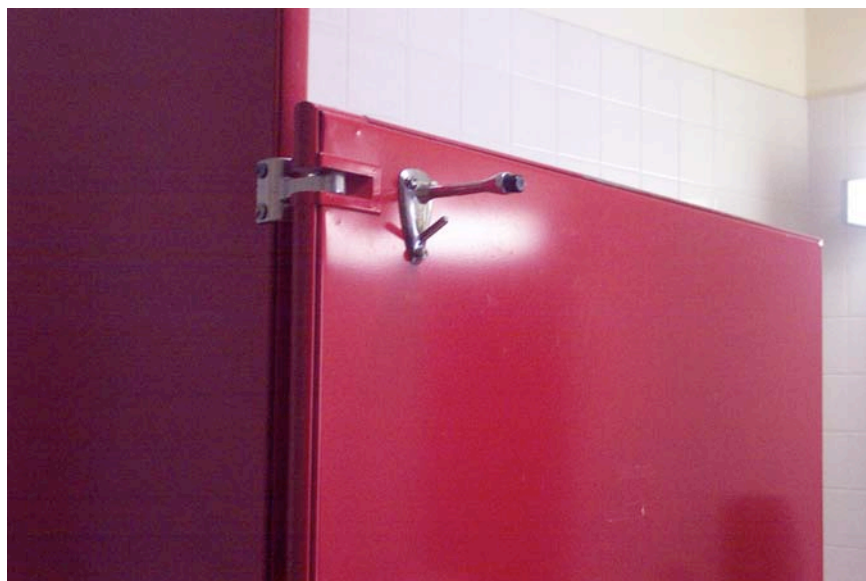
- h. The coat hook measures 68.5 inches above the finished floor, contrary to ANSI section 604.8.4.2 and ADAAG section 4.2.6.

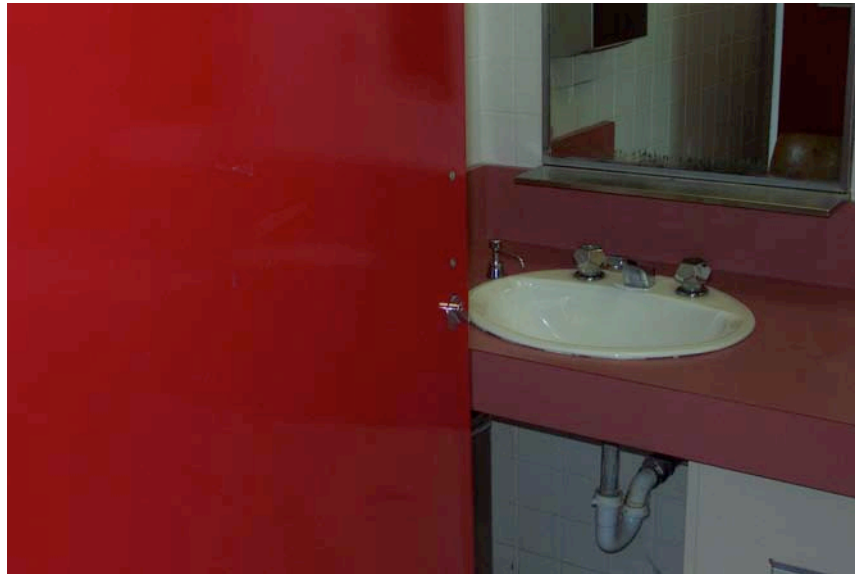
- i. There is a pinch lock on the stall door which requires pinching, grasping, and twisting of the hand and wrist, contrary to ANSI section 404.2.7 and ADAAG section 4.13.9.
- k. The stall does not have a self closing door, contrary to ANSI section 604.8.

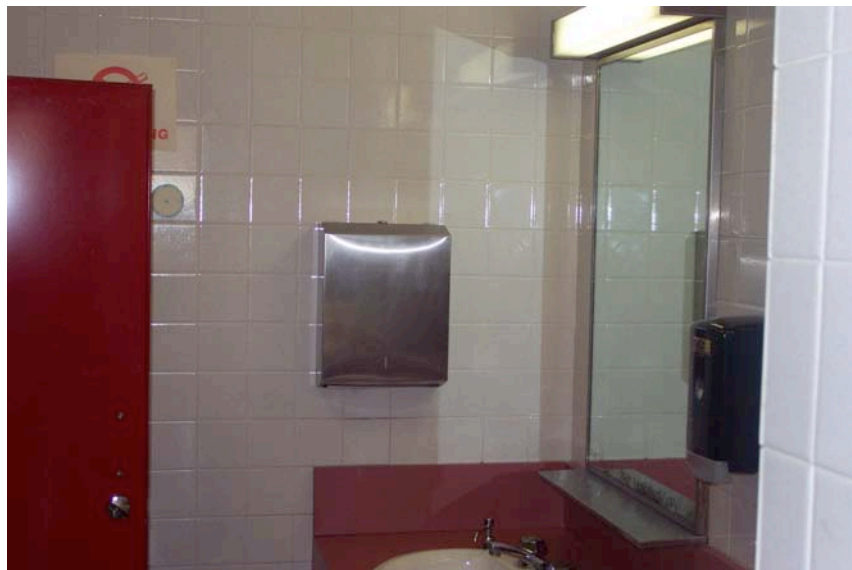
- j. The bathroom door requires more than 5 pounds of pressure to open, contrary to ANSI section 4.4.2.9 and ADAAG section 4.13.11.
- l. The paper towels are dispensed in a way that requires a guest to pinch and grasp with the hand, contrary to ANSI section 309.4 and ADAAG section 4.27.4.
- m. The mirror measures 41 inches to the bottom of the reflective surface above the finished floor, contrary to ADAAG section 4.19.6.

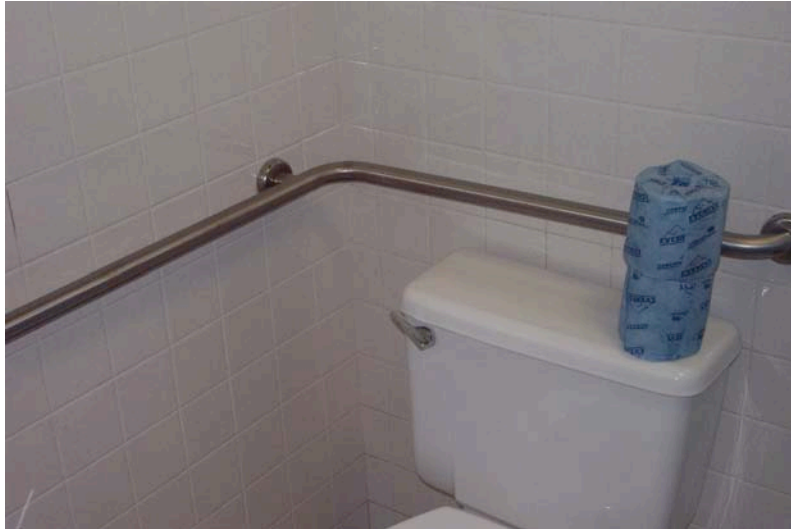
2. The men's bathroom at the Johnson Gill Annex building has the following problems which need to be corrected.
  - a. The toilet measures 16 inches above the finished floor to the top of the seat, contrary to ANSI section 604.4 and ADAAG section 4.16.3.
  - b. The continuous grab bar measures 4 inches off of the wall at the corner, contrary to ANSI section 609.3 and ADAAG section 4.26.2.
  - c. The flush valve is located on the narrow side of the toilet, contrary to ADAAG section 4.16.5.

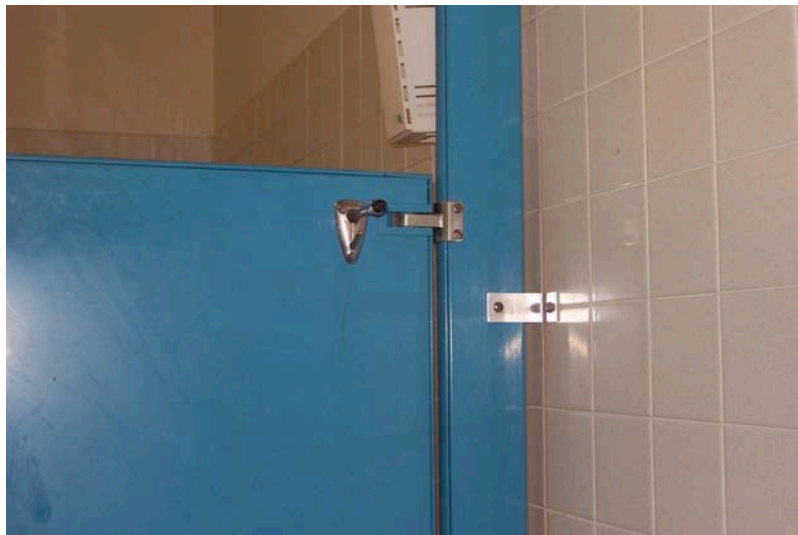
- d. The sink apron measures 28 inches above the finished floor, contrary to ADAAG section 4.19.2.
- e. The door requires more than 5 pounds of pressure to open, contrary to ANSI section 404.2.9 and ADAAG section 4.13.11.
- f. The coat hook measures 68.5 inches above the finished floor, contrary to ANSI section 604.8.4.2 and ADAAG section 4.2.6.

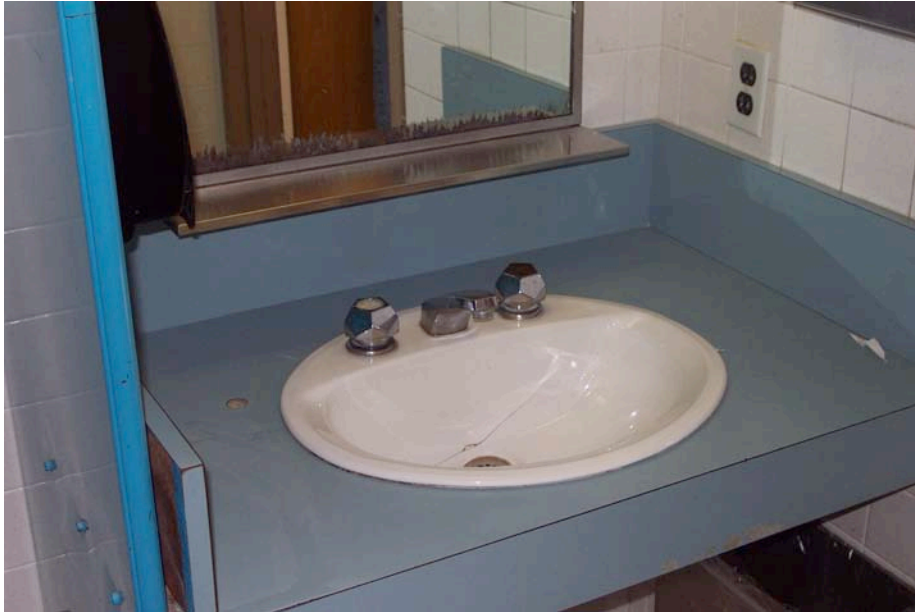
- g. There are round handles on the faucets which require guests to twist with the wrist, contrary to ANSI section 309.4 and ADAAG section 4.19.5.

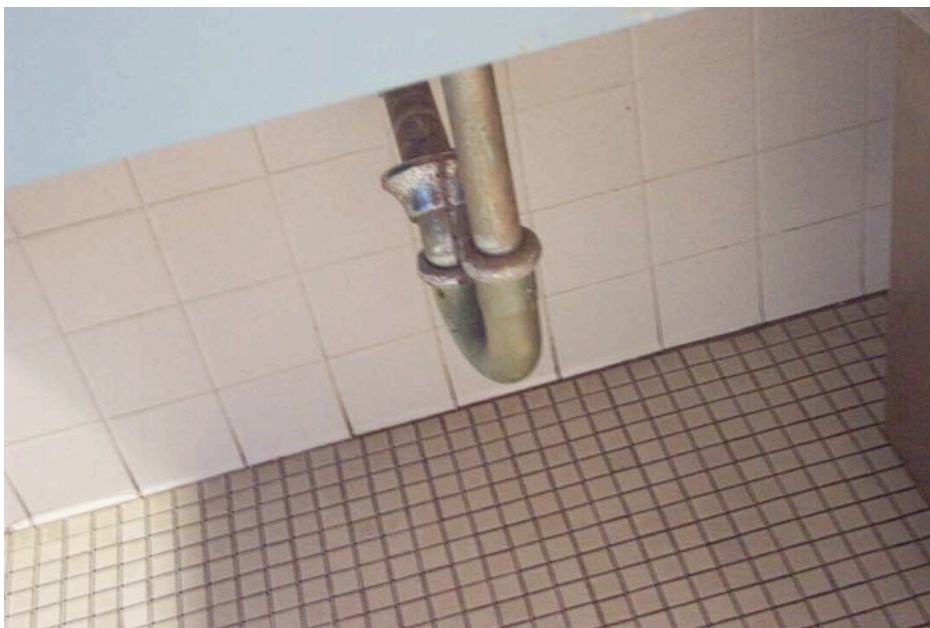
- h. There is no insulation on the sink pipes under the sink to avoid possible contact by a person contrary to ANSI section 606.6 and ADAAG section 4.19.4.

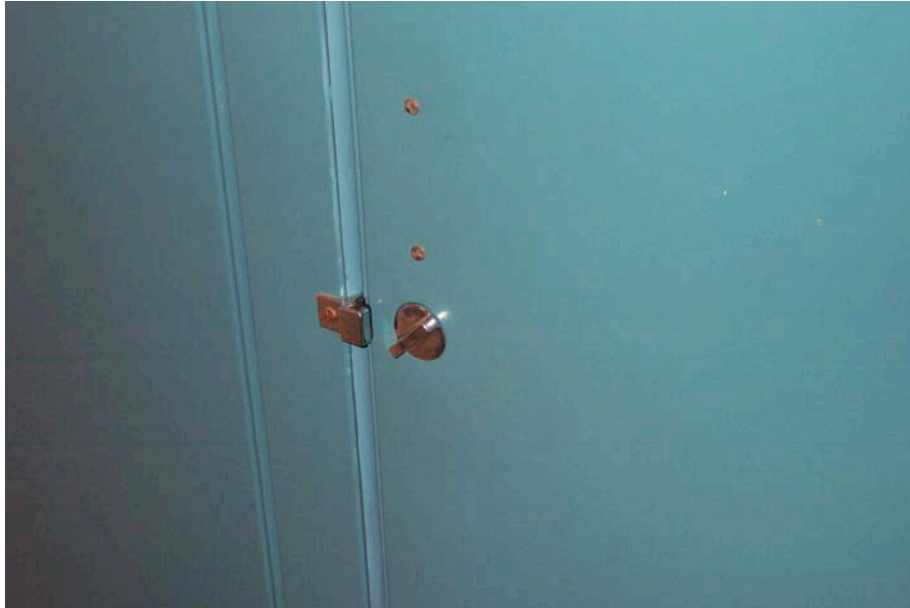
- i. There is a pinch lock on the stall door which requires pinching, grasping, and twisting of the hand and wrist, contrary to ANSI section 404.2.7 and ADAAG section 4.13.9.

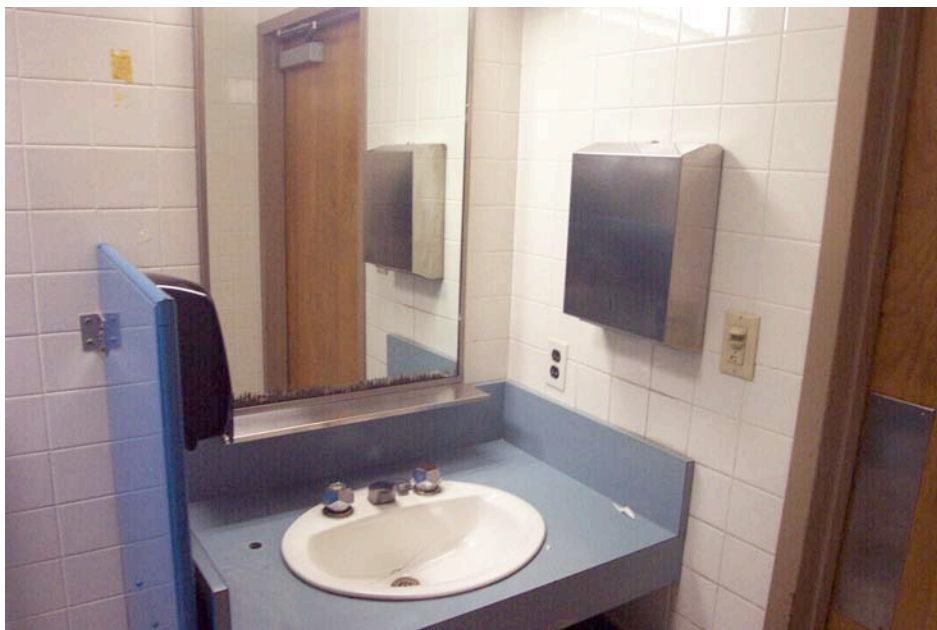
- j. The paper towels are dispensed in a way that requires a guest to pinch and grasp with the hand, contrary to ANSI section 309.4 and ADAAG section 4.27.4.

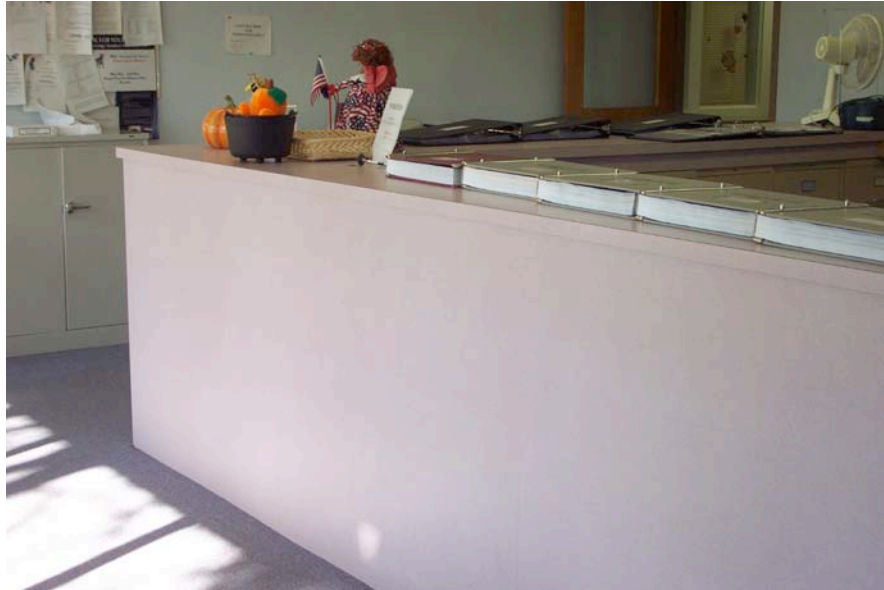
3. The counter at the Tax Assessment office measures 45 inches above the finished floor, contrary to ANSI section 904.2 and ADAAG section 7.2(1).

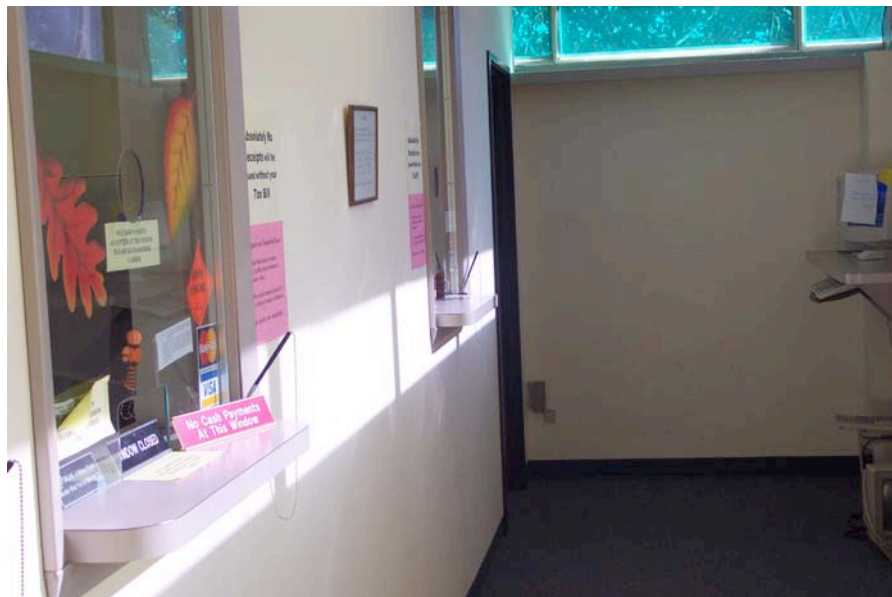
4. The Tax Collector's office has the following problems which need to be corrected.
  - a. The counter, where money is collected, measures 45 inches above the finished floor, contrary to ANSI section 904.2 and ADAAG section 7.2(1).

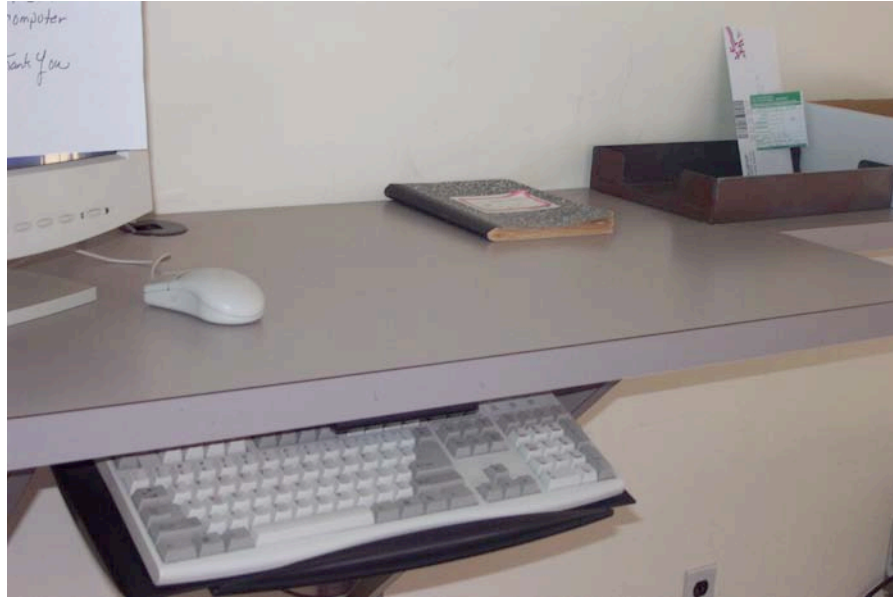
- b. The computer keyboard measures 41 inches to the bottom and 42 inches to the top, contrary to ANSI section 902.3 and ADAAG section 4.32.4 .

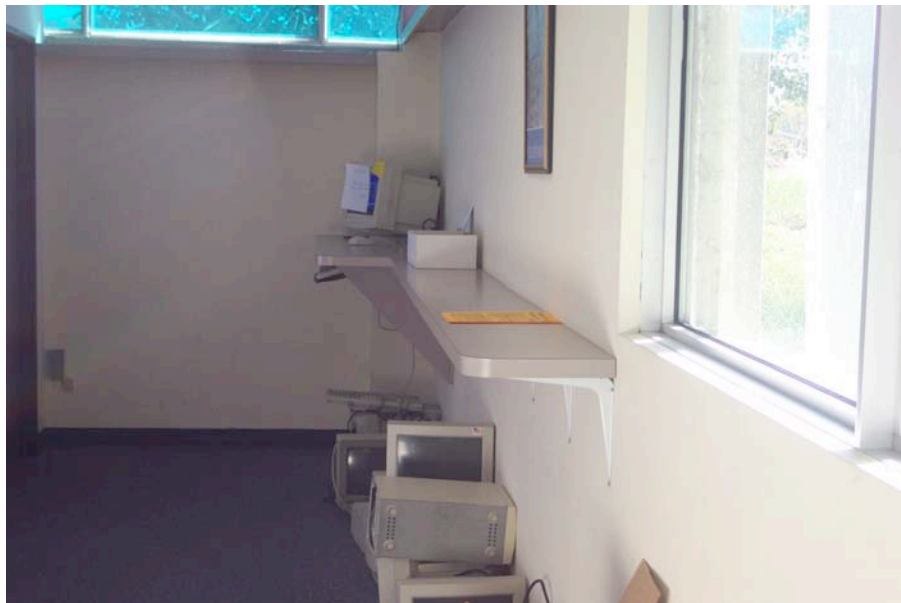
- c. The side counter next to the computer measures 45 inches above the finished floor, contrary to ANSI section 902.3 8 and ADAAG section 4.32.4.

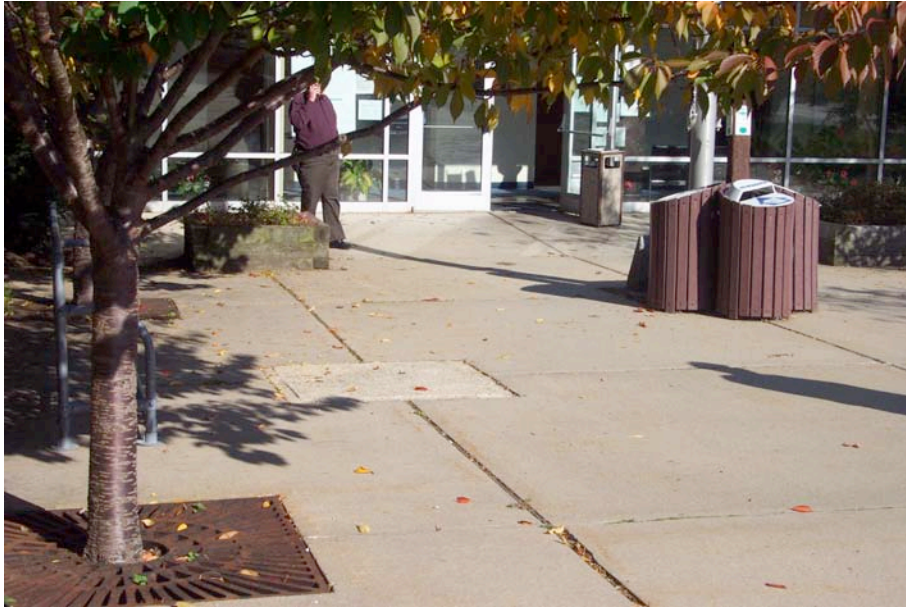
5. The door at the entrance to the Johnson Gill Annex closes faster than 3 seconds, contrary to ANSI section 404.2.8.1 and ADAAG section 4.13.10. The pull weight on the door is more than 5 pounds contrary to ANSI section 4.4.2.9 and ADAAG section 4.13.11.

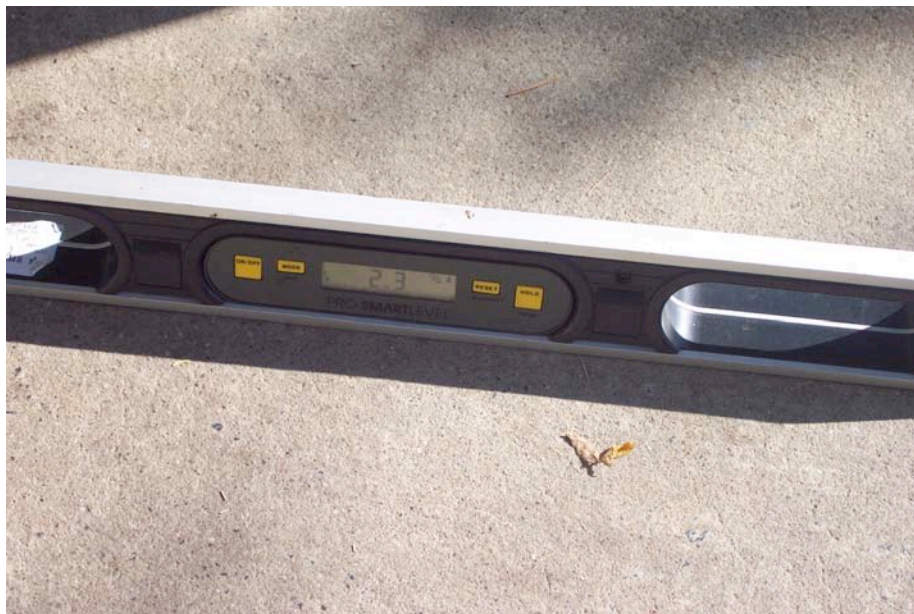
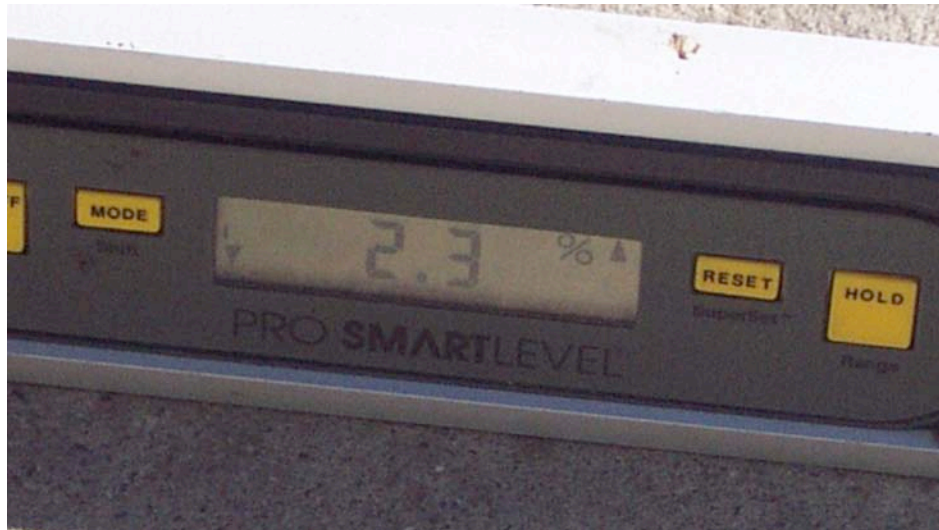
6. There is a slope at the door to the entrance of the Johnson Gill Annex that is 2.3%, contrary to ANSI section 404.2.4.5 and ADAAG section 4.13.6.

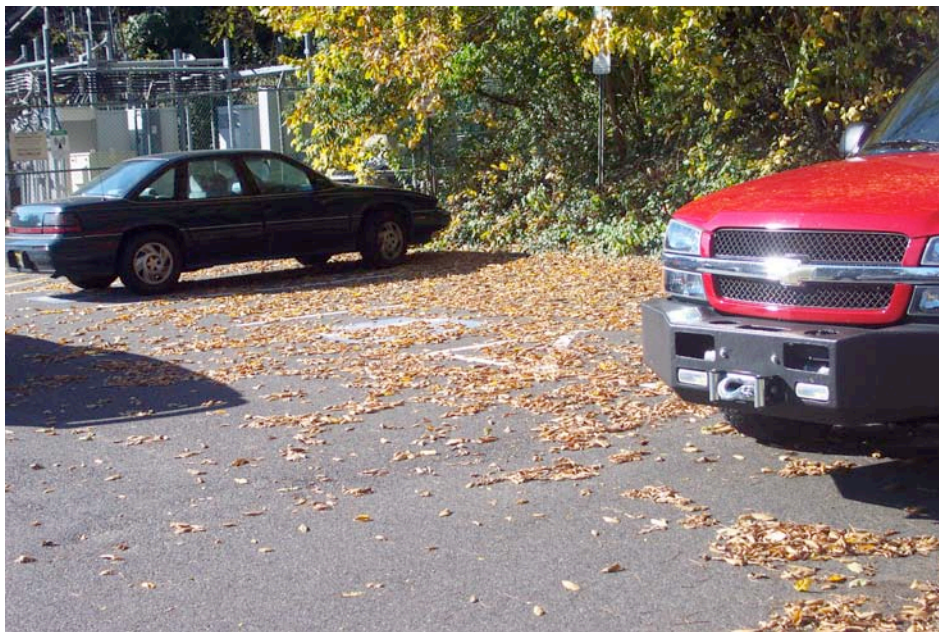
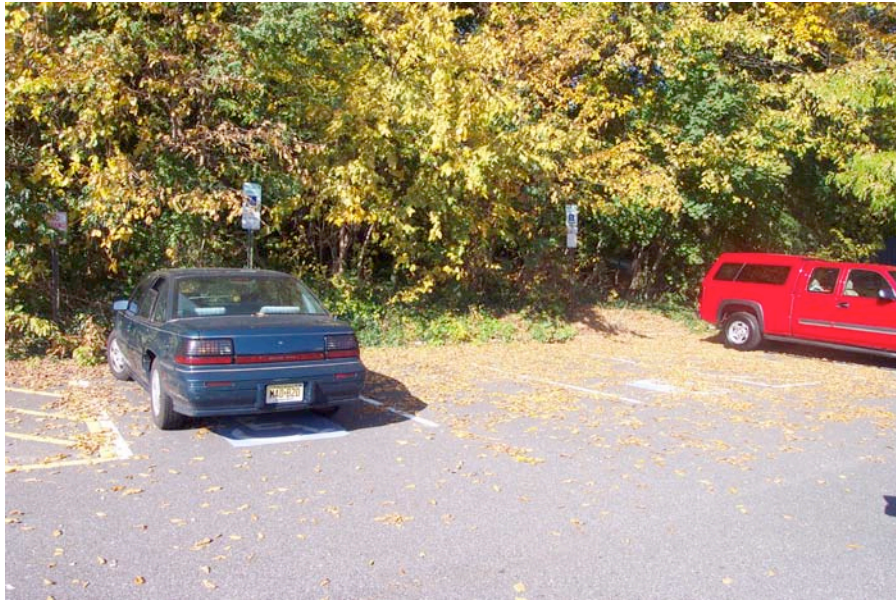
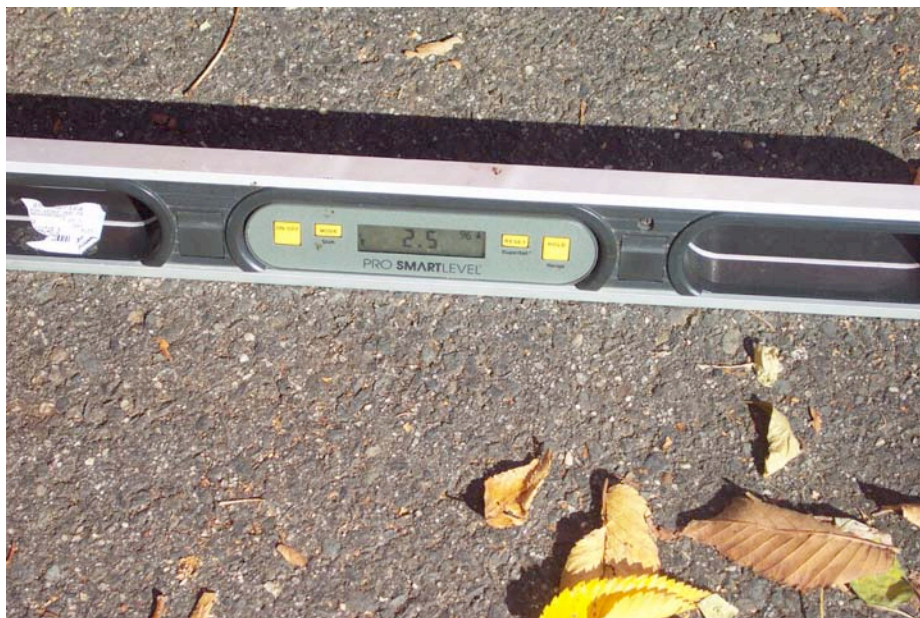
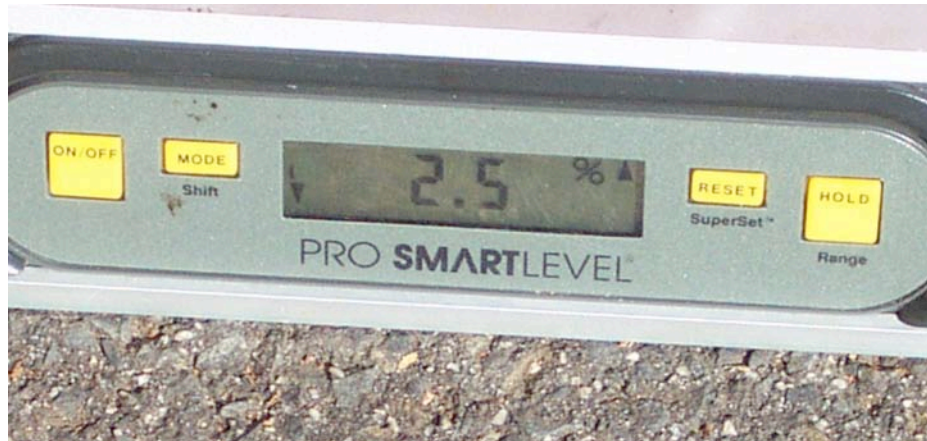
7. The parking area at the Johnson Gill Annex has the following problems to be corrected.
  - a. The curb cut threshold is 1/3 inch deep, contrary to ANSI section 303.3 and ADAAG section 4.3.8.
  - b. The first designated disabled parking space and access aisle have a slope of 2.5%, contrary to ANSI section 502.4 and ADAAG section 4.6.3.

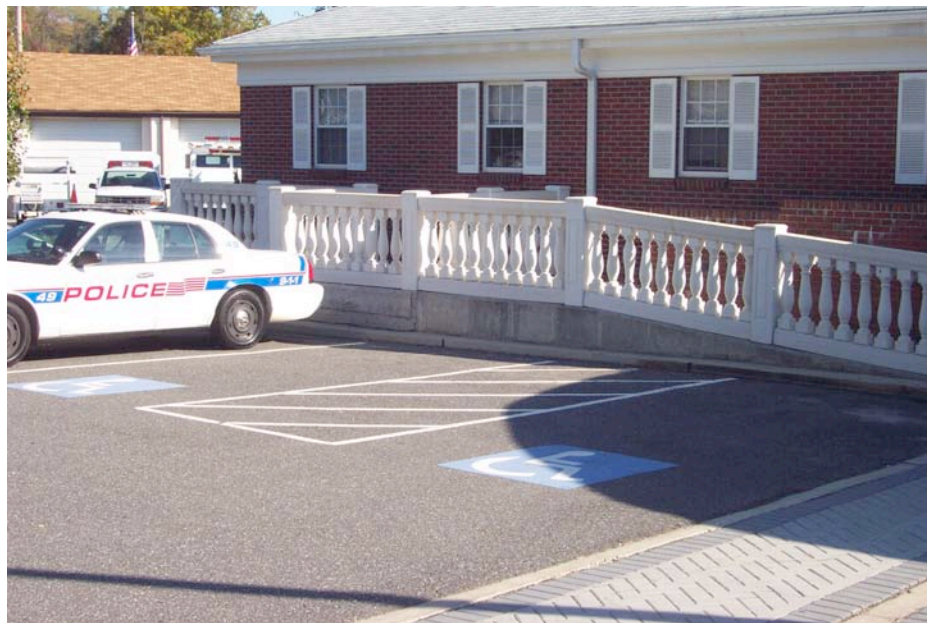
8. The parking at the police station has the following problems which need to be corrected.
  - a. There is no proper signage at the spaces, contrary to ANSI section 502.6 and ADAAG section 4.6.4.

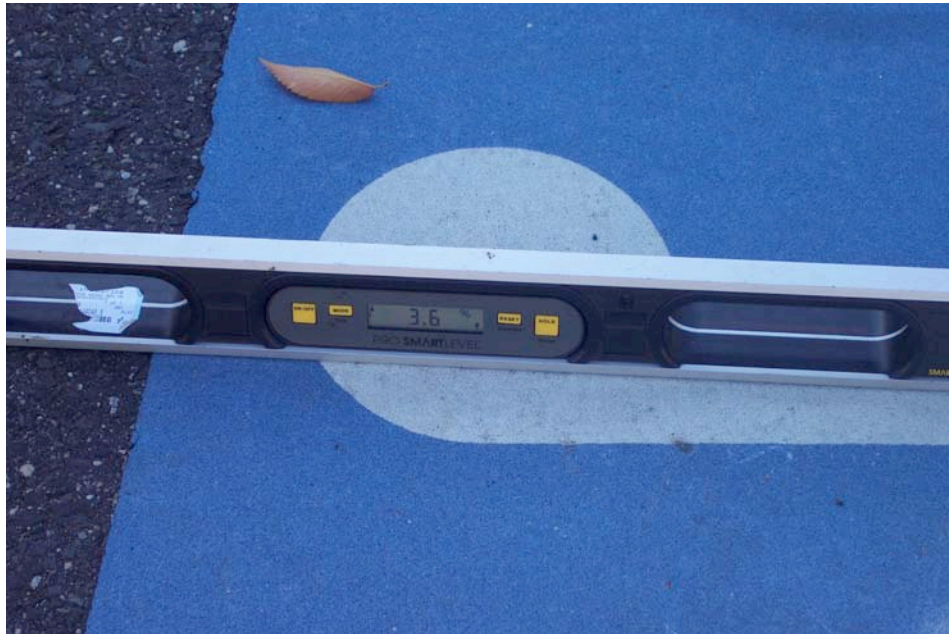
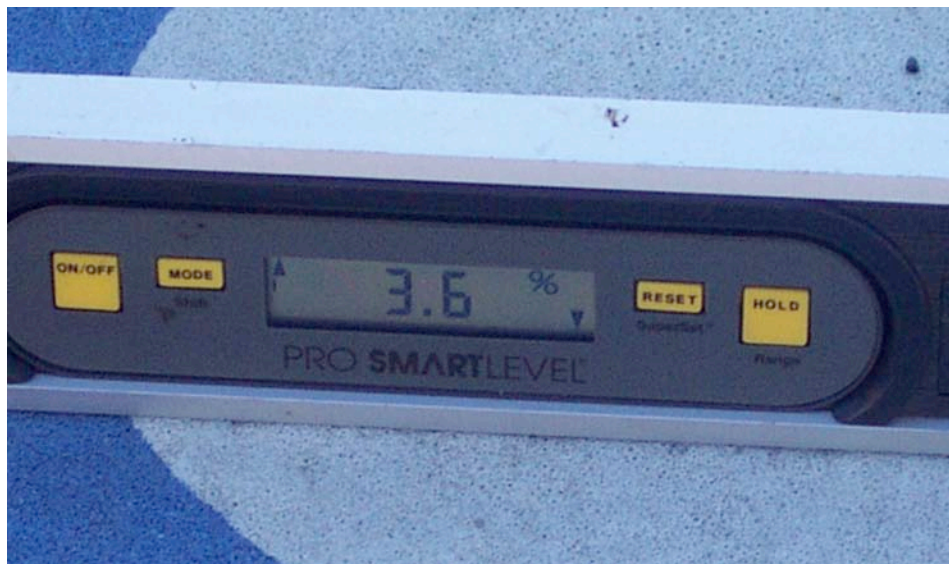
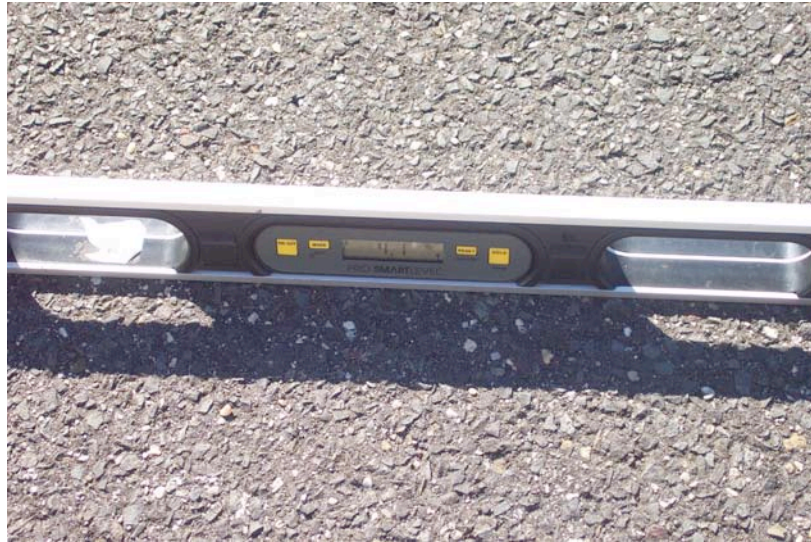
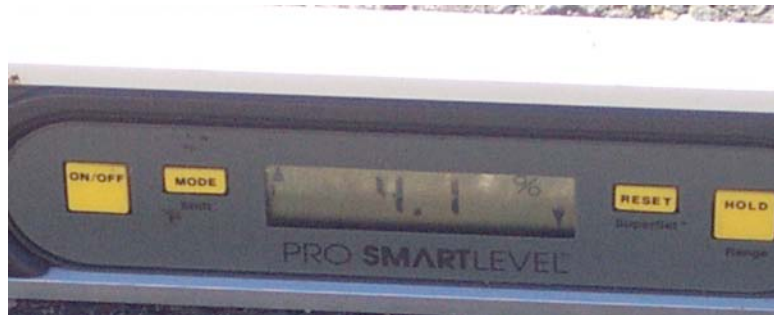
- b. The parking spaces have running slopes ranging from 3.6% to 4.1%, contrary to ANSI section 502.4 and ADAAG section 4.6.3.

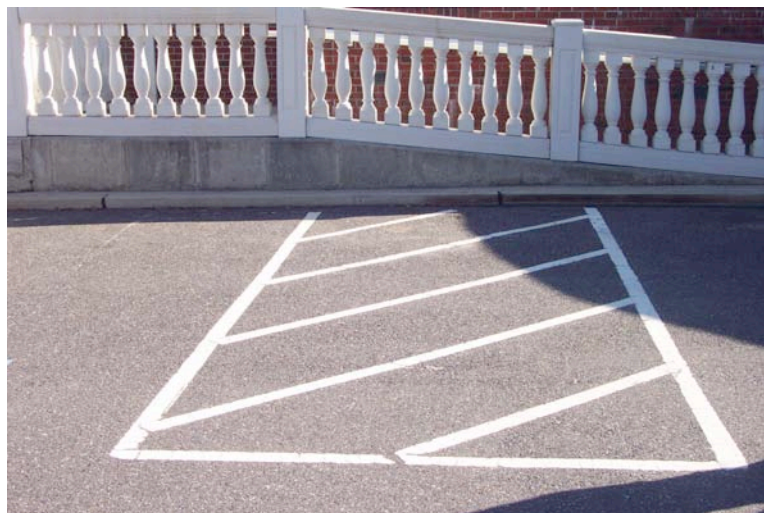
- c. The access aisle is only 7 feet wide, contrary to ANSI section 502.3.1 and ADAAG section 4.6.6. There is also no route of travel to the ramp from the parking space except into traffic behind parked vehicles contrary to ANSI section 502.3. and ADAAG section 4.6.3.

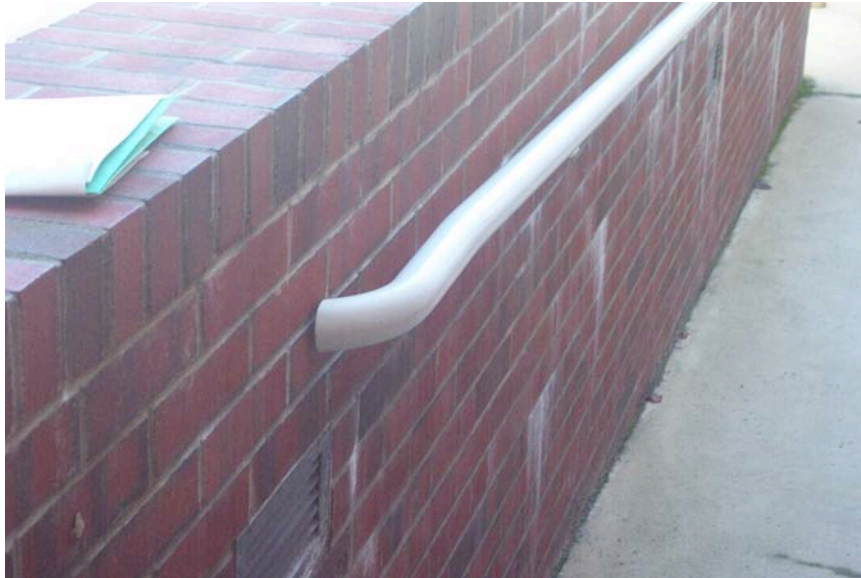
- d. The landing at the bottom of the ramp to the court house door has a cross slope of 2.3%, contrary to ANSI section 405.7 and ADAAG section 4.8.4.
- e. The handrail extensions on the ramp are not long enough ( 12 inches ), contrary to ANSI section 505.10.1 and ADAAG section 4.8.5(2).

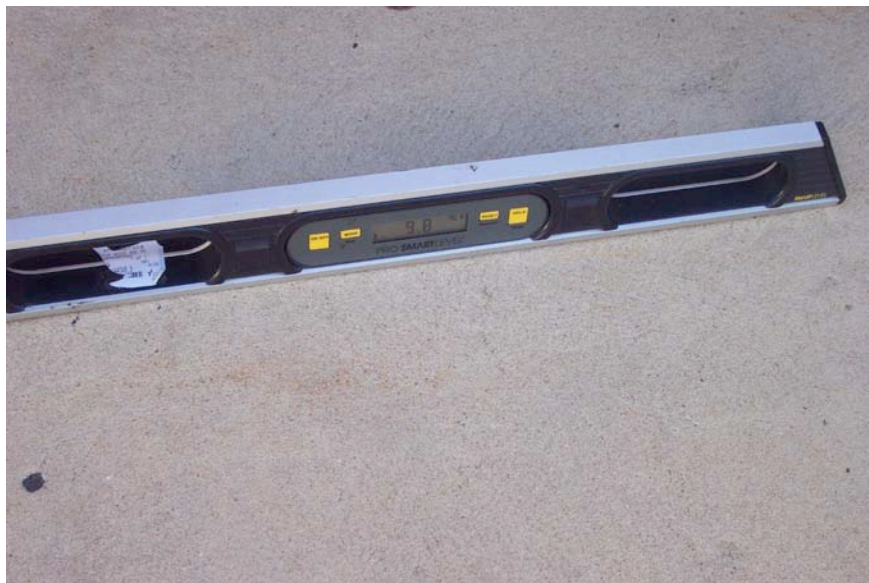
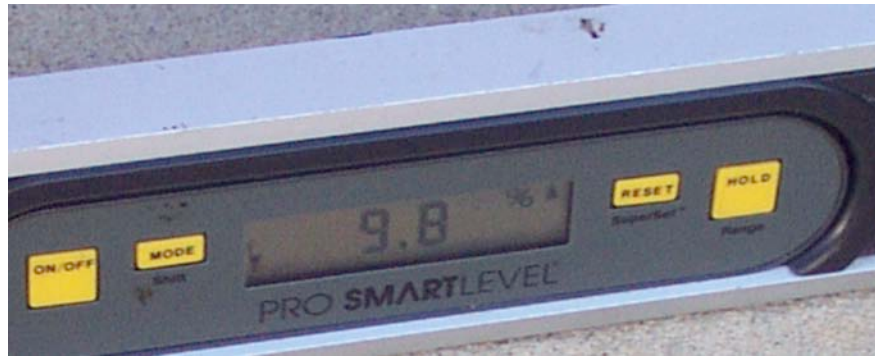
- f. The slope of the first section of the ramp to the landing is 9.8%, contrary to ANSI section 405.2 and ADAAG section 4.8.2.

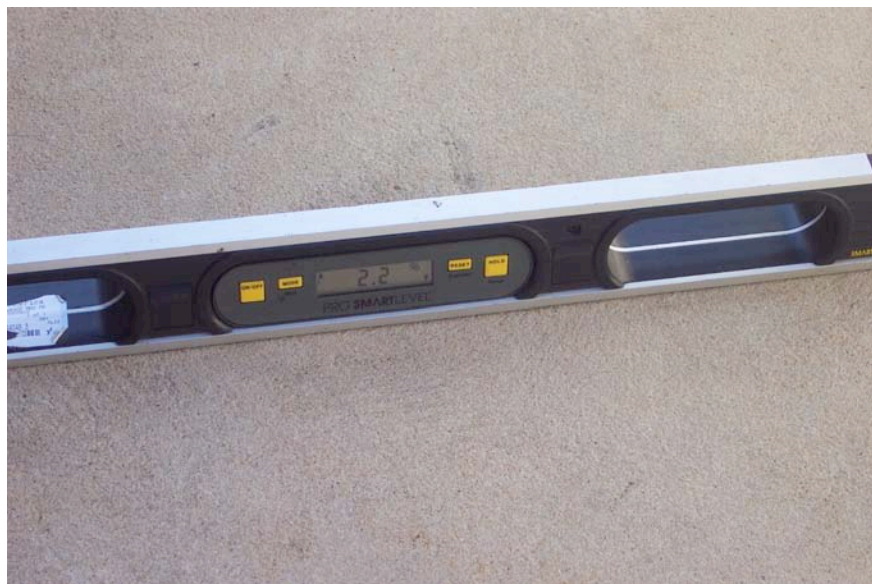
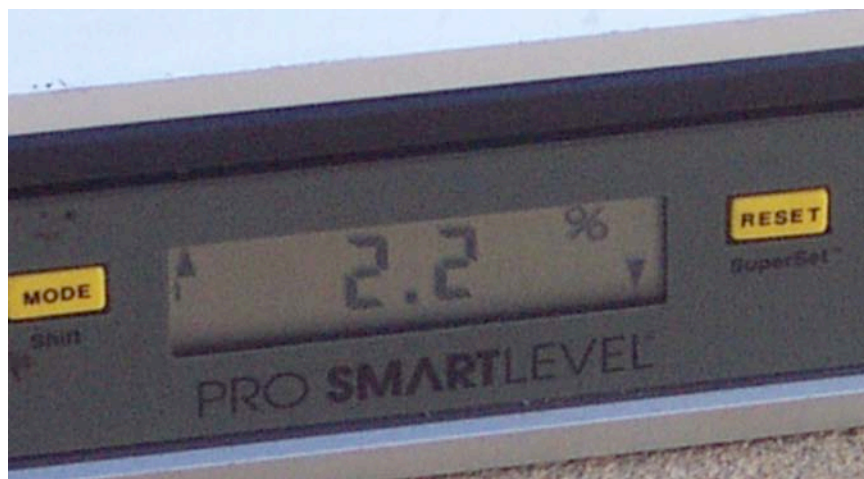
- g. The cross slope at the landing is 2.2%, contrary to ANSI section 405.7.1 and ADAAG section 4.8.4.

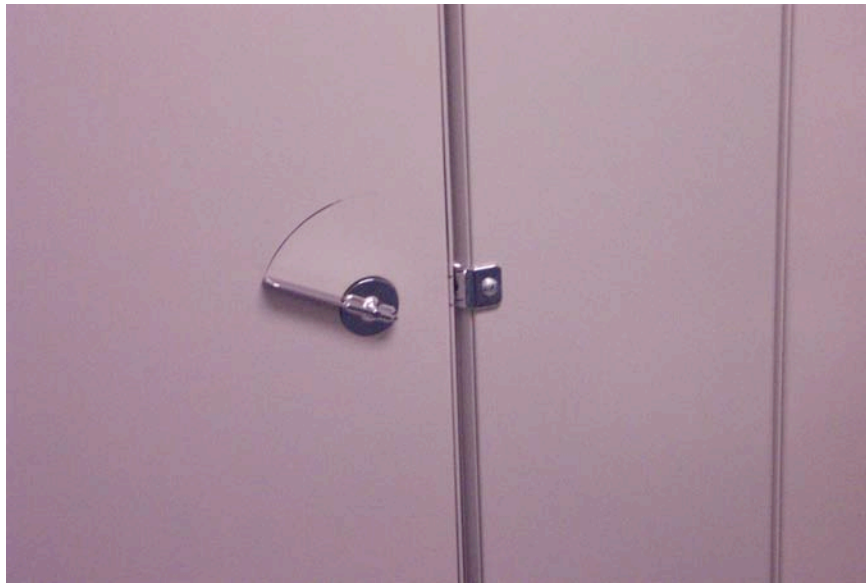
9. The women's bathroom inside the police department and court has the following problem which need to be corrected.
  - a. There is a pinch lock on the stall door which requires pinching and grasping with the hand, contrary to ANSI section 404.2.7 and ADAAG section 4.13.9. Because there is no self door closing mechanism there is a need to pinch the handle to secure the door.

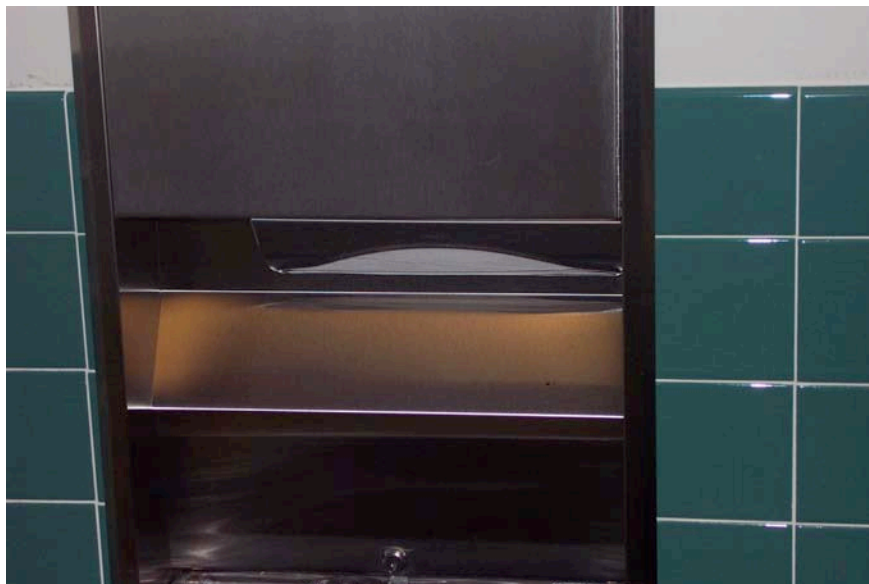
- b. The paper towel dispenser requires pinch to remove paper towels contrary to ANSI section 309.4 and ADAAG section 4.27.4.

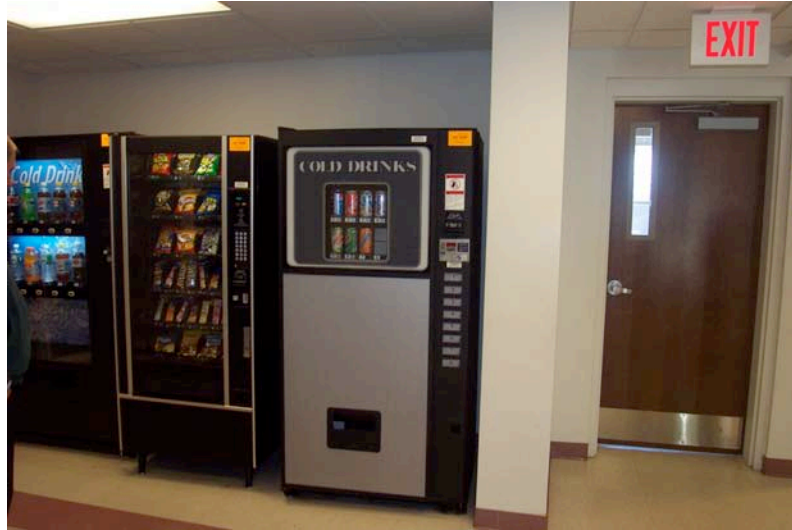
10. The coke machine coin slots measure 55 inches above the finished floor, contrary to ANSI sections 308.2.1 and 308.3.1 and ADAAG section 4.2.6.

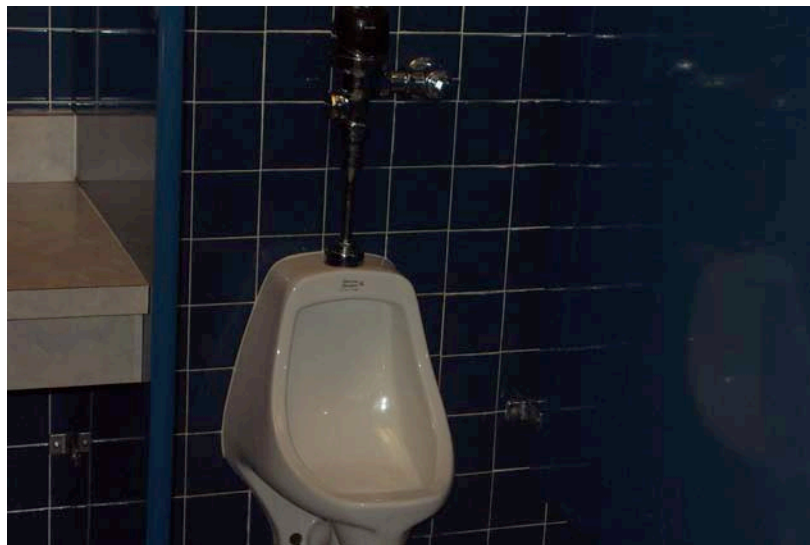
11. The men's bathroom inside the Police Department and Court has the following problems to be corrected.
- a. The toilet paper dispenser is mounted 44 inches off of the back wall, contrary to ANSI section 604.7 and ADAAG section 4.16.6.
  - b. The coat hook is mounted 52 inches above the finished floor, contrary to ANSI section 604.8.4.2 and ADAAG section 4.2.6.
  - c. There is 30 inches of clearance from the toilet to the coat hook, contrary to ANSI section and ADAAG section.
  - d. The width between the urinal shields is 29.5 inches, contrary to ANSI section 605.3 and ADAAG section 4.18.3.

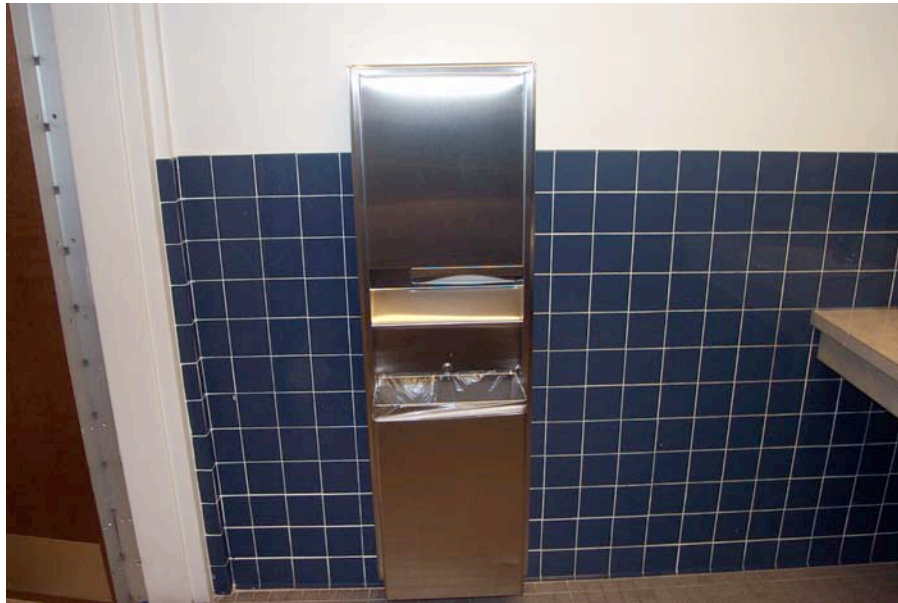
- e. The paper towel dispenser requires pinch to remove paper towels contrary to ANSI section 309.4 and ADAAG section 4.27.4.

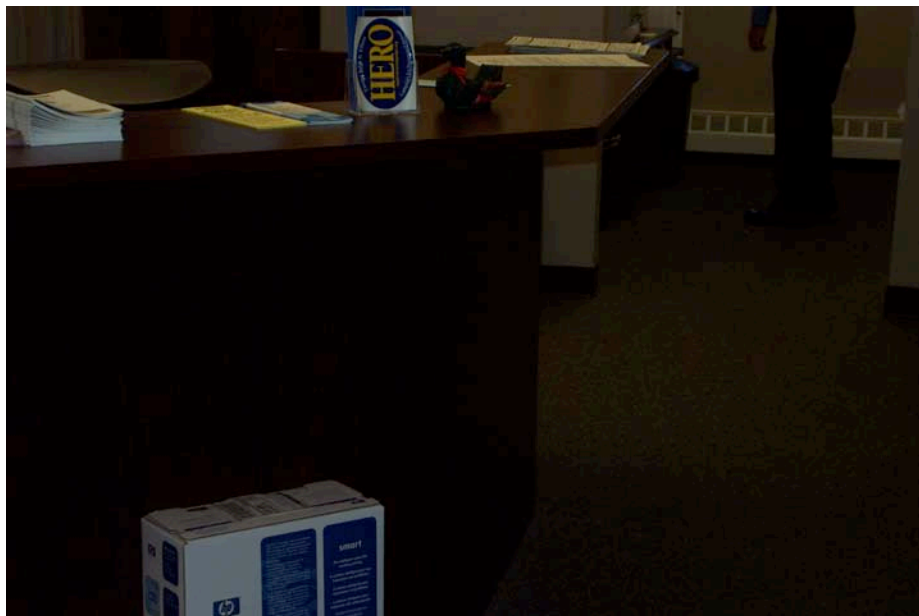
- 12. The counter height at the Police Station Administration Office is 43 inches above the finished floor, contrary to ANSI section 904.2 and ADAAG section 7.2(1).

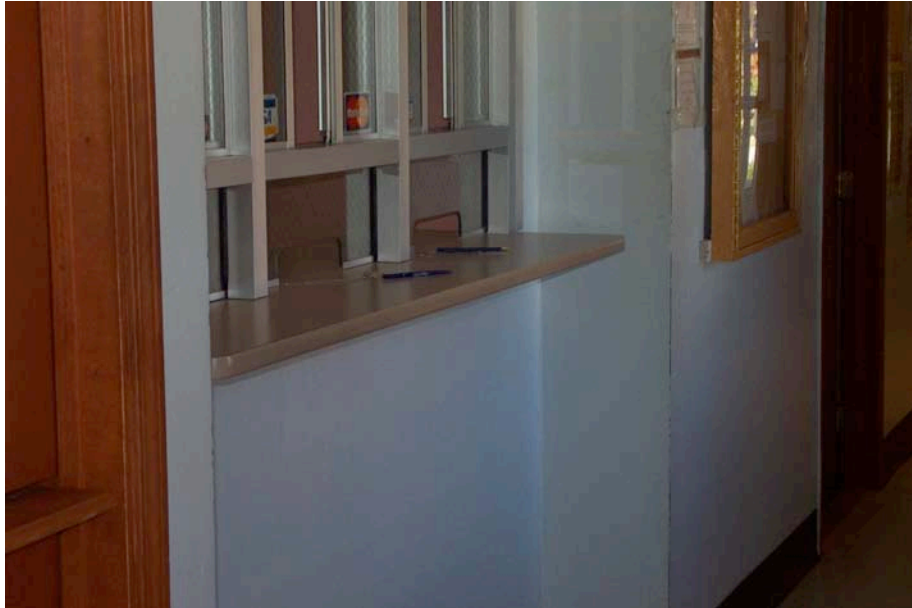
13. The Court Office counter height is 43.5 inches above the finished floor, contrary to ANSI section 904.2 and ADAAG section 7.2(1).

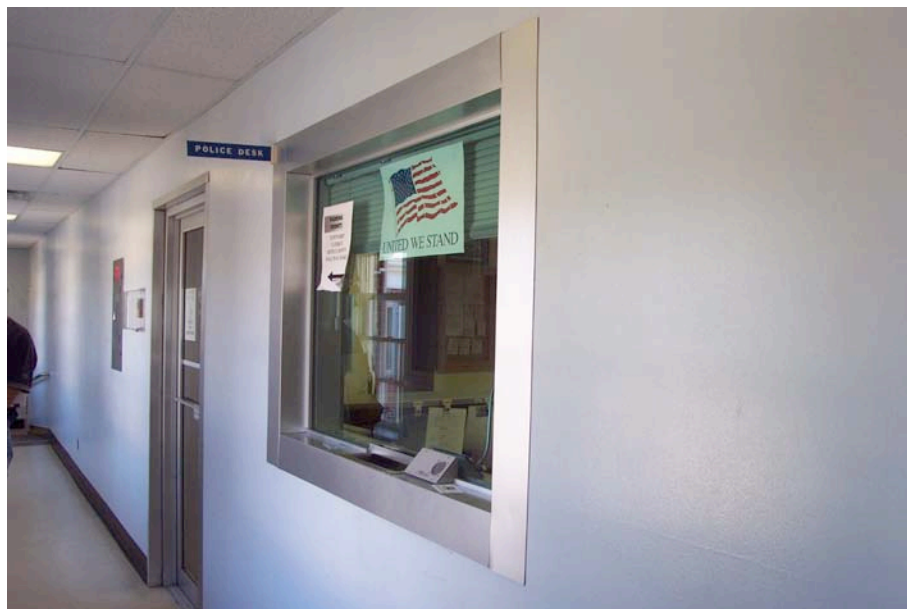
14. The Police Department Service Window has a counter that measures 45.5 inches above the finished floor, contrary to ANSI section 904.2 and ADAAG section 7.2(1).
