## Johnson Gill Annex and Courthouse 1 Kings Highway, Middletown, NJ

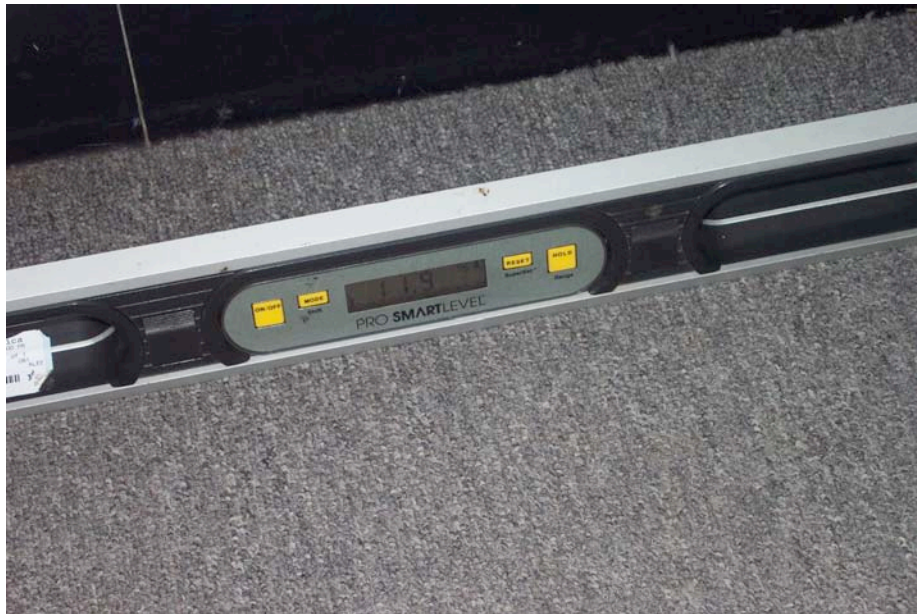
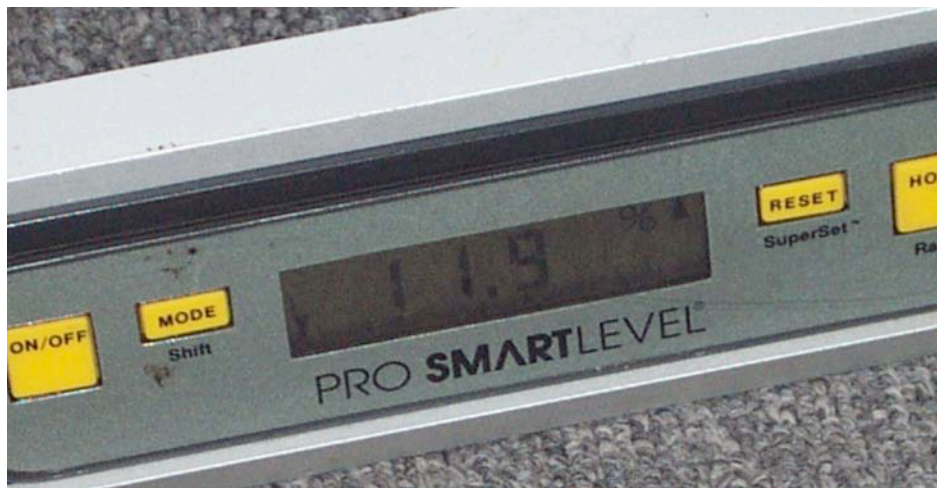
15. The ramp leading to the Mayor's Office has a slope of 11.9% and does not contain the required handrail extensions, contrary to ANSI sections 405.2 and 505.10.1 and ADAAG sections 4.8.2 and 4.8.5(2).

Note: The hand rails that are installed presently are not secured properly and could buckle when used.

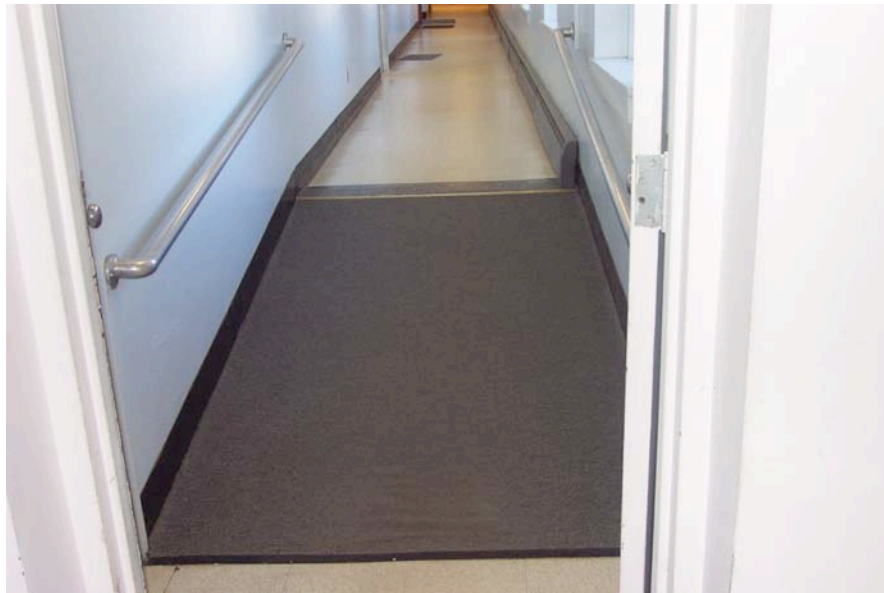
16. The diameter of the handrails is 1.75 inches, contrary to ADAAG section 4.8.5.

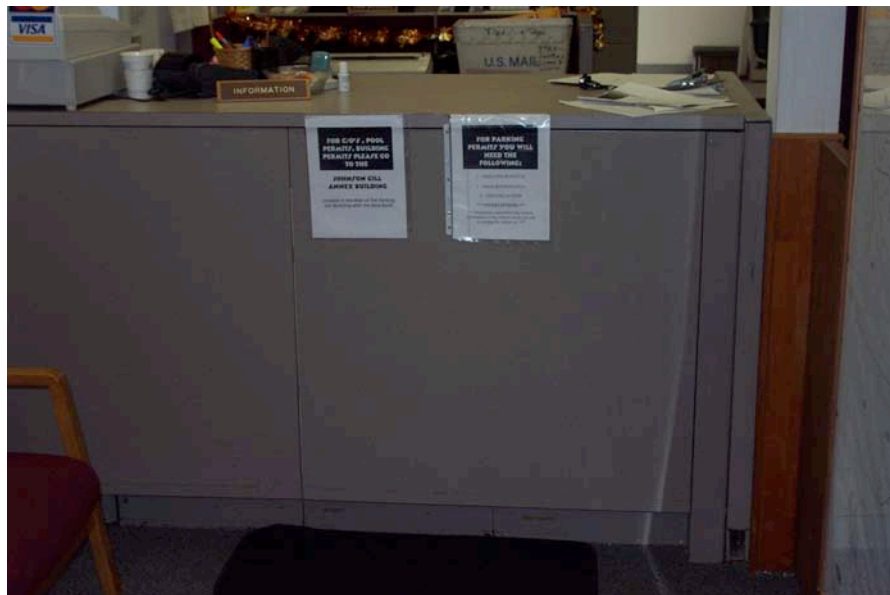
17. The door at the mayor's office requires more than 5 pounds of pressure to open, contrary to ANSI section 404.2.9 and ADAAG section 4.13.11.
18. The counter at the Clerk's office measures 43 inches above the finished floor, contrary to ANSI section 904.2 and ADAAG section 7.2(1).

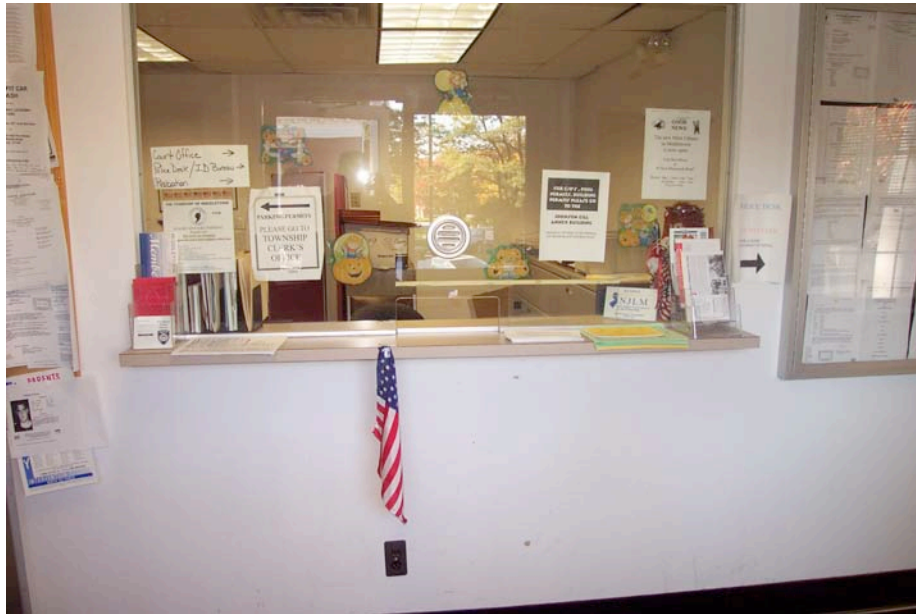
19. The Administration office counter measures 41 inches above the finished floor, contrary to ANSI section 904.2 and ADAAG section 7.2(1).

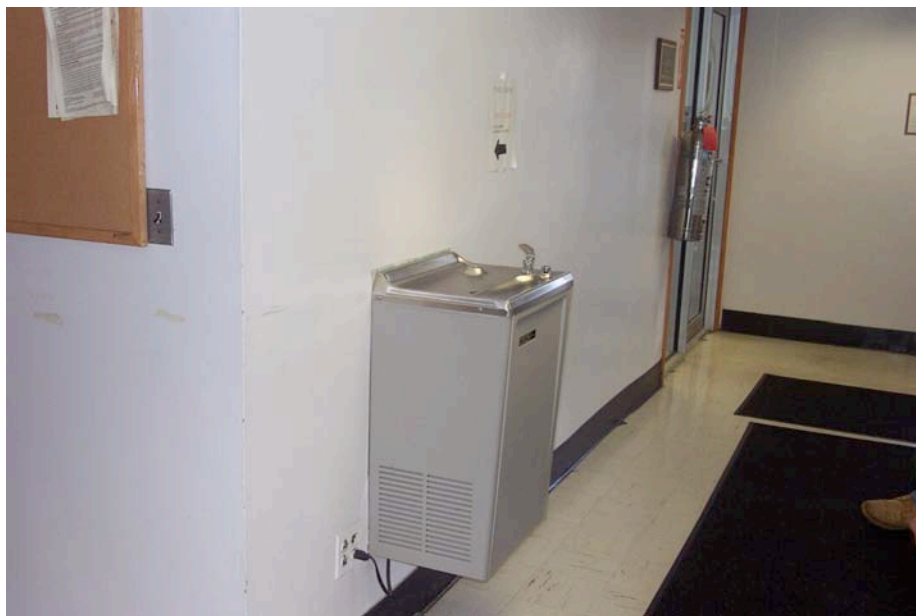
20. The water fountain in the building is above 36 inches and the controls are not in there proper place to be accessible ADAAG section 4.15.4.

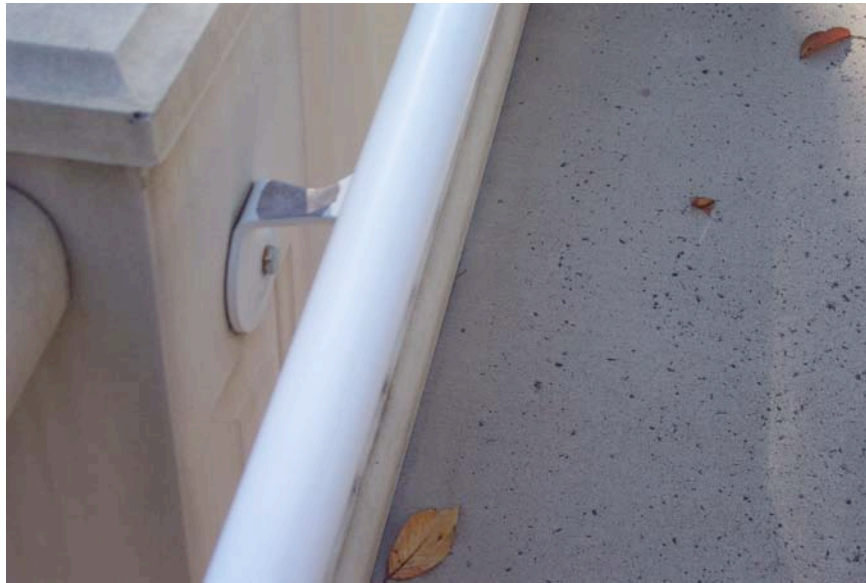
21. The ramp on the Administration building has handrails 2.25 inches, contrary to ANSI section 505.7 and ADAAG section 4.8.5. In places the handrail is more than 1.5 inches and poses a danger of a disabled person getting their arm or hand trapped.

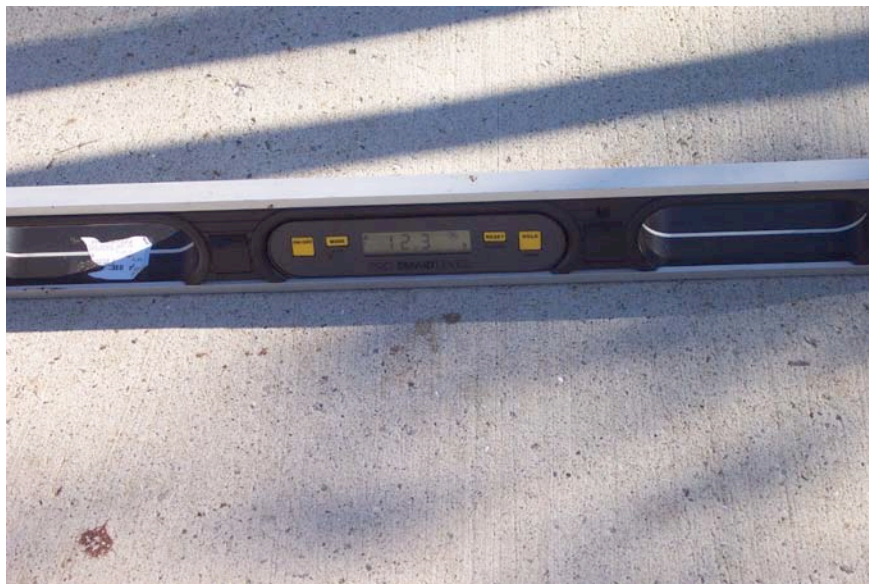
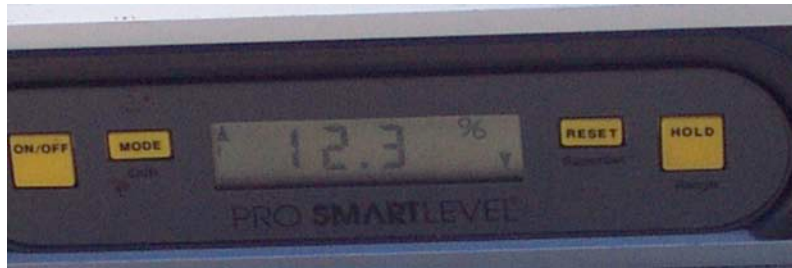
22. The curb cut at the Administration building has a slope of 12.3%, contrary to ANSI section 406.2 and ADAAG section 4.7.2.

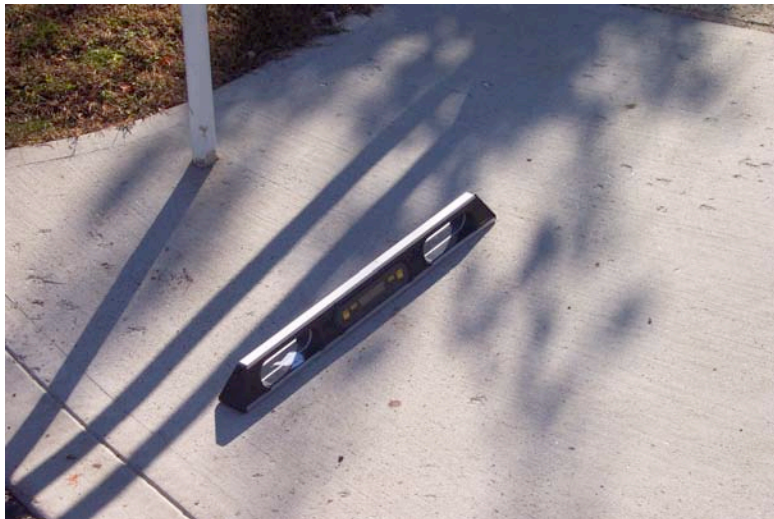
23. There is no landing at the bottom of the ramp, contrary to ANSI section 406.3 and ADAAG section 4.8.5.

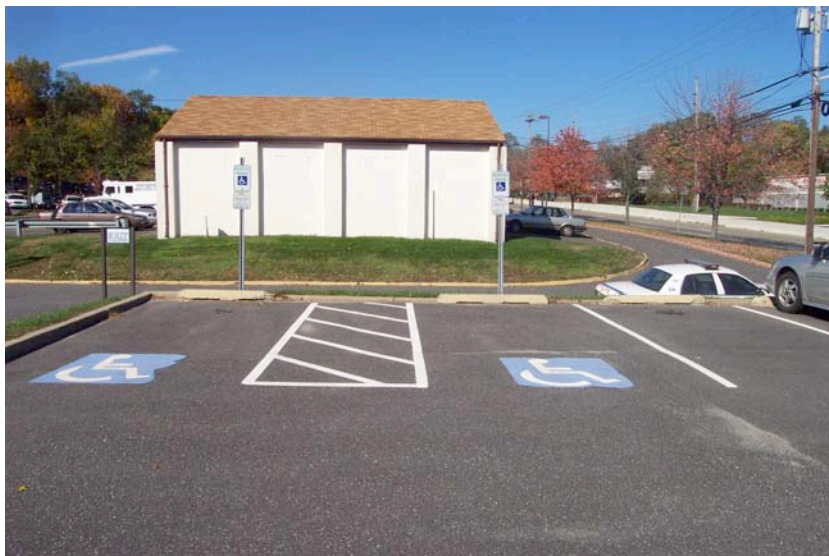
24. The access aisle at the parking space outside the entrance is 53 inches wide, contrary to ANSI section 502.3.1 and ADAAG section 4.6.6.
