Ideal Beach Park

Bayside Parkway, North Middletown, Middletown Township NJ

Page 5 - Ideal Park

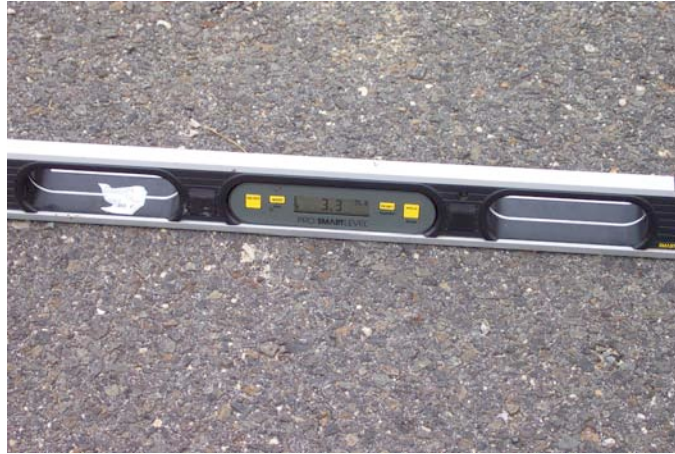
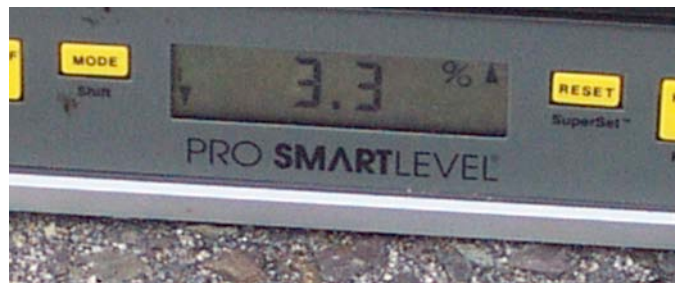
1. The parking lot has the following problems which need to be corrected.
 - a. The right parking space facing the beach has a running slope of 3.3%, contrary to ANSI section 502.4 and ADAAG section 4.6.3.

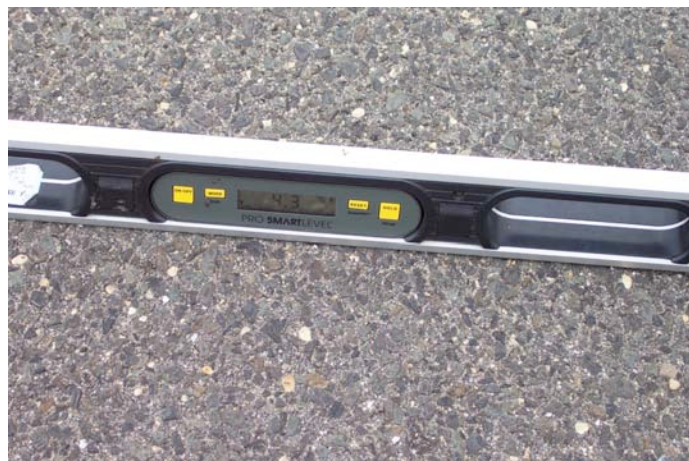
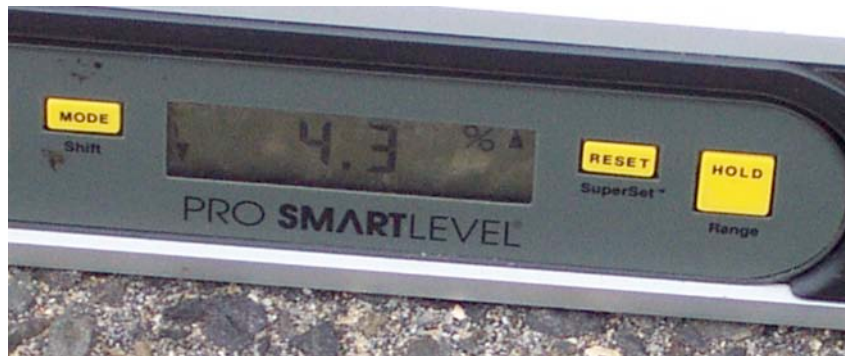
- b. The left parking space has a slope of 4.3%, contrary to ANSI section 502.4 and ADAAG section 4.6.3.

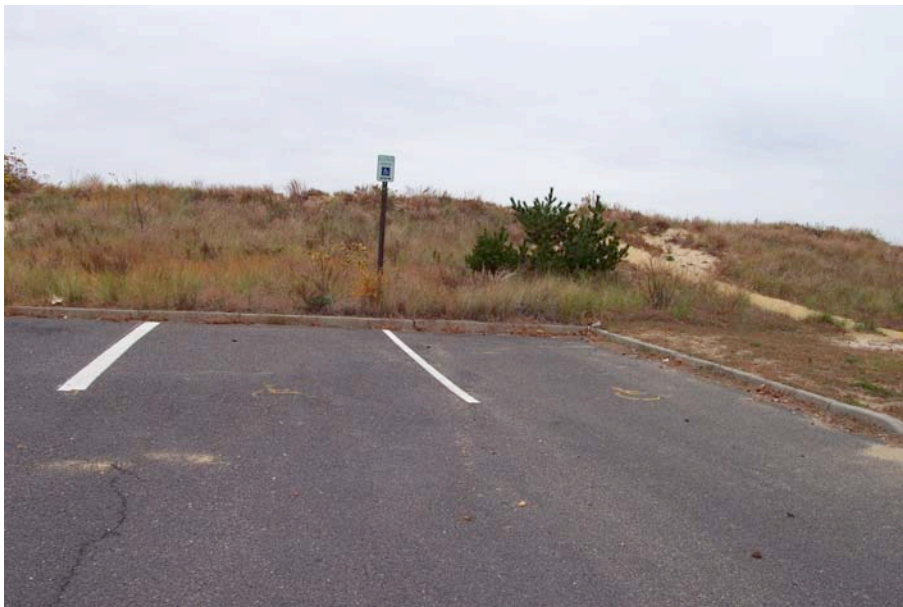
- c. The designated disabled parking spaces do not contain a proper access aisle, contrary to ANSI section 503 and ADAAG section 4.6.6.
- d. The designated disabled parking spaces are not properly painted to designate them as disabled spaces, contrary to ANSI section 502.3.3 and ADAAG section 4.6.4.
- e. Each of the spaces has to be properly labeled with a parking sign to designate them as being accessible, according to ANSI section 502.6 and ADAAG section 4.6.4.
- f. There are no additional signs mounted below the parking signs stating the fines for parking violations, which is a violation of local and state parking codes.

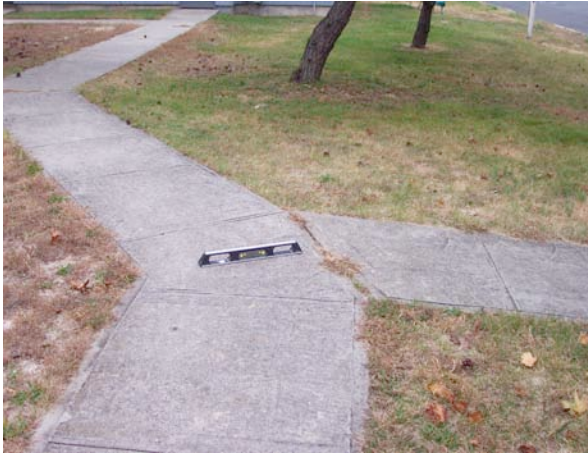
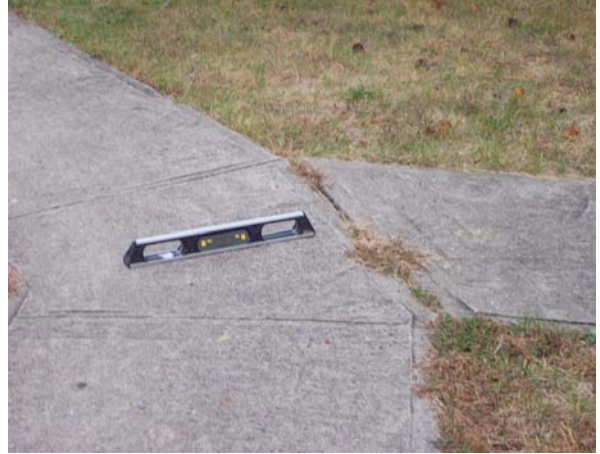
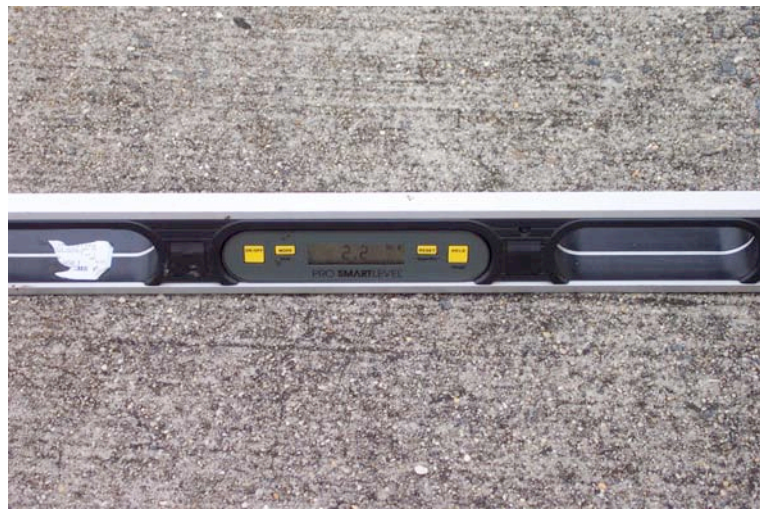
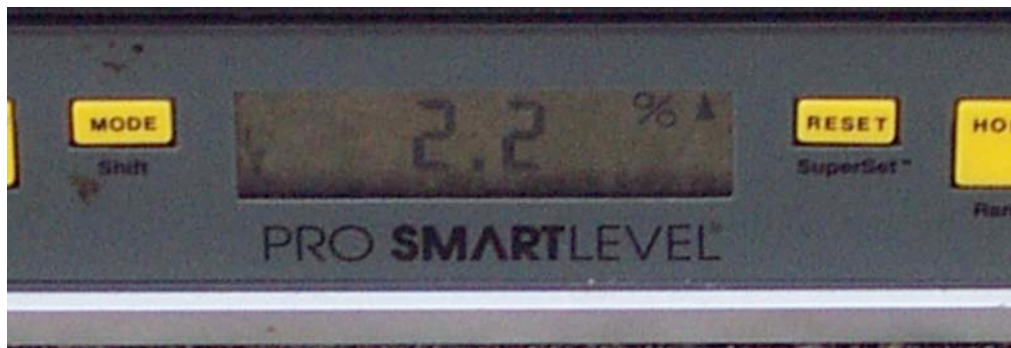
2. The accessible route to the restroom has a 90 degree turn with a cross slope of 2.2%, contrary to ANSI section 402.2 and ADAAG section 4.3.7.

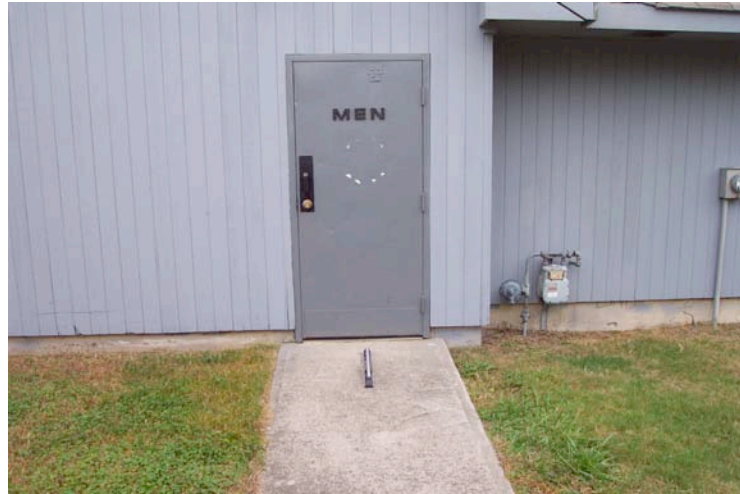
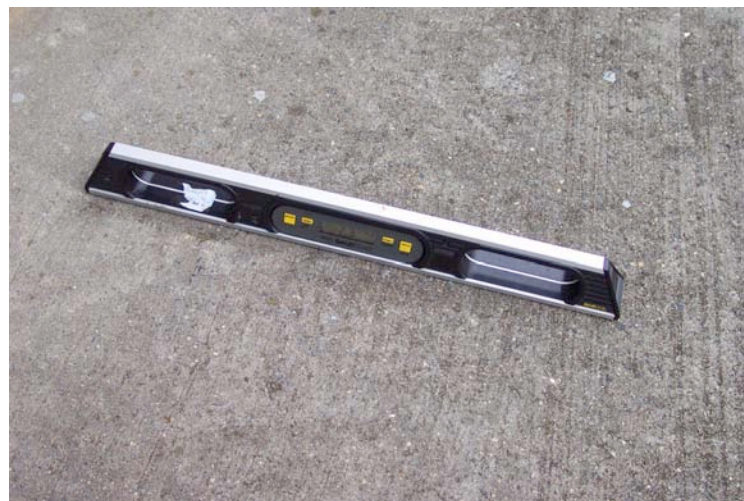
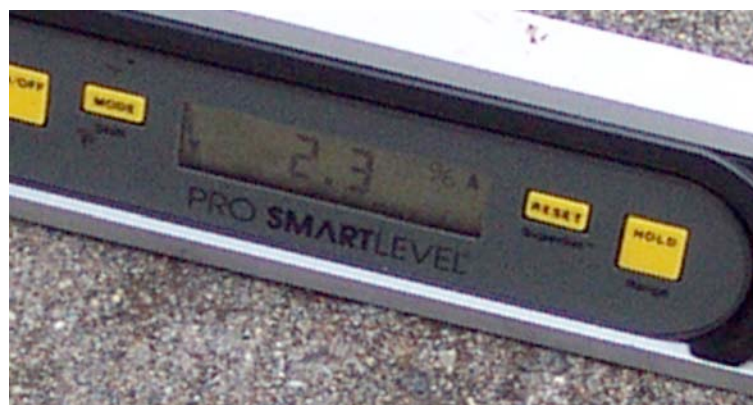
3. The slope at the bathroom door is 2.3%, contrary to ANSI section 404.2.4.5 and ADAAG section 4.3.7.

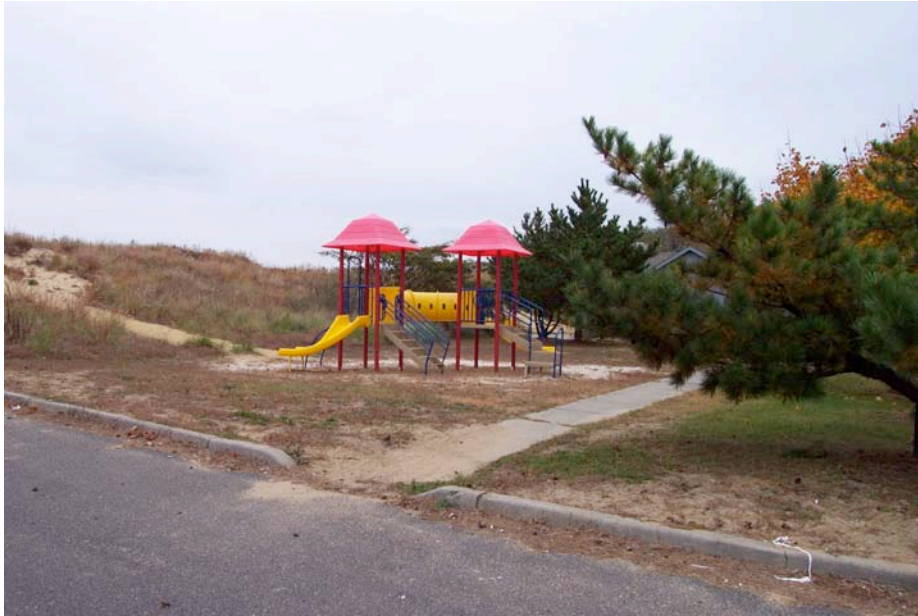
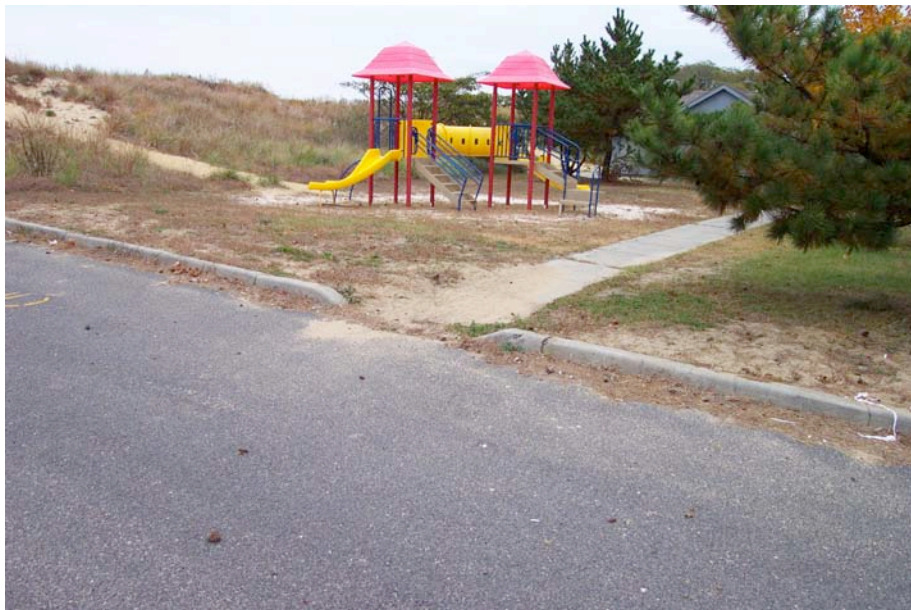
4. There is no proper sign centered at 60 inches on the latch side of the door, contrary to ANSI section 703.2.8 and ADAAG section 4.30.6.
5. The playground is not accessible due to sand surrounding the area, contrary to ANSI section 302.1 and ADAAG section 4.5.1.

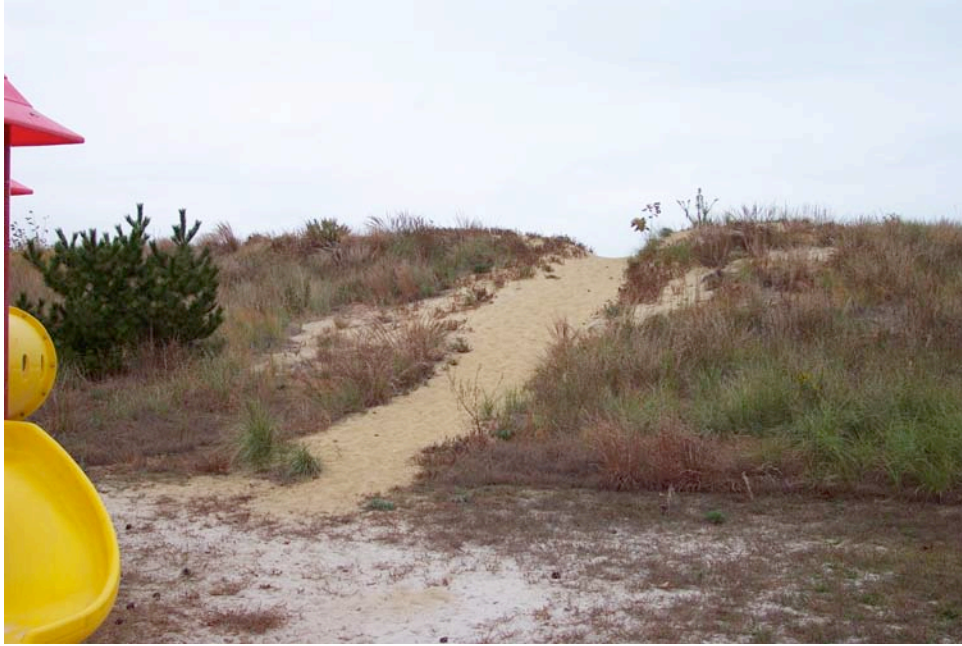
6. There is no access to the beach and waterfront area due to a sandy embankment, which is the only path leading to the beach, contrary to ANSI section 302.1 and ADAAG section 4.5.1.

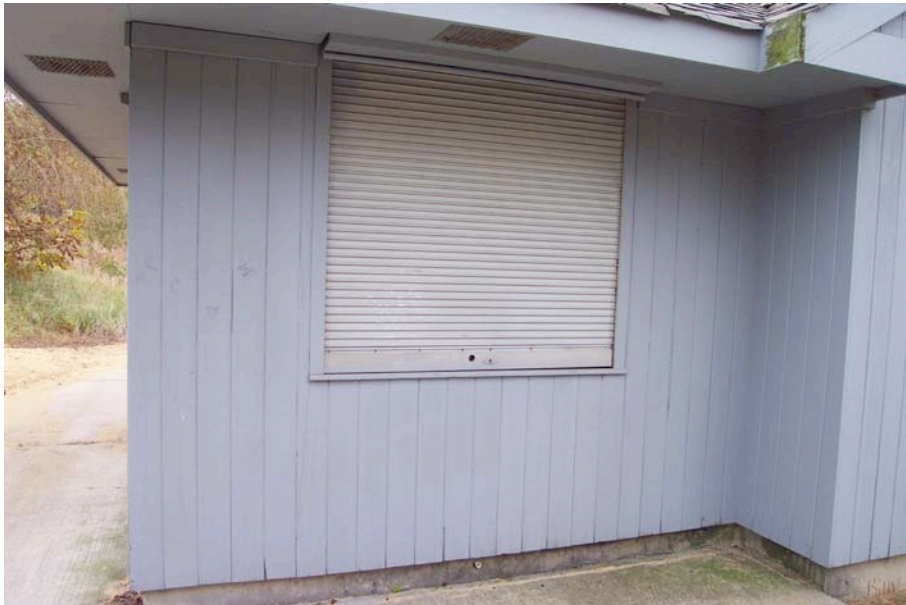
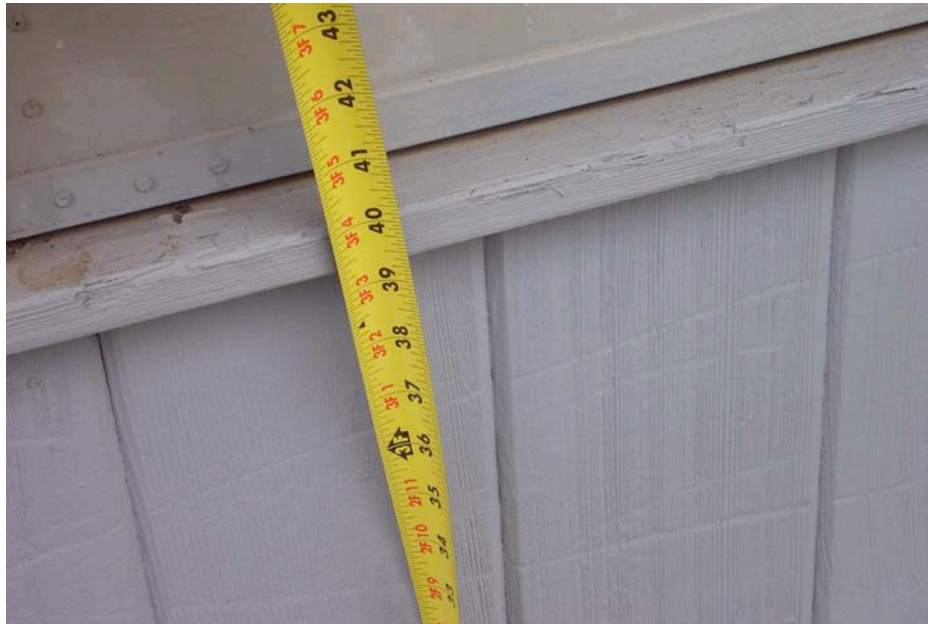
7. The sales counter, which was closed at the time of inspection, measures 40 inches above the finished floor, contrary to ANSI section 902.3 and ADAAG section 4.32.4.
