Tindell Park

Tindall Road Middletown, NJ

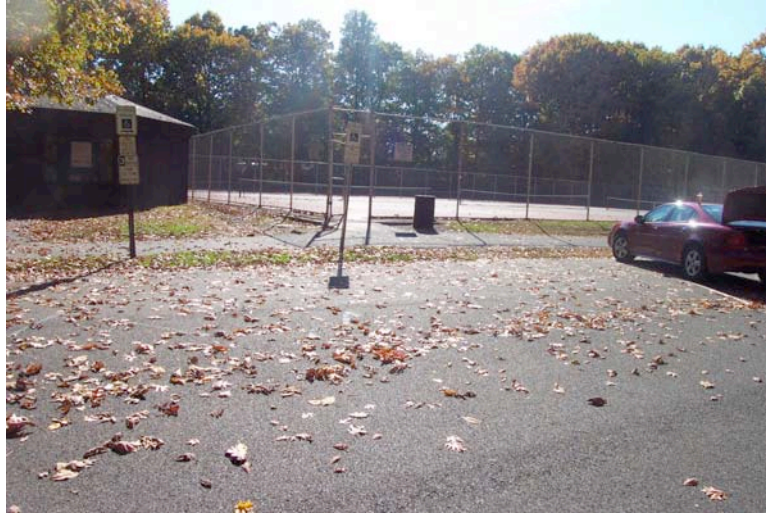
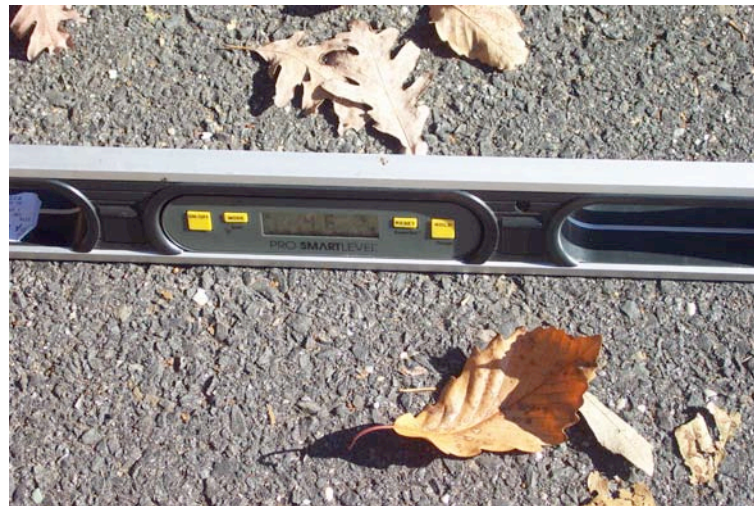
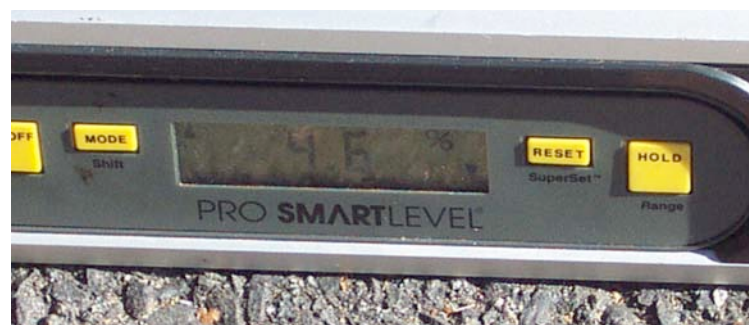
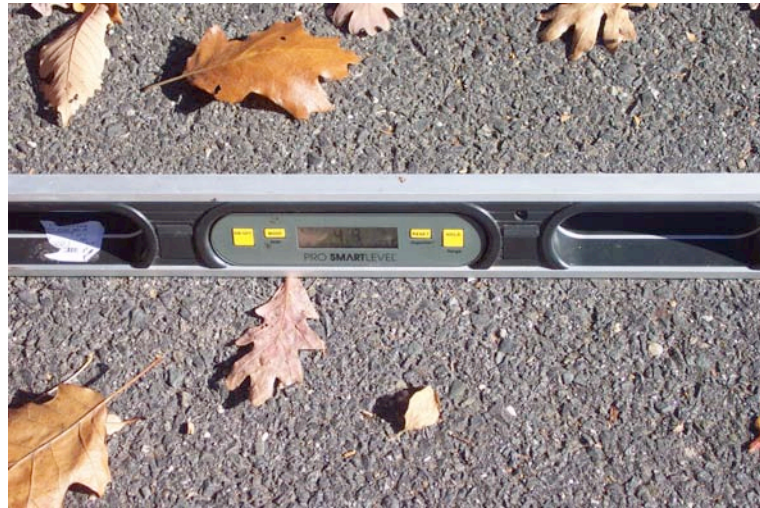
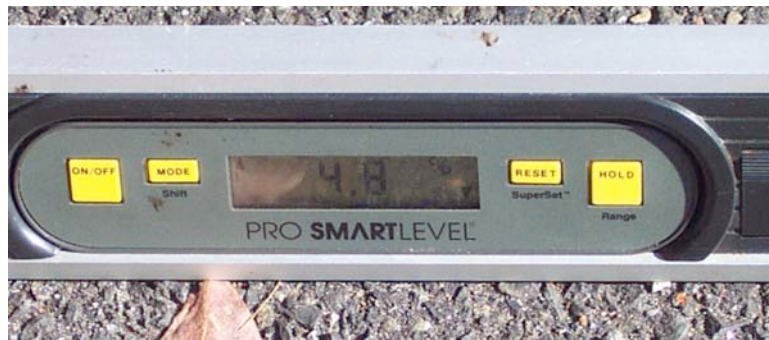
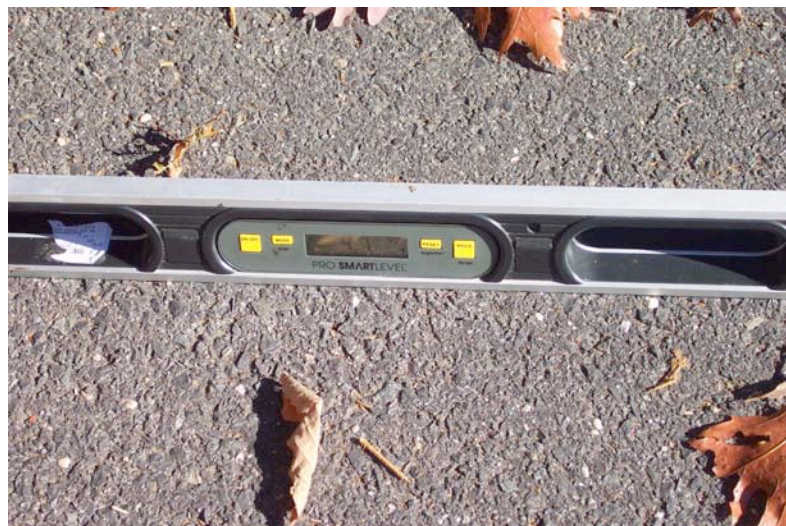
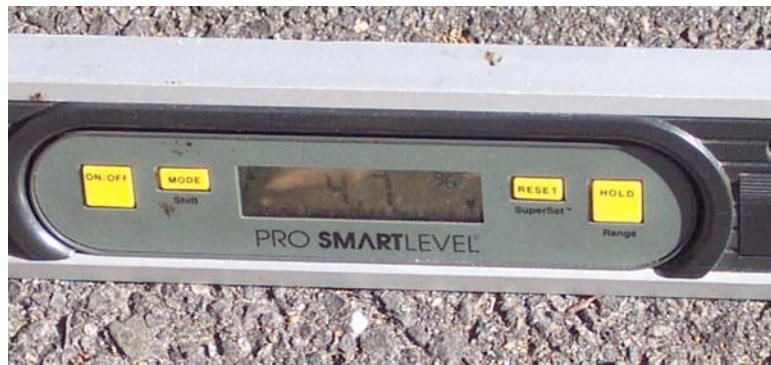
1. The parking area in front of the park has several problems to be corrected.
 - a. The parking spaces have running slopes of between 4.6% to 4.8%. There is a dip in each space which gives the excessive incline, contrary to ANSI section 502.4 and ADAAG section 4.6.3.

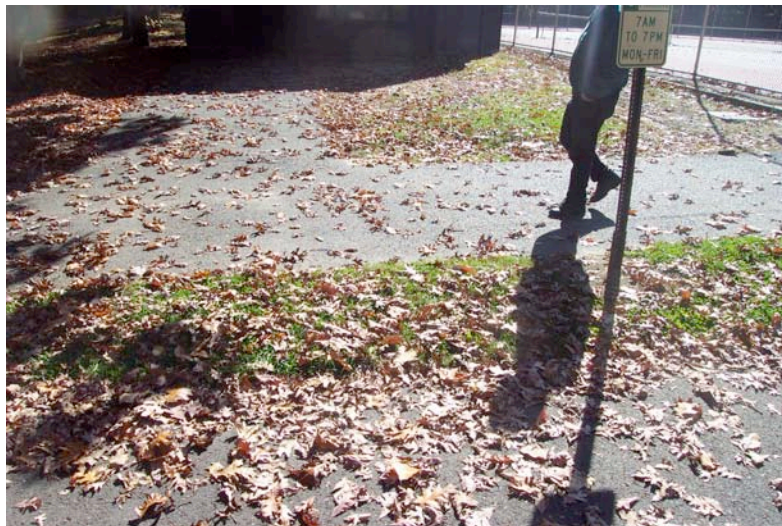
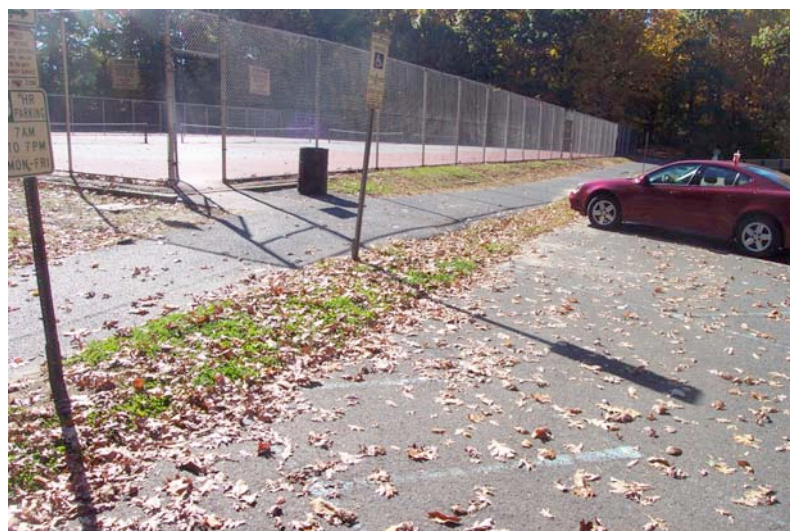
- b. The bottom of the signs at each space is below 60 inches when measured above the ground surface contrary to ANSI section 502.6 and ADAAG section 4.6.4.
- c. There is no accessible route from the access aisles to the sidewalk contrary to ANSI section 502.3 and ADAAG section 4.6.3.

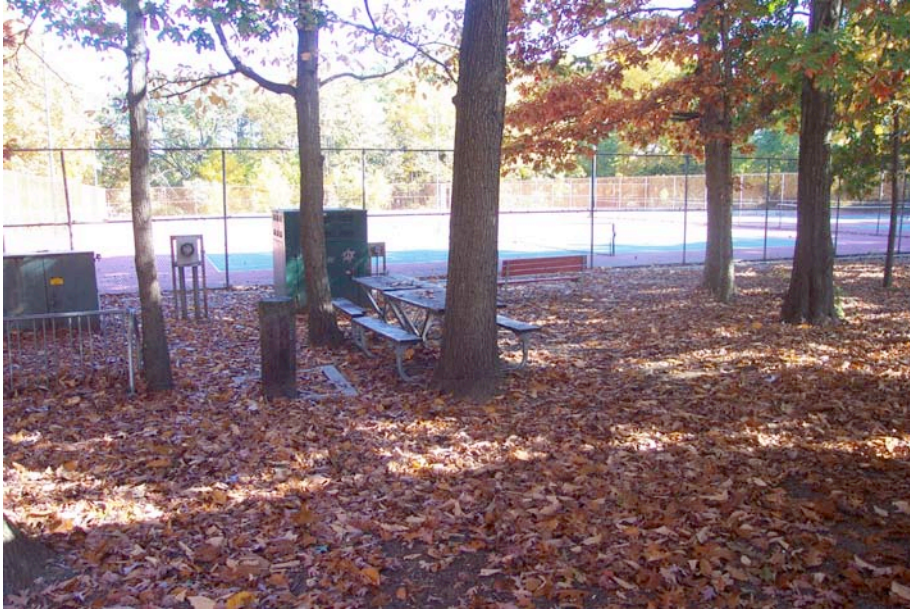
2. There are picnic tables at this site which have no accessible route of travel to them, contrary to ANSI section 403.2 and ADAAG section 4.5.1.

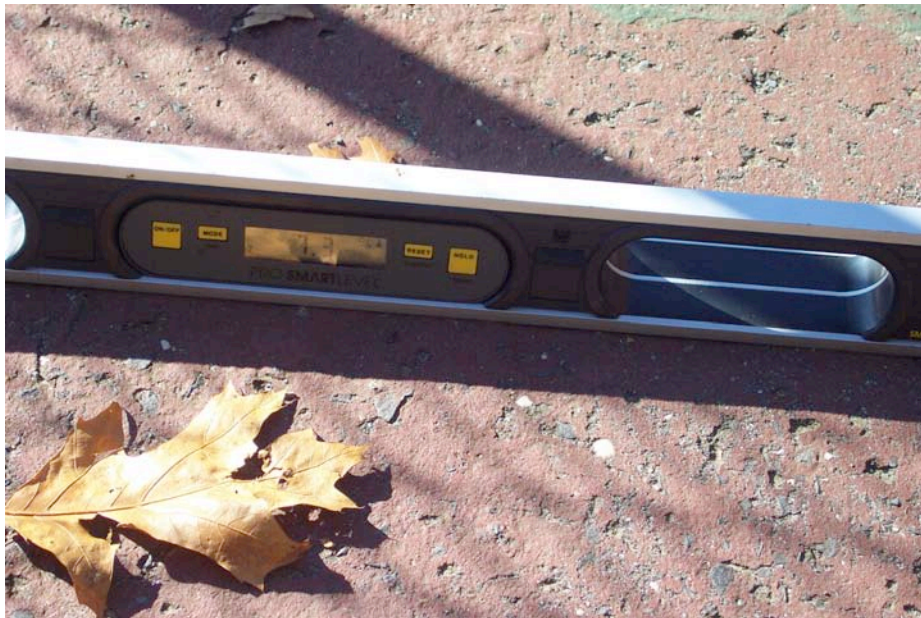
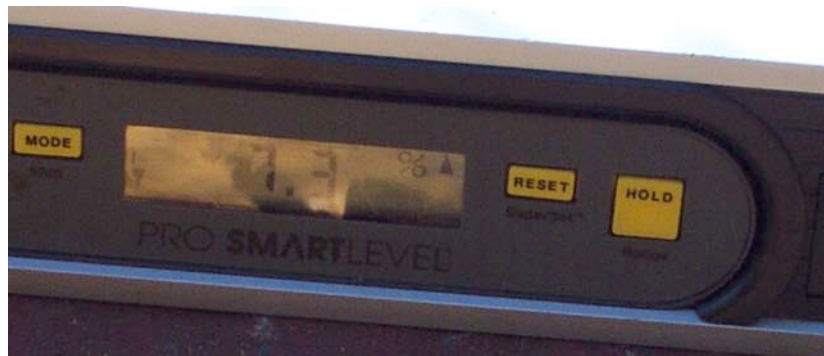
3. The path of travel to the tennis courts has a ramped surface which has a slope of 7.3% slope, contrary to ANSI section 405.2 and ADAAG section 4.8.1.

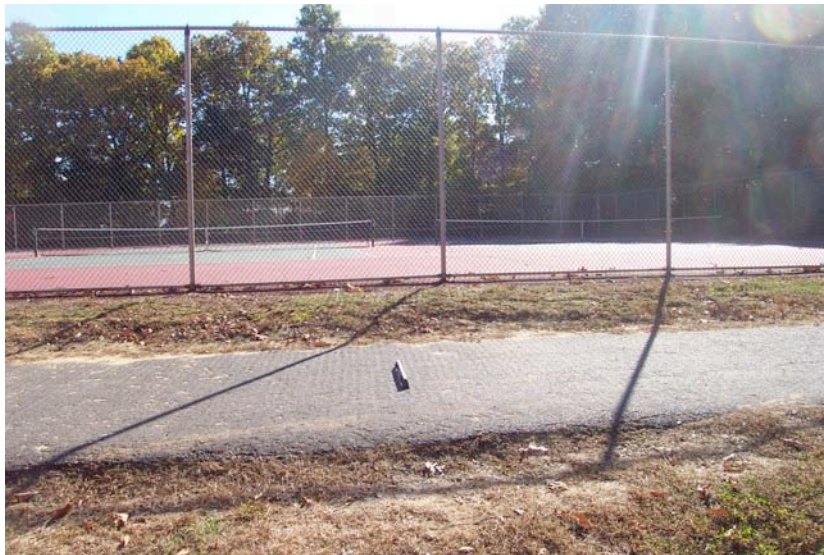
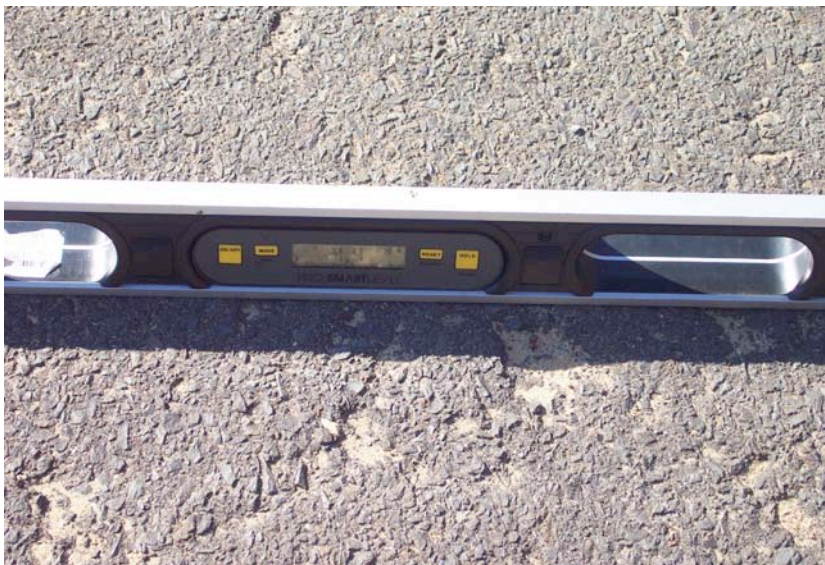
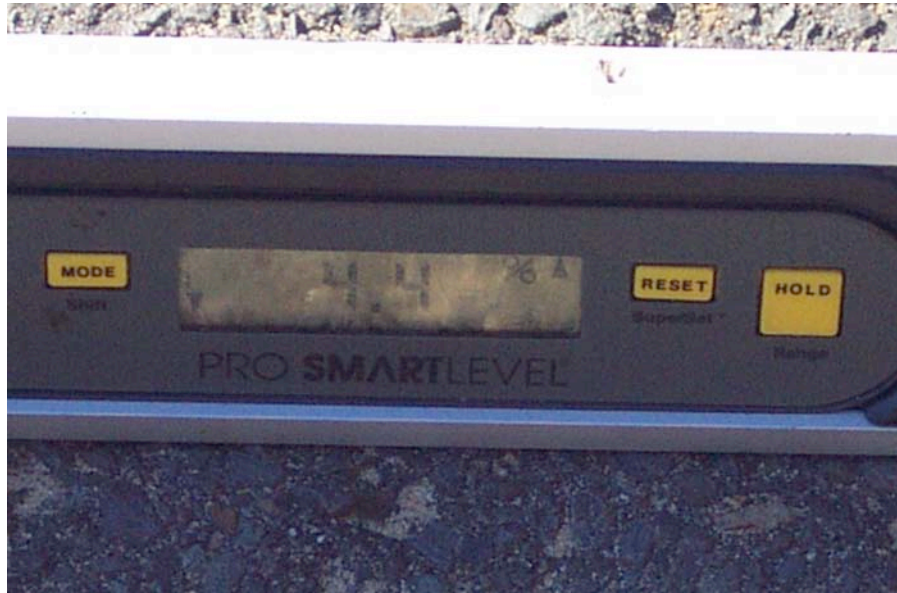
4. There is a 4.4% cross slope on the sidewalk in front of the tennis courts, contrary to ANSI section 305.2 and ADAAG section 4.3.7.

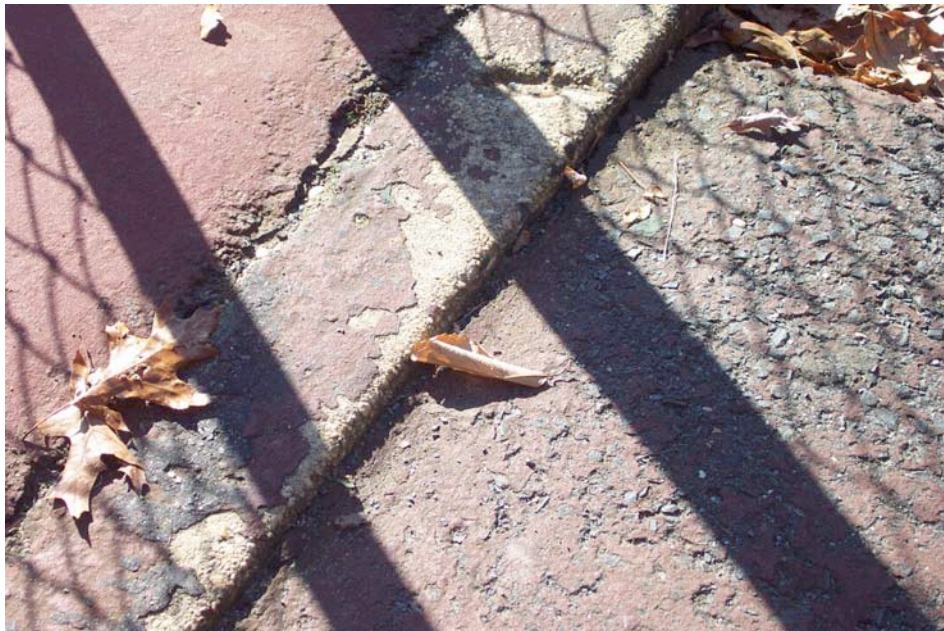
5. There is a 1 inch transistion into the tennis court, contrary to ANSI section 303.2 and ADAAG section 4.5.2.

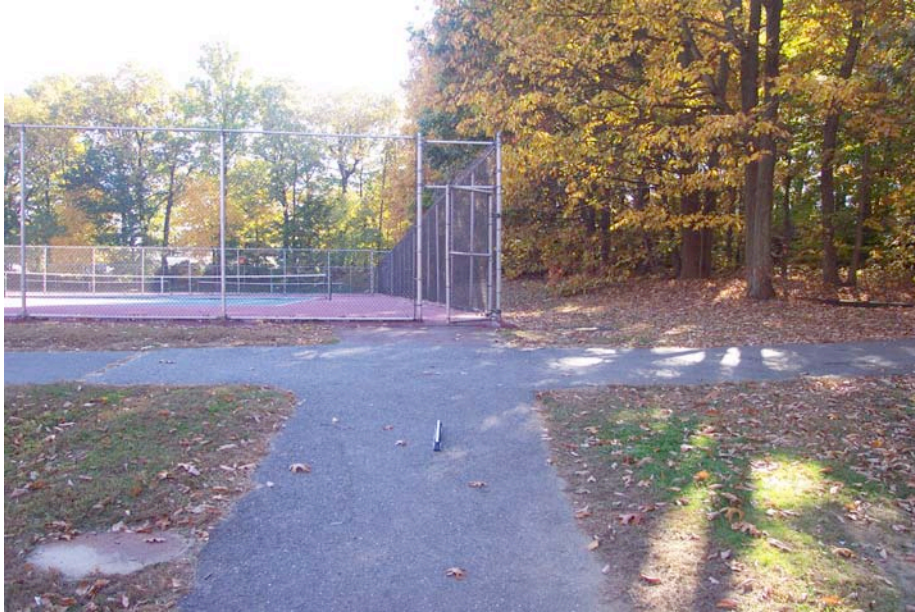
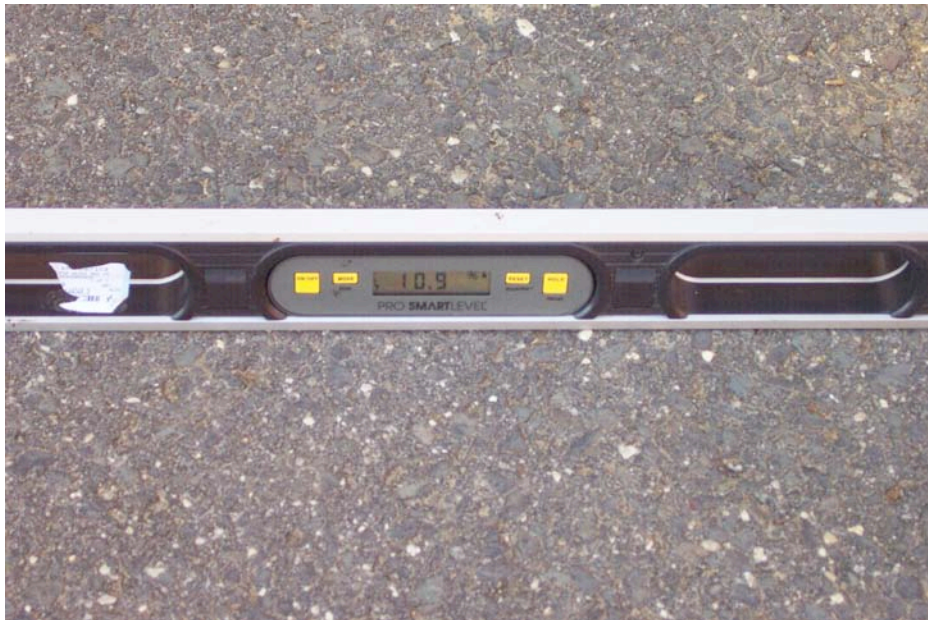
6. The ramp to the playground has a slope of 10.9%, contrary to ANSI section 405.1 and ADAAG section 4.8.2.

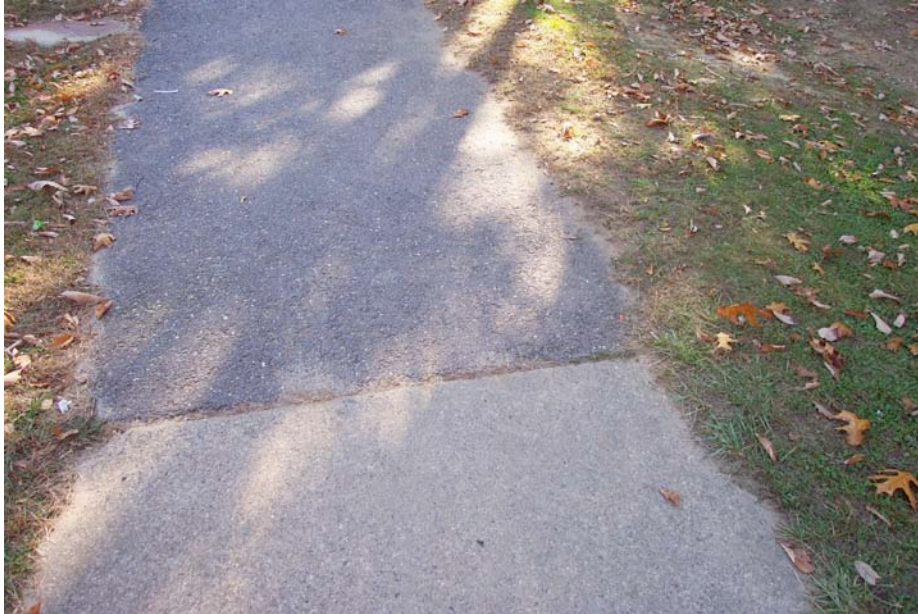
7. The ramp to the playground lacks a landing with less than a 2% slope, according to ANSI section 405.7 and ADAAG section 4.8.4..

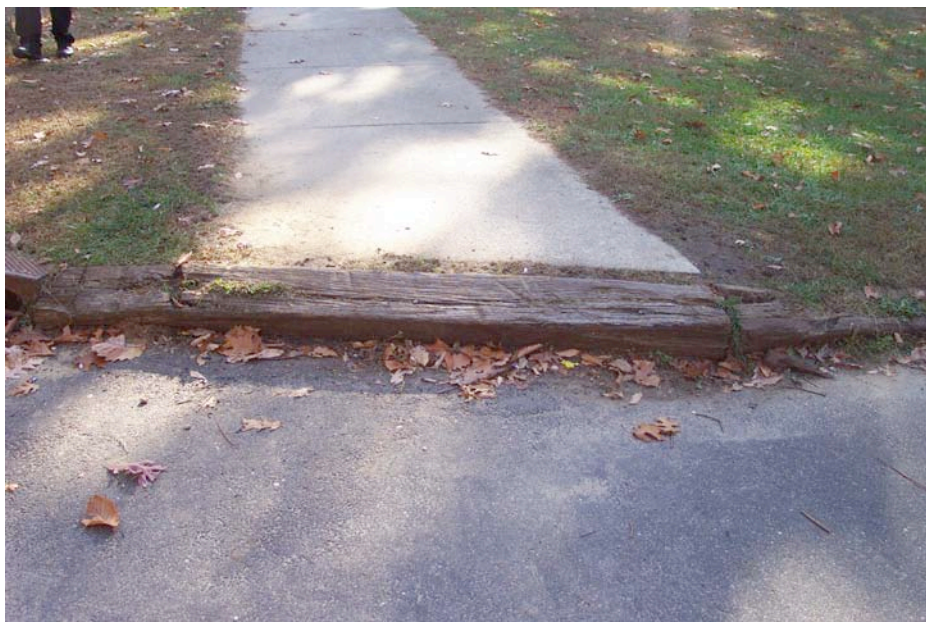
8. At the end of the sidewalk there is no curb cut, contrary to ANSI section 303.4 and ADAAG section 4.7.1.

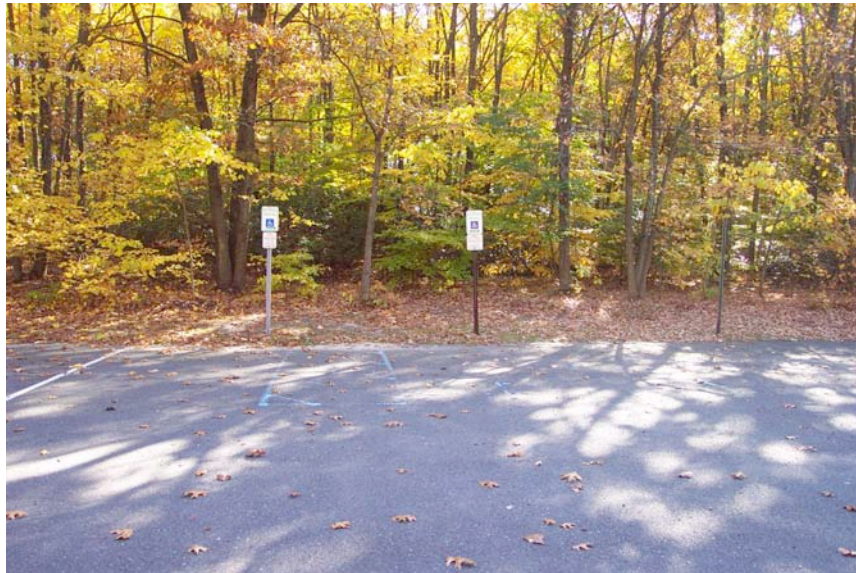
9. The parking spaces at the golf course do not have maintained paint and striping, contrary to ANSI section 502.3.3 and ADAAG section 4.6.4.
10. The parking area at the miniature golf course needs an access aisle added to one space, contrary to ANSI section 502.3 and ADAAG section 4.6.3.

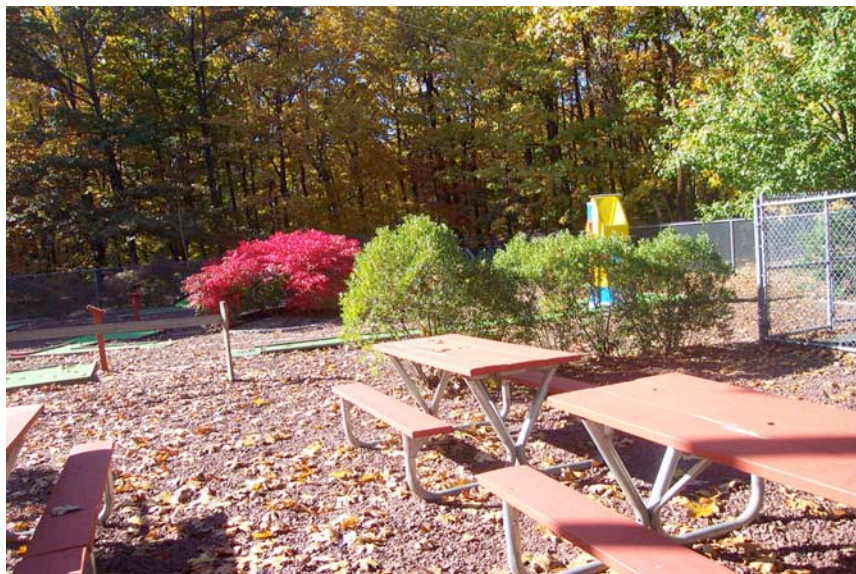
11. There are 10 tables at the golf course, none of which are accessible with 19 inches of underside clearance and 30 inches by 48 inches of clear floor space, contrary to ANSI section 902.2 and ADAAG section 4.32.3.

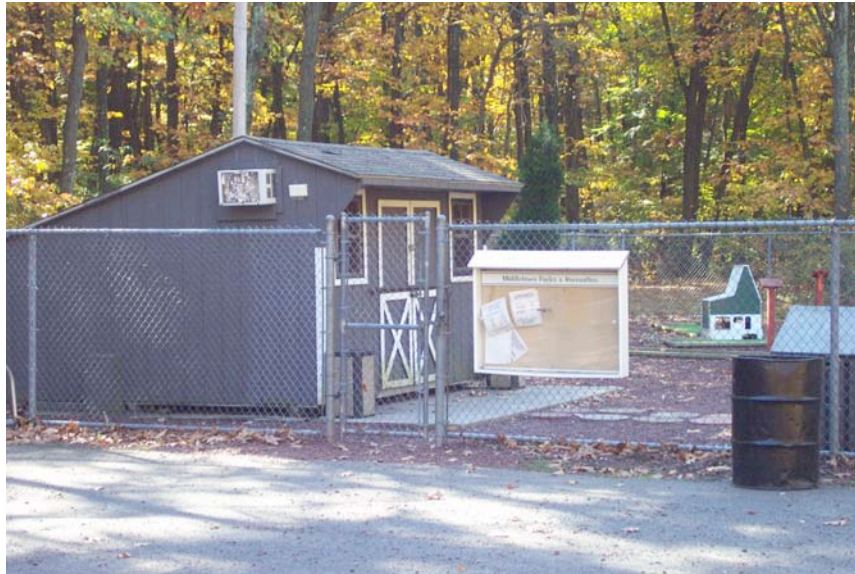
12. The counter at the miniature golf course is higher than 36 inches without a lowered section of 60 inches, contrary to ANSI section 904.3 and ADAAG section 7.2.

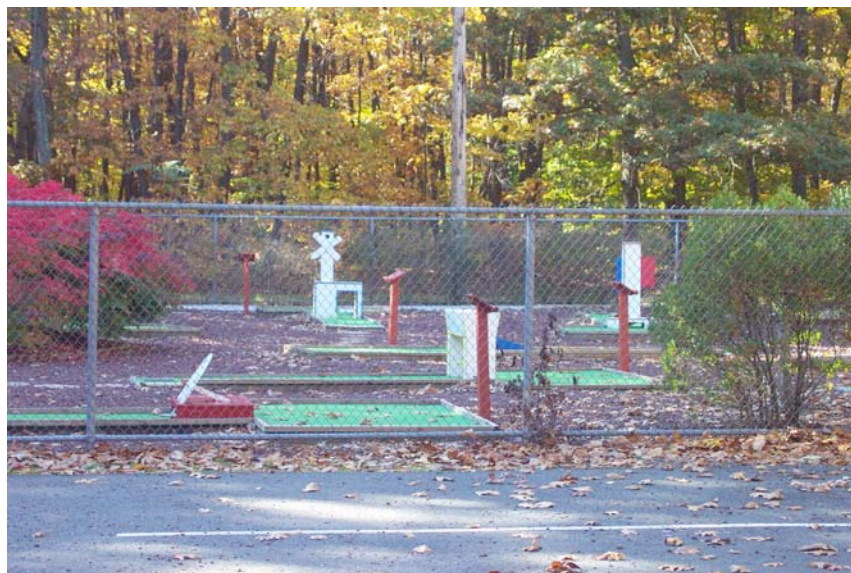
13. There is no access around the golf course because there is no hard ground surface contrary to ANSI section 302.1 and ADAAG section 4.5.1. There is also a transition more than .25 inches from the entrance to the concrete pad in front of the service window.
