Navesink Library

149 Monmouth Ave. Navesink, NJ

Upon inspection the following problems were confirmed at the Navesink Branch Library located 149 Monmouth Ave, Navesink, NJ.

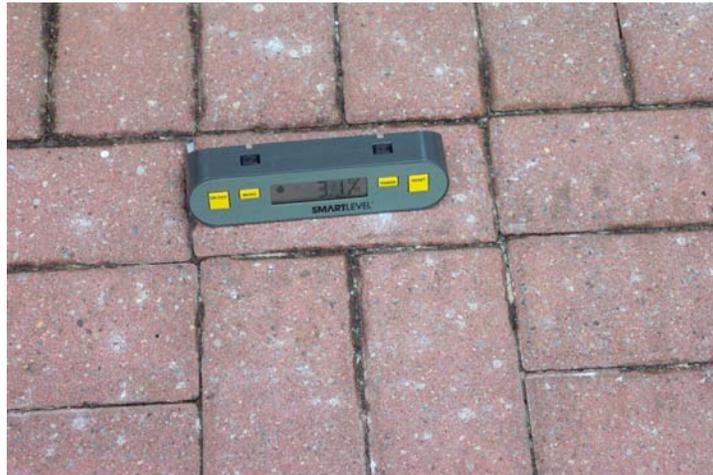
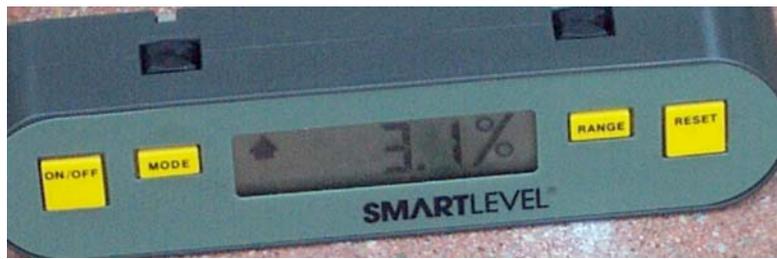
9. Upon discussions with the librarian it was stated that this entrance is only used by patrons who come to see performances of a local theatre group. Since this appears to be the only entrance that can be made into an accessible element, upon correction of the problems outlined this door needs to be open during business hours to allow disabled guests the ability to enter and utilize the facilities.
