Middletown Public Library  
Main Branch  
55 New Monmouth Rd Middletown, NJ

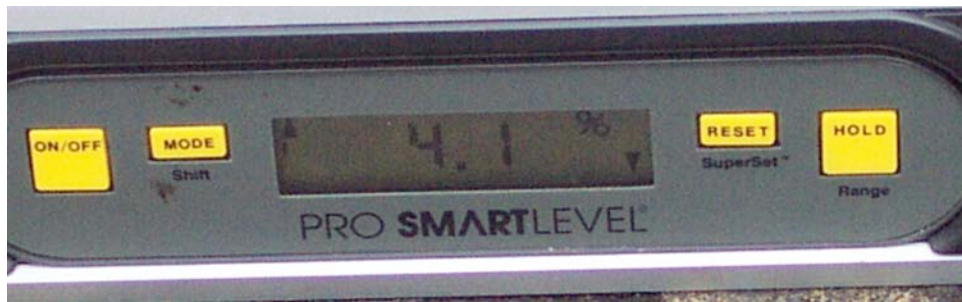
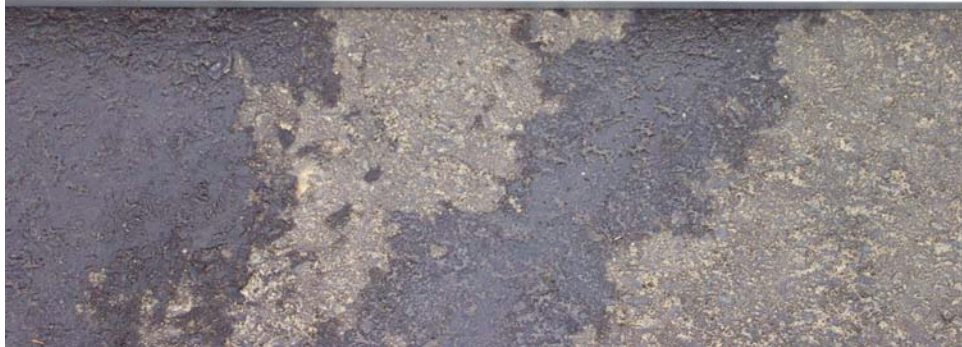
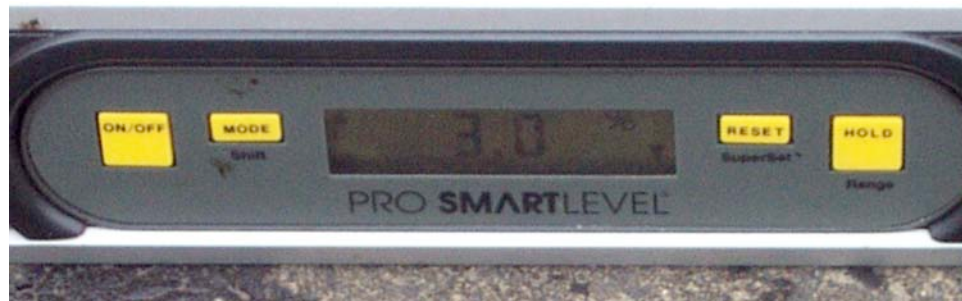
2. The front ramp has 8 sections with the following running slope measurements, contrary to ANSI section 405.1 and ADAAG section 4.8.1.
  - a. The second section from the bottom has a slope of 6.2%.
  - b. The third section from the bottom has a slope of 6.4%.

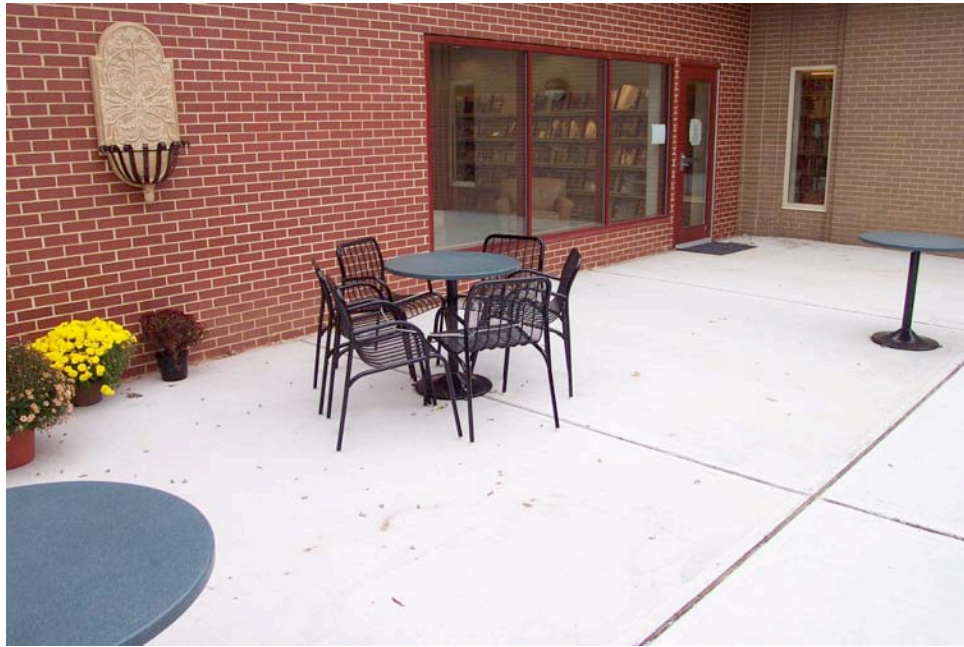
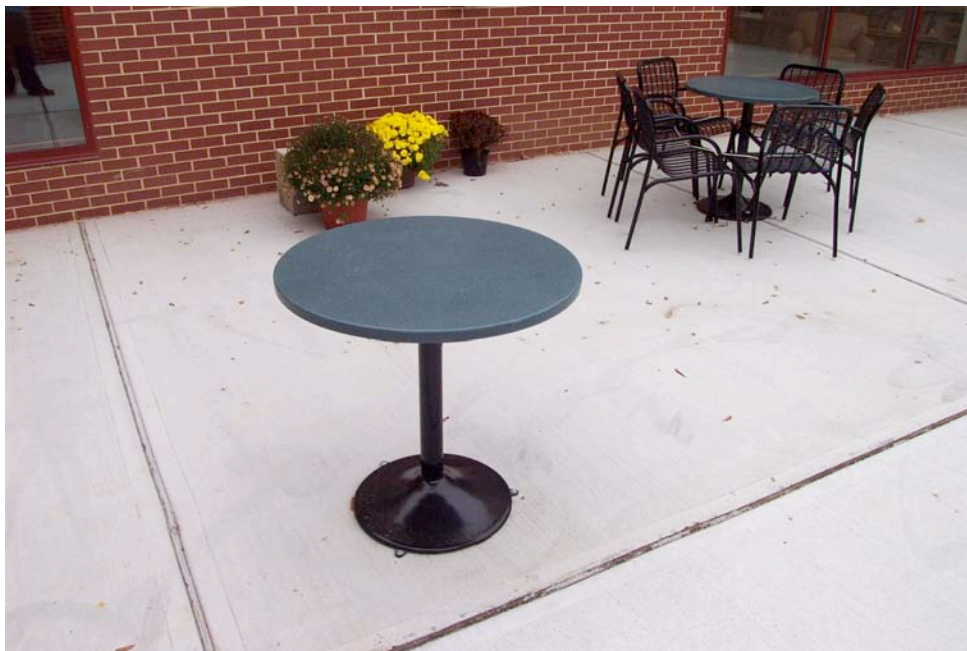
9. The secondary means of egress has tables that are not accessible contrary to ANSI section 902.3 and ADAAG section 4.32.3. Where as these tables are not built in, the important matter is offering equal accommodations to disabled customers. This area is used as a study area and should have accessible elements also.
